The main problems with Porsche engines

The 3 main failures of M96/7 engines

IMS bearing, Cylinder cracking and “D” chunking, Cylinder scoring.

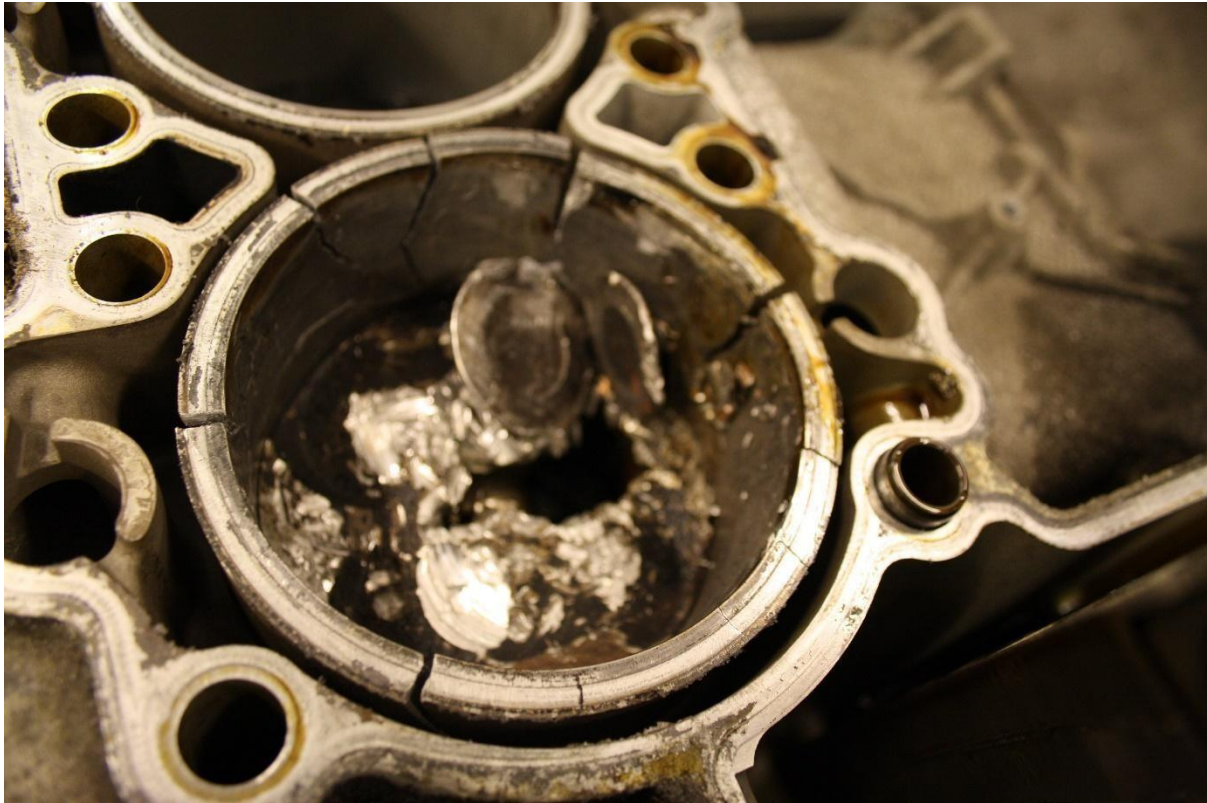
The weakness of the cylinders is also exposed when there is a major failure as shown in the following picture – but even this did not prevent us being able to rebuild the crankcase with new cylinders.

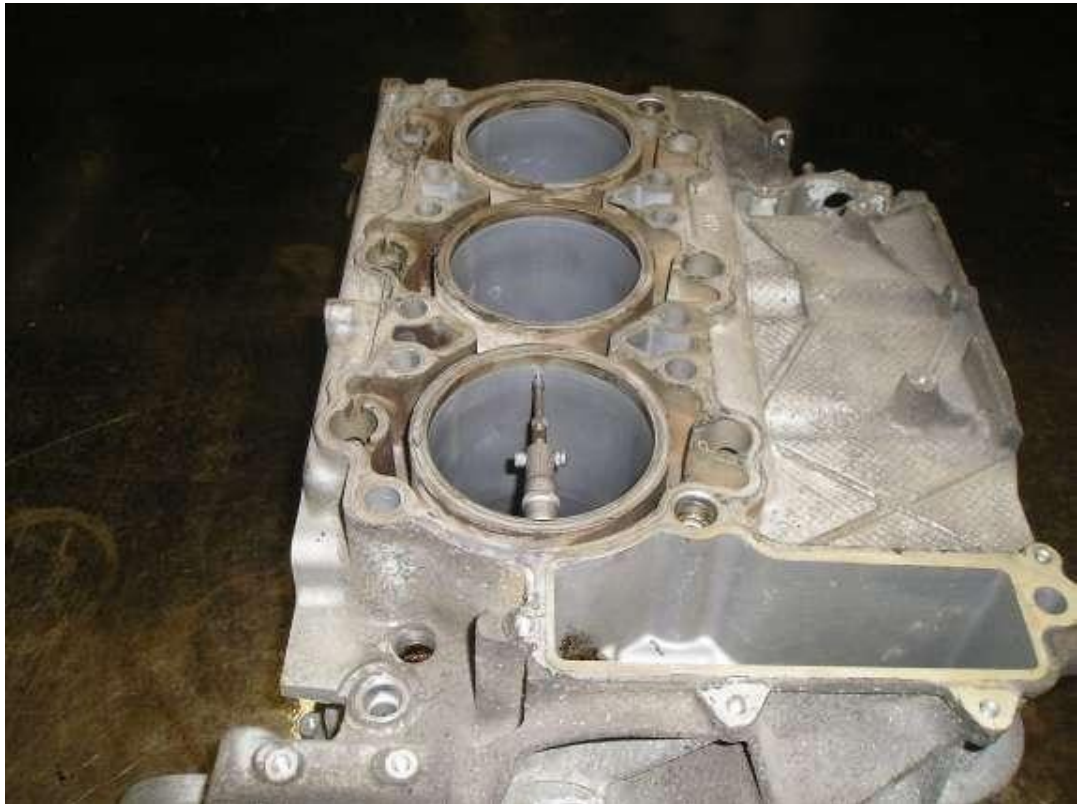
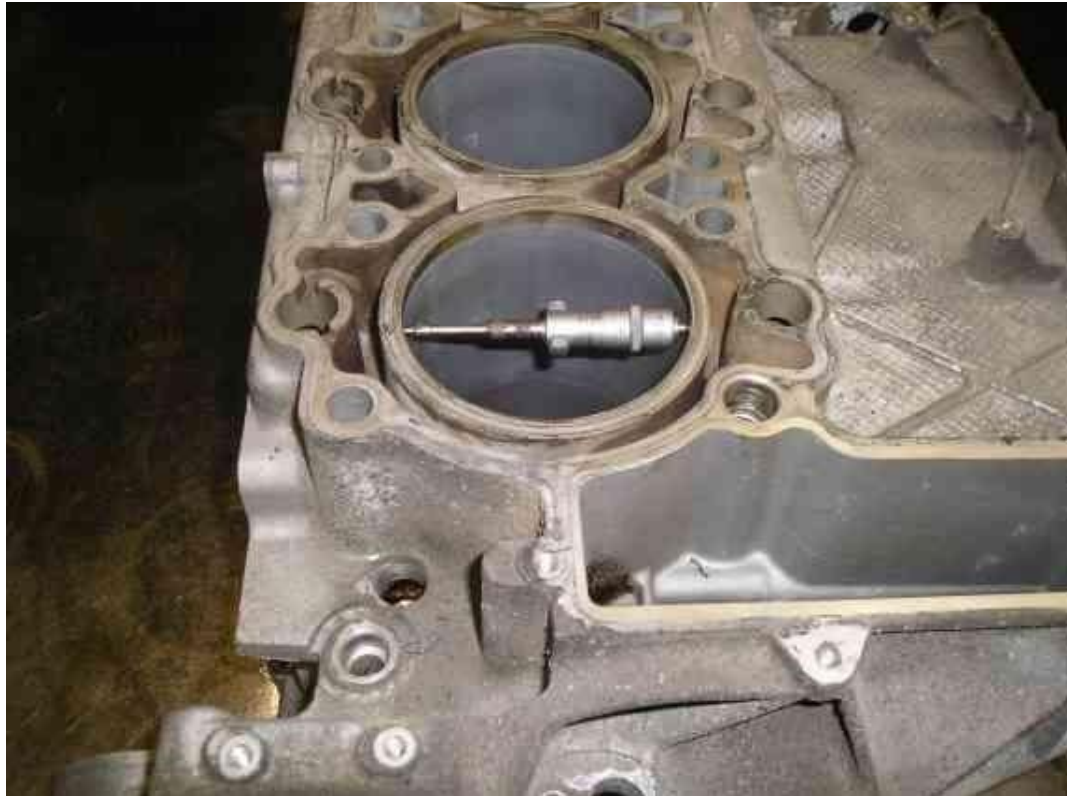
Measuring the bores showed that because the piston forces only apply to the opposite sides of the cylinder tube - they had gradually changed shape to oval and were wider in one direction (where the thrust occurs) and narrower in the other. Because pistons are also made oval there was no problem with the narrower dimension pinching the sides of the pistons (because they were already narrower) but the wider area eventually stretched the material too far at the unsupported top and cracks would appear.

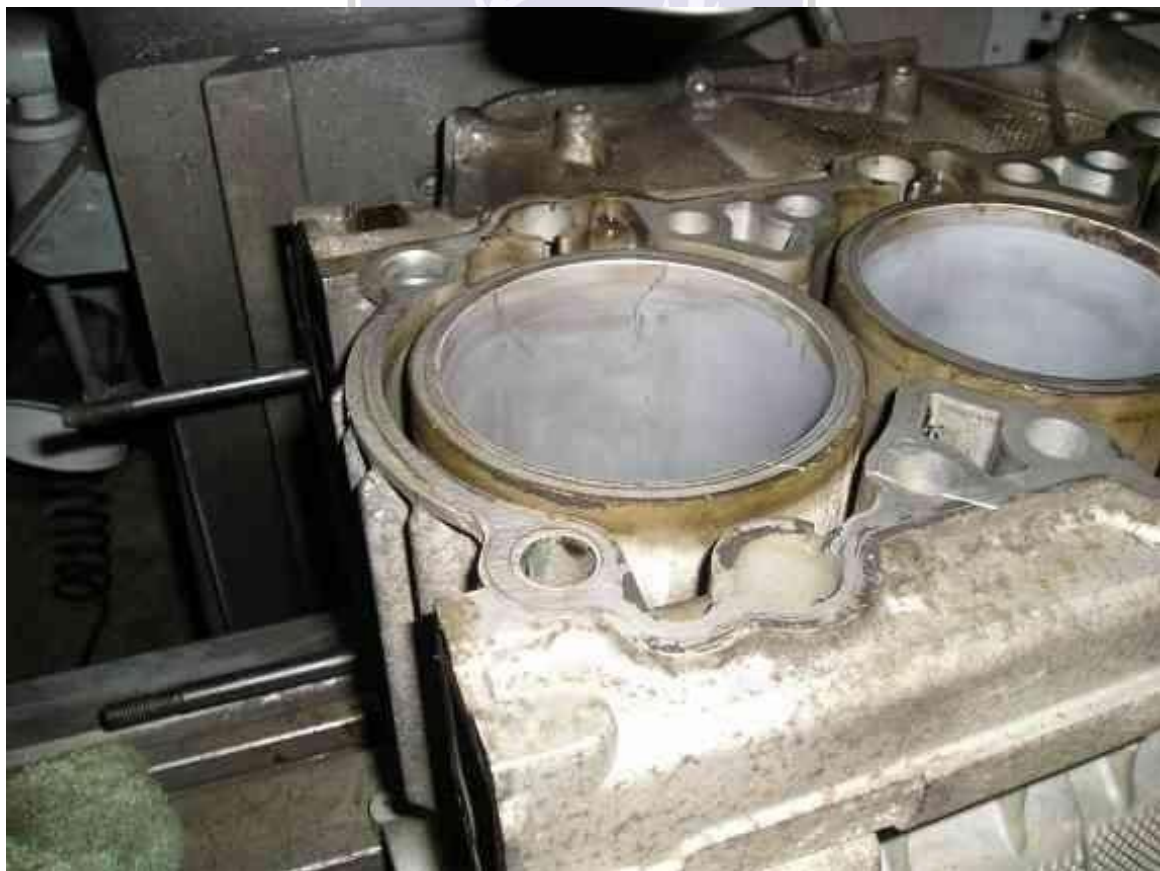
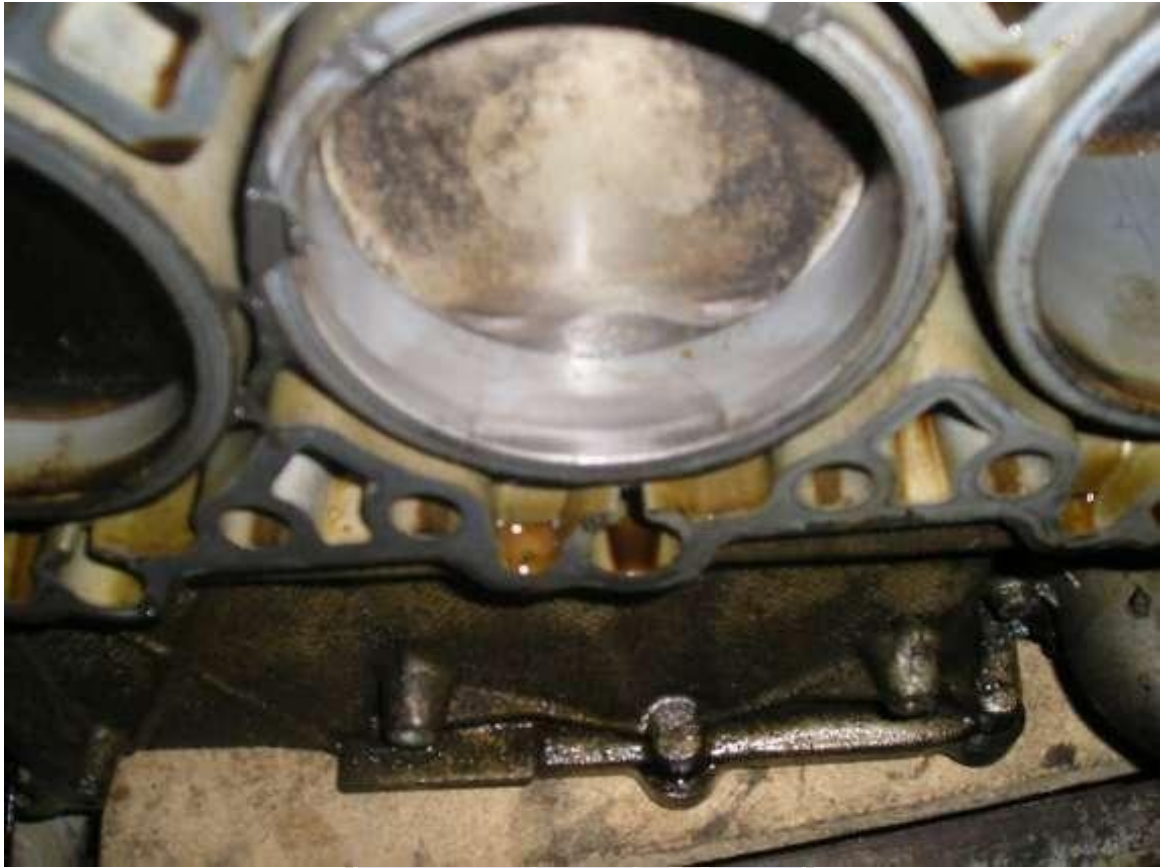
Cracks shown below leading to a chunk eventually breaking free.

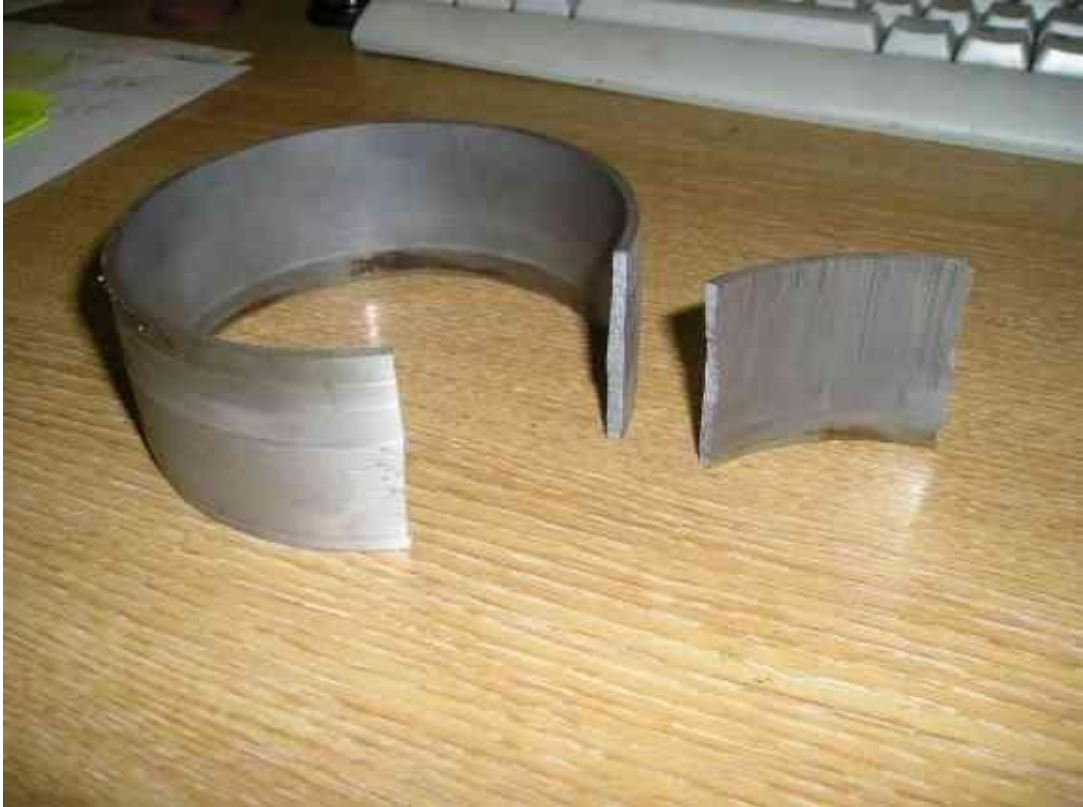
The following picture of the Lokasil portion after testing for bending resistance shows that it had a brittleness that cracked the section out before the circular tube permanently distorted (which aluminium by comparison would just bend or crush permanently oval before breaking). The cracked area clearly shows the crystalline structure in Lokasil even at this low magnification.

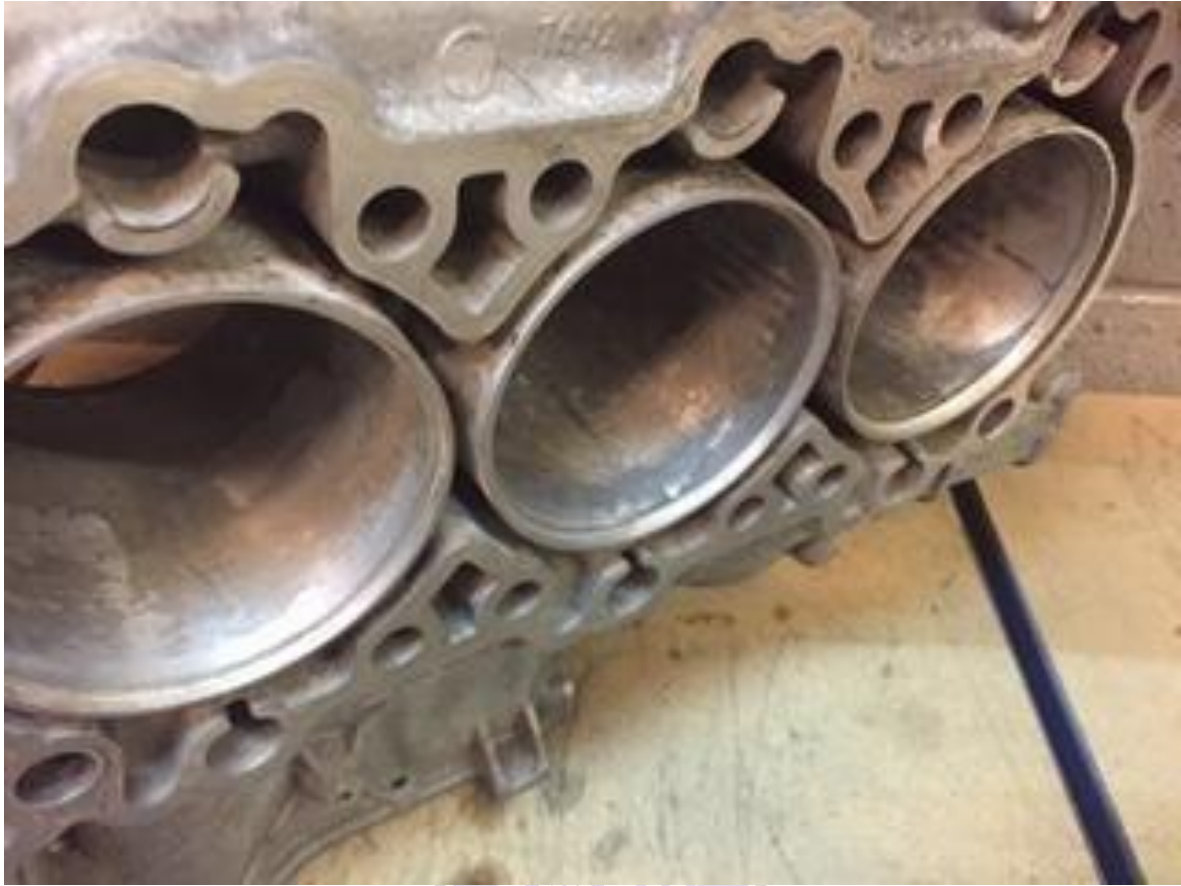
The next picture shows how once the crankcases expanded with heat – all three liners have slipped down from the top due to how thin and weak the outer remaining aluminium was and how the coolant had then got past the head gasket and corroded the bores.

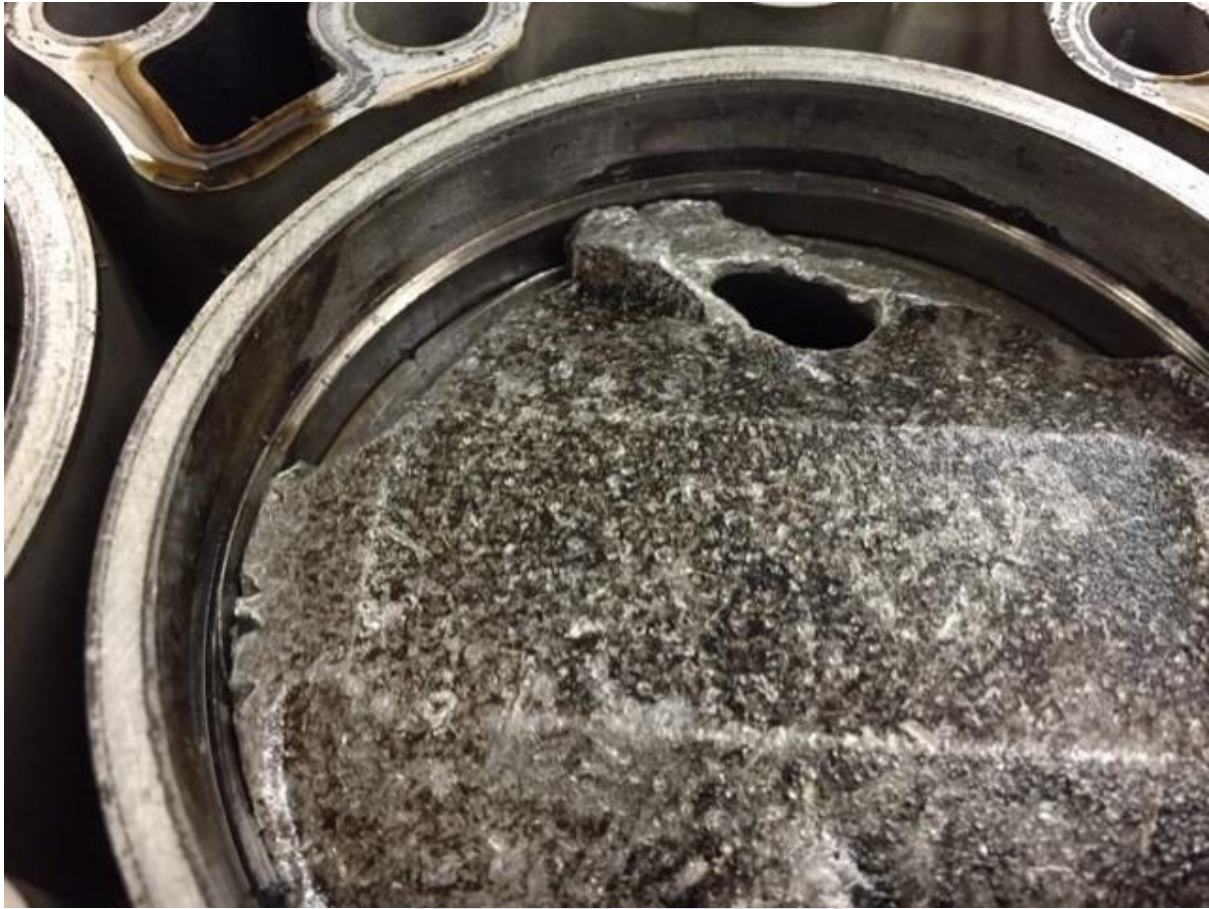
This next picture also shows a liner that has slipped down and what can happen as a result.

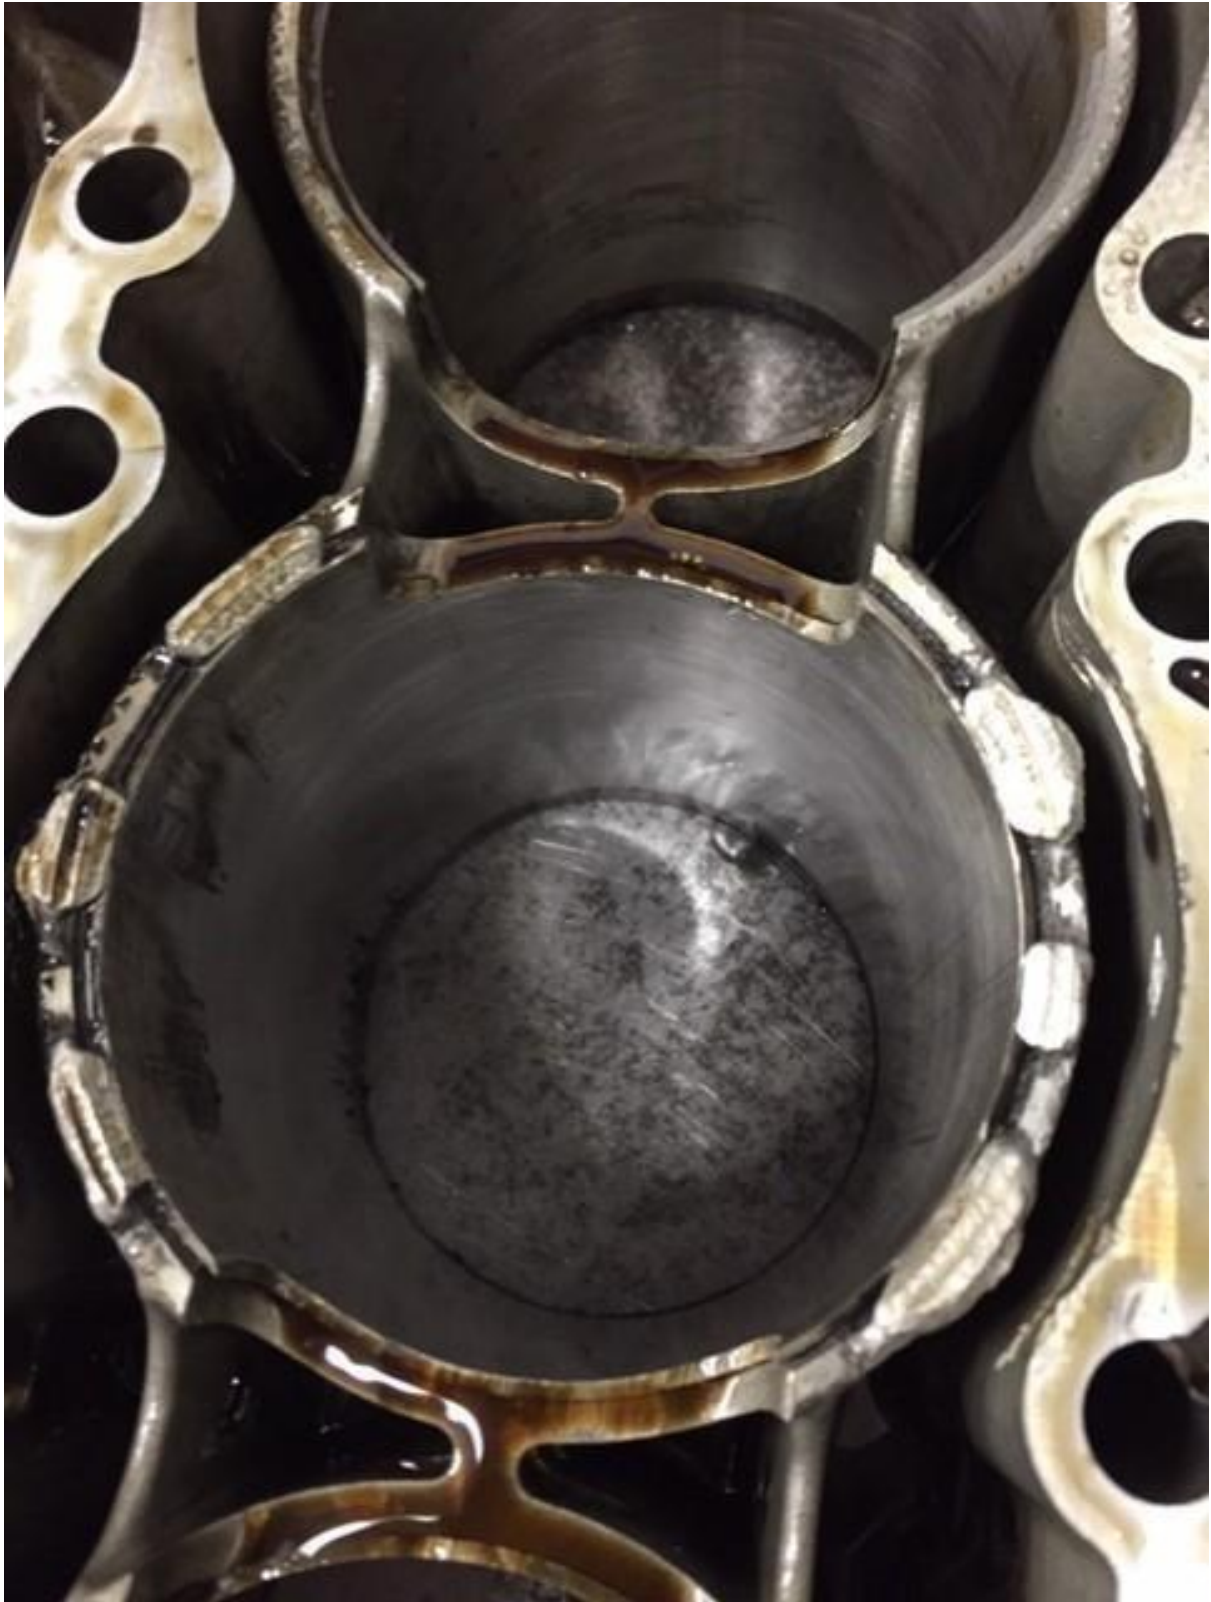
We have many more examples and so many old iron liners that we no longer bother to keep them – but this next photo just shows how far some repairers go to try and bodge the repair by trying to weld the bottom of the alloy block – to stop the liner slipping down – and you can see that despite this it still seized to the piston at the bottom. How would you feel if you had paid for a rebuild of this standard - just absolutely horrendous.

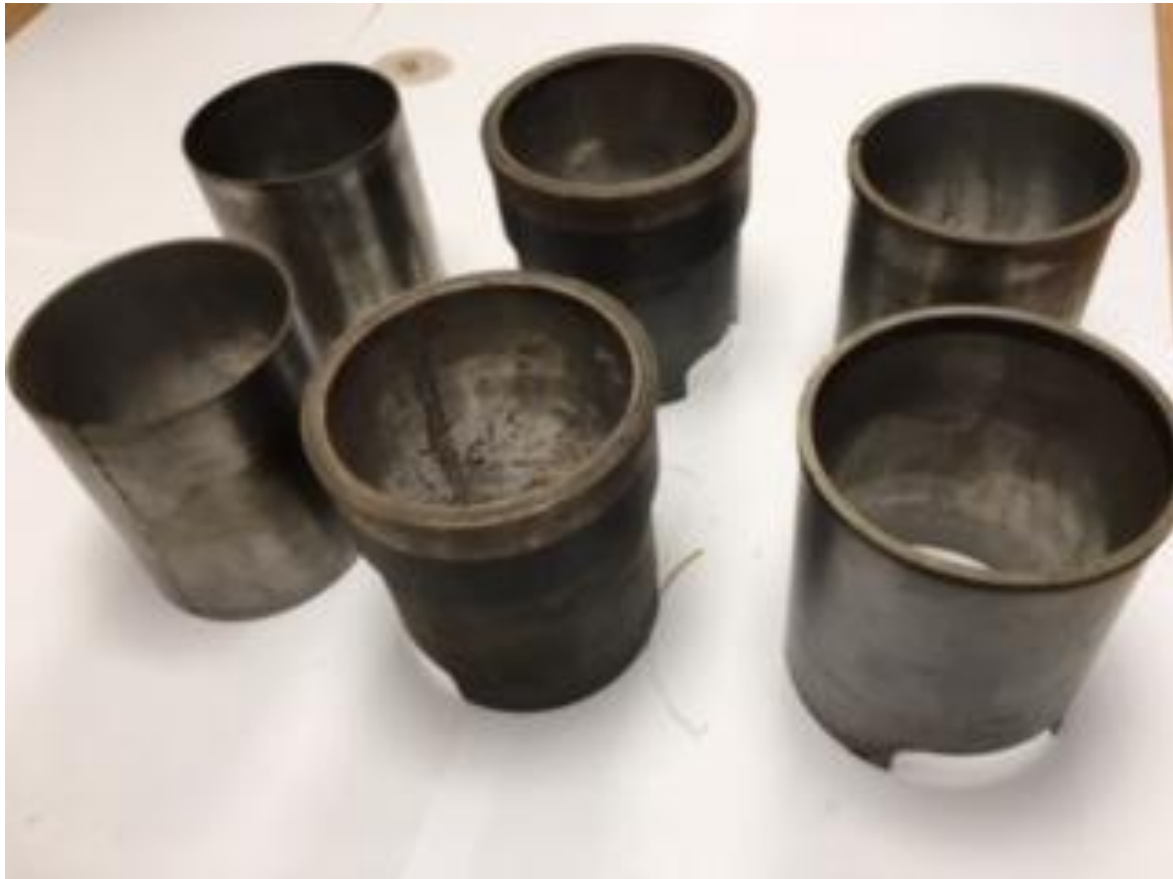
The next picture shows some of the variety of iron liner designs that failed.

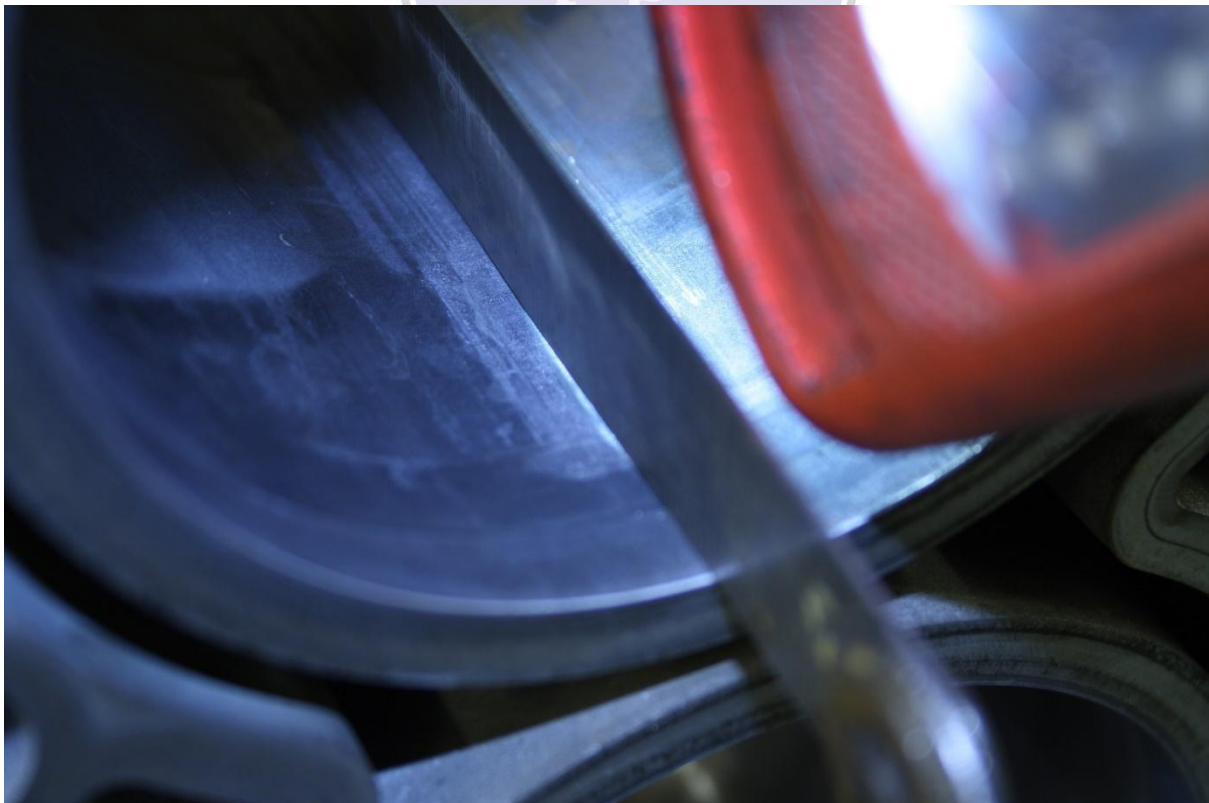
In the following picture the light is seen under a straight edge where considerable amounts of material have disappeared from the surface despite there being no actual bore scoring nearby. The shape of the missing material could not be caused by piston rings.

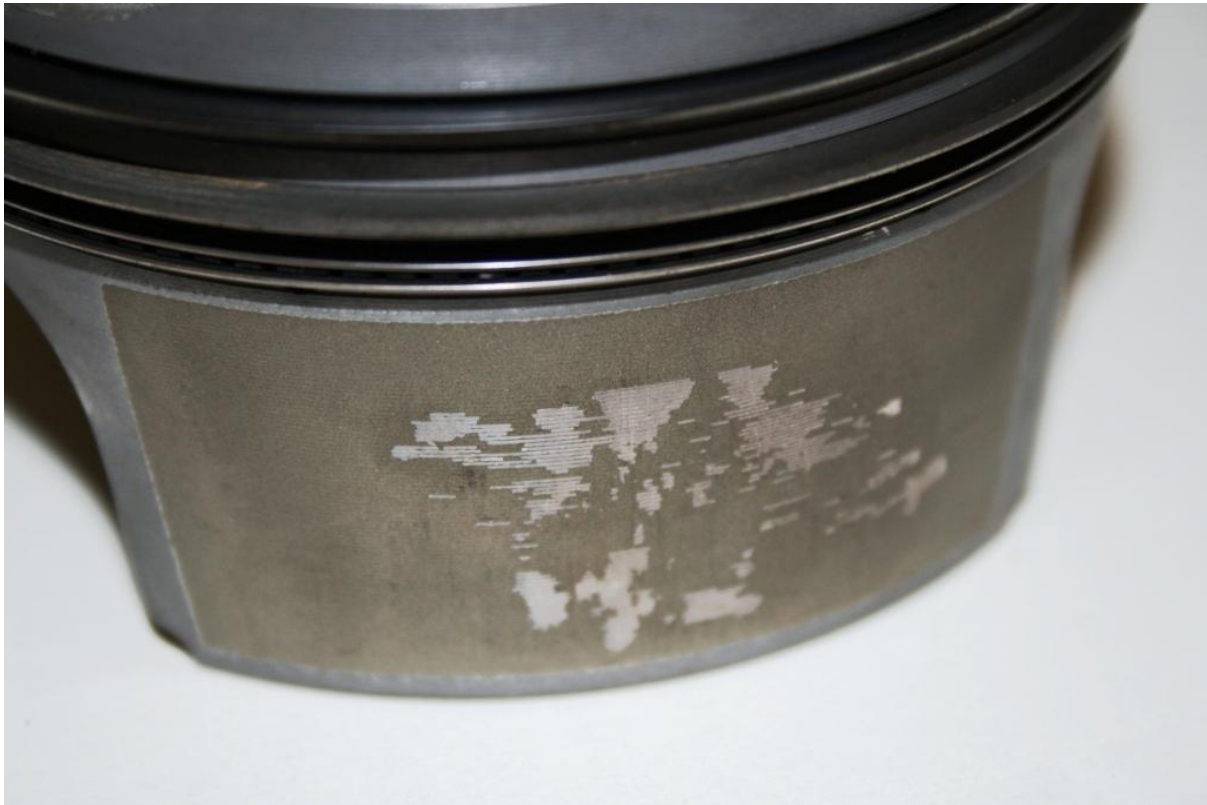
The following picture shows how loose silicon particles have gradually plucked out pieces of plastic coating moving to each side of the centre of the piston. If it was the surface of the bore that caused the problems it would be expected to result in a smooth wear pattern all over the thrust face and not patches as observed.

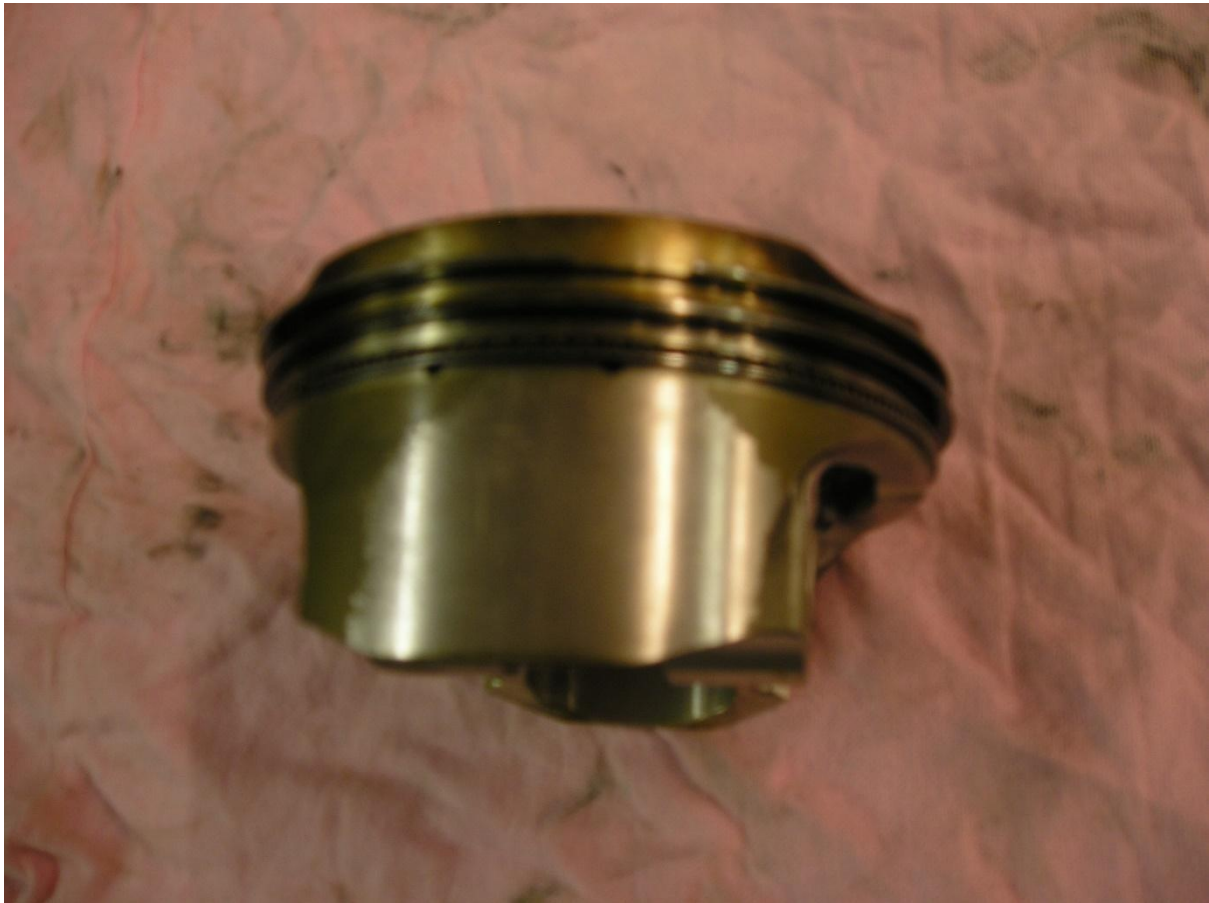
The next photo shows how sometimes we find a whole area has just completely flaked off leaving the original piston surface shiny (as it was when it was originally machined) before wear against the cylinder wall would dull the surface.

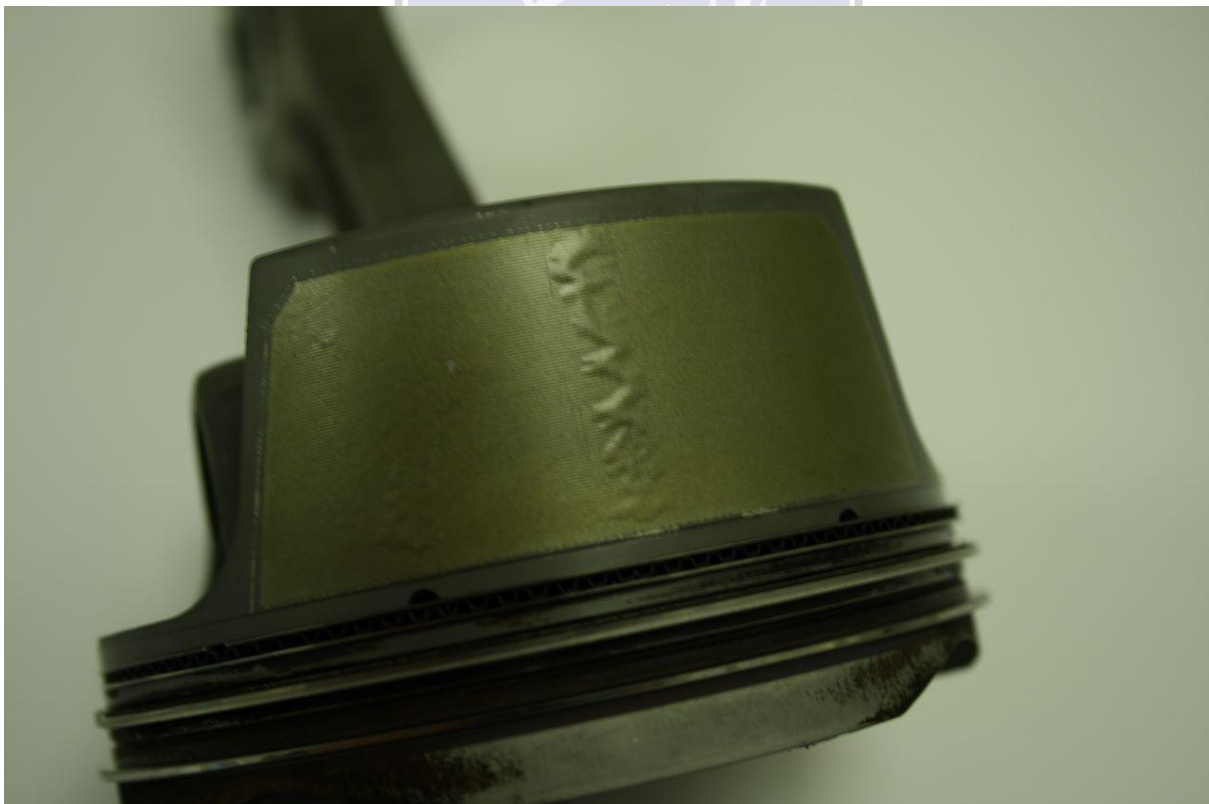
And this photo shows that bonding strength of the plastic coating to the piston face must also be an issue to enable a diagonal strip that will have been plucked in the centre first - to come off diagonally when all the motion is only vertical.

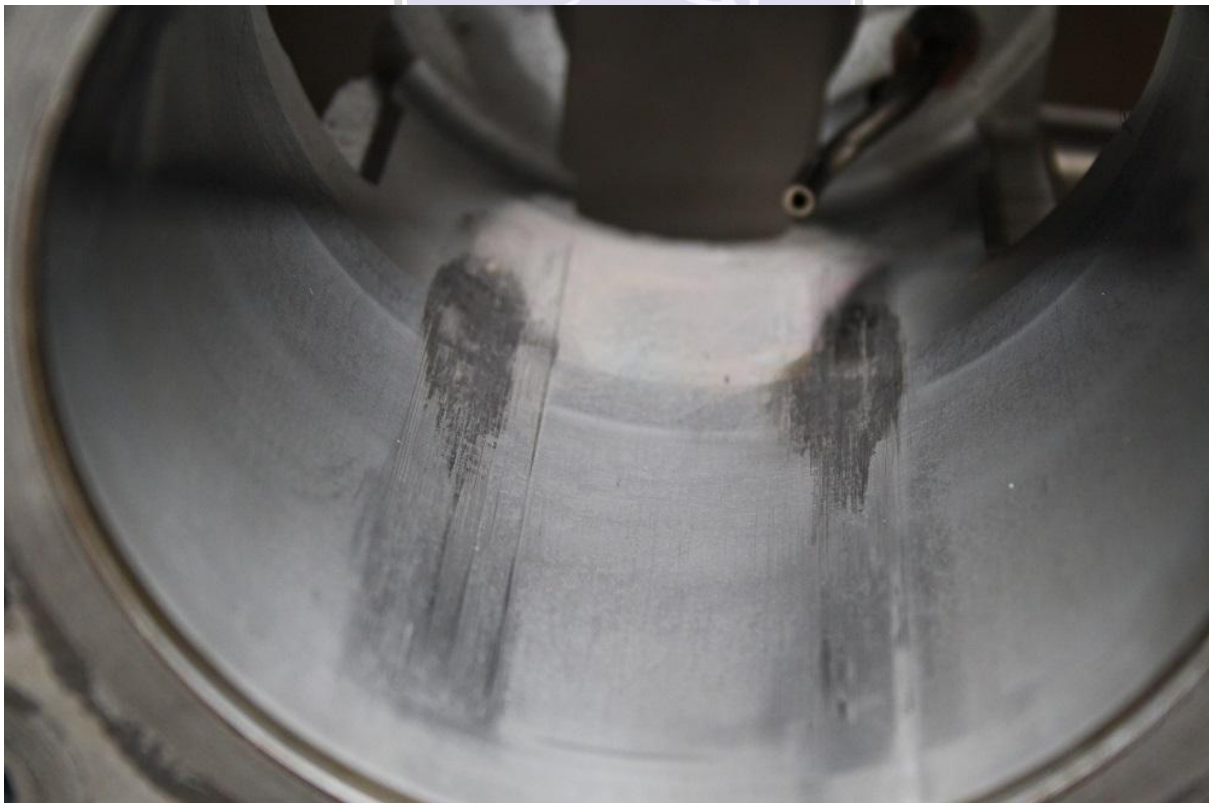
It is very clear from the following photo that the area that has seized is in line with the connections across the bore of the lower casting areas.

The 2 principle causes of this failure are – (a) anything that makes the piston run hotter than it was designed to do – resulting in it expanding thermally too much (weak mixtures, too advanced ignition, higher coolant temperatures, loss of
