Hartech Engine Rebuilds (interim)

Index of the content with explanations and descriptions.

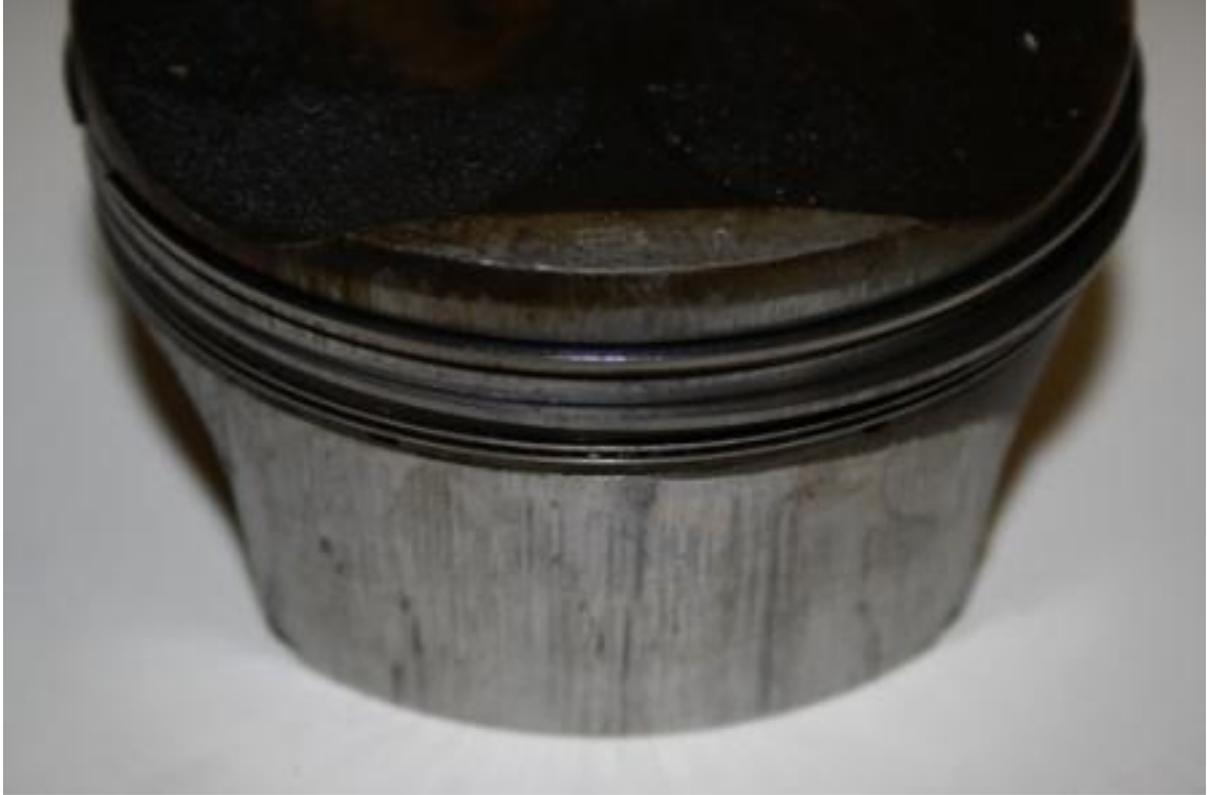
PICTURE OF A SCUFFED PISTON AND SIGNS AT THE TOP EDGE OF THE PISTON TILTING AS A RESULT OF INCREASED PISTON CLEARANCE AND TAPPING AGAINST THE SQUISH BAND TOP OF THE CYLINDER HEAD.

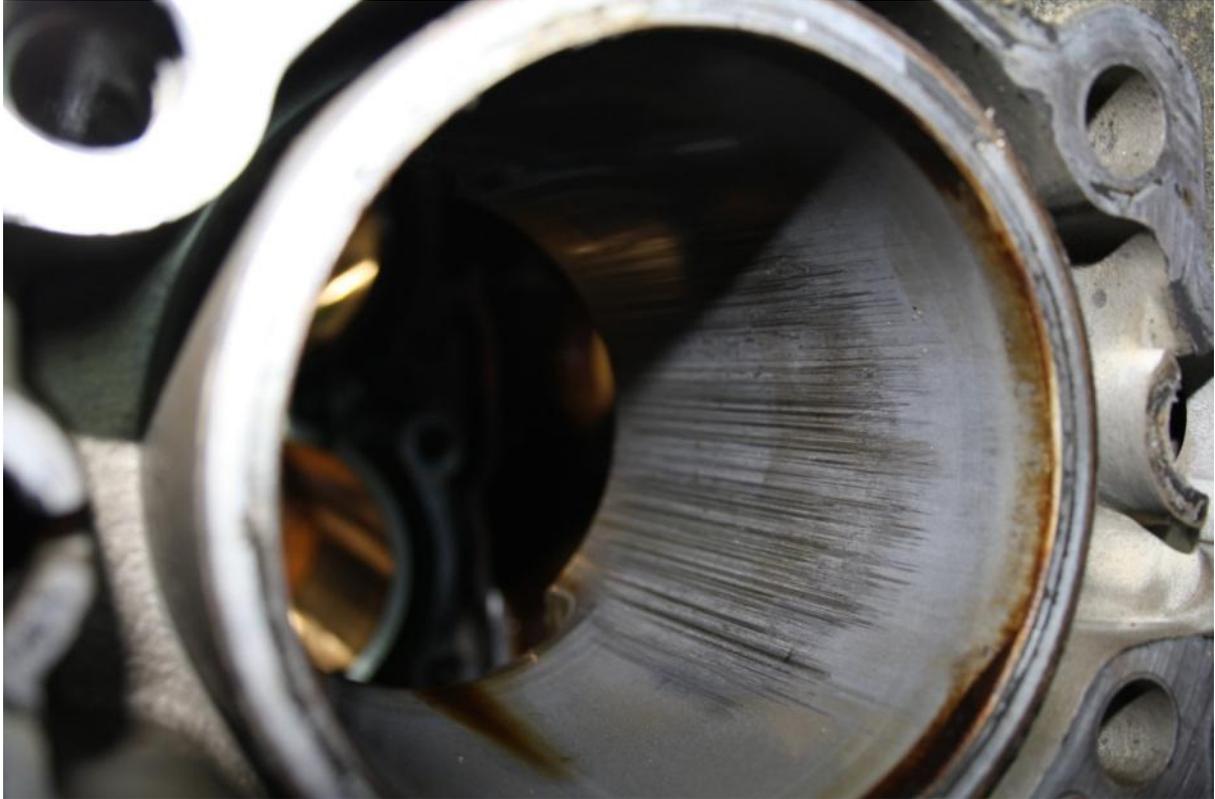
THE PICTURE BELOW IS A GOOD EXAMPLE OF THE RESULTING CYLINDER SCORING.

This usually afflicts cylinder no 6, or 5 and 6 or 4, 5 and 6 – almost always from bank 2 (4, 5 and 6) only very- very rarely from the other bank 1 (cylinders 1, 2 and 3). Note (for future references) that the top is not scored – the bottom is and the scoring is in a slight oval pattern widest midway down.

The pistons are always badly scored on one side only (always the thrust side where the piston transfers the pressure between it and the cylinder wall into rotational movement turning the crankshaft under power). The other side has usually survived seizures but pistons often show signs of the coating material delaminating in patches (due to the high temperatures and pressures).

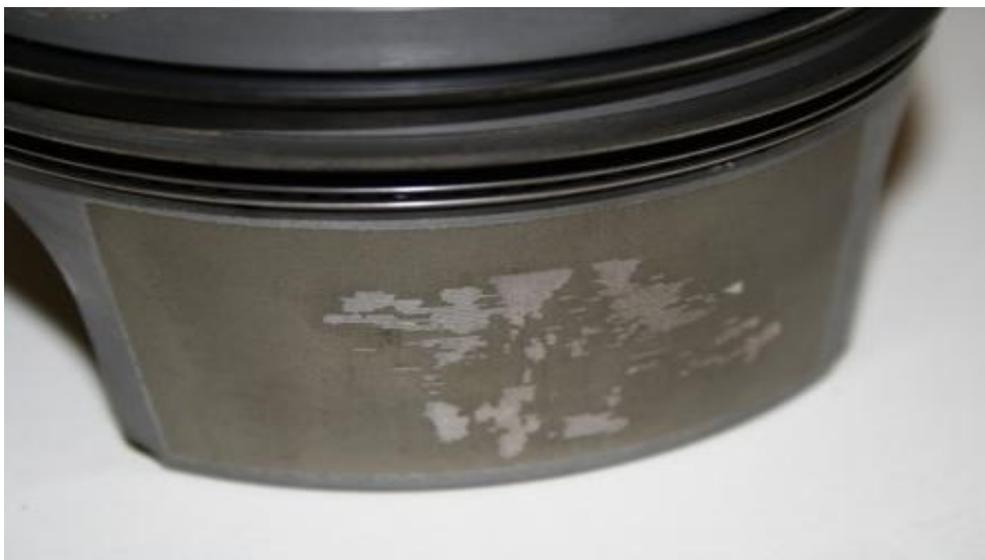
PICTURE SHOWING PISTON COATING DELAMINATION

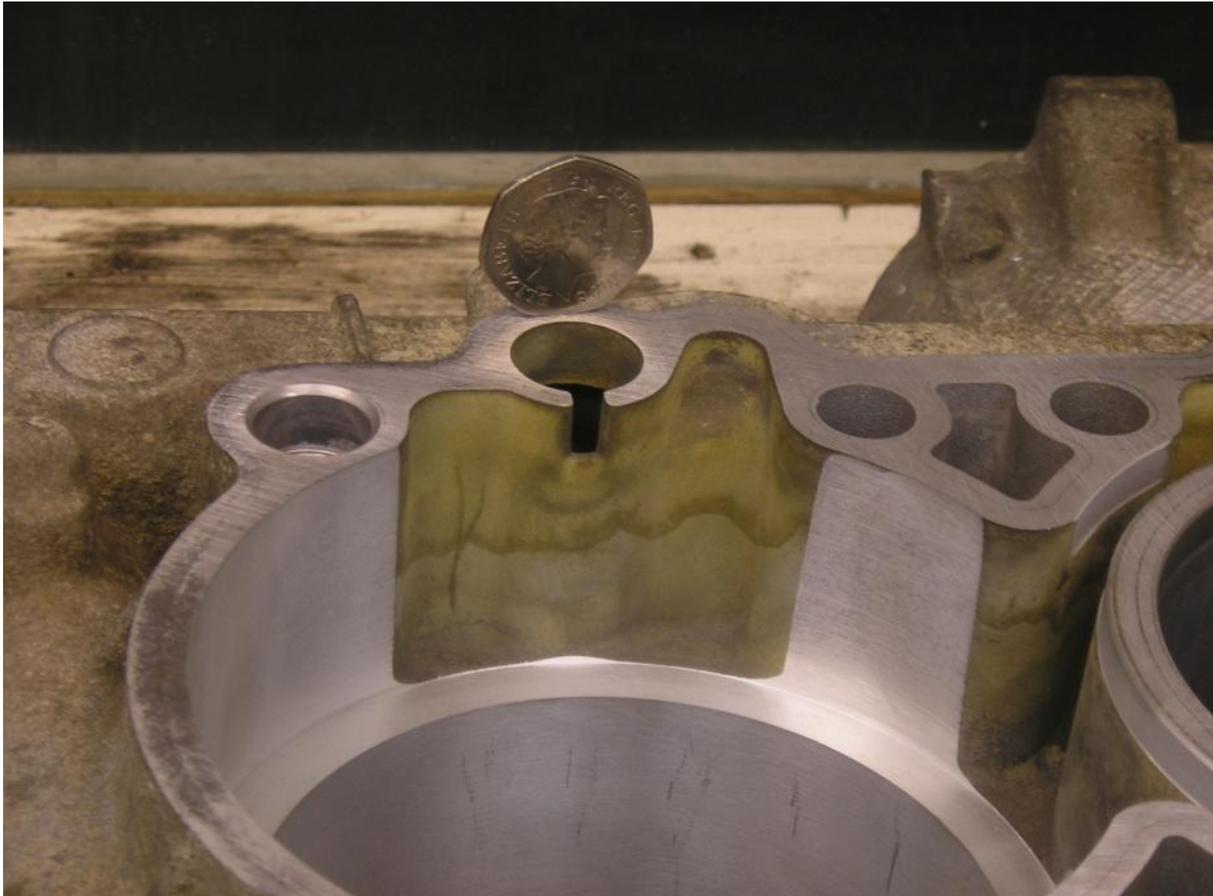
PICTURE OF a typical BLOCK TOP (machined out to fit a Hartech liner) that shows the hole that feeds coolant upwards to the cylinder head (near the 50P coin) and the tiny slot in front of it (that is all that feeds coolant into the cylinder block to cool the cylinder walls and the piston skirts).

By altering the inlet and outlet slot sizes from the tubes that feed the coolant into the cylinders – this split enabled Porsche to control the flow rates into all 6 cylinders individually. To refine that control further, models up to and including the 996 3.4 also had different sized holes in the head gaskets connecting the feeder hole to each individual cylinder head as well (getting larger as the feeder tube flow reduces – towards the clutch end), the biggest being the number 6 cylinder head feed hole in bank 2. Hole diameters are 11.2mm (cylinder 1 & 4), 12.8mm (2 & 5), 14.8mm (3) and 20mm (6) making cylinder 6 feed hole area 3 times the flow capacity of cylinders 1 & 4.

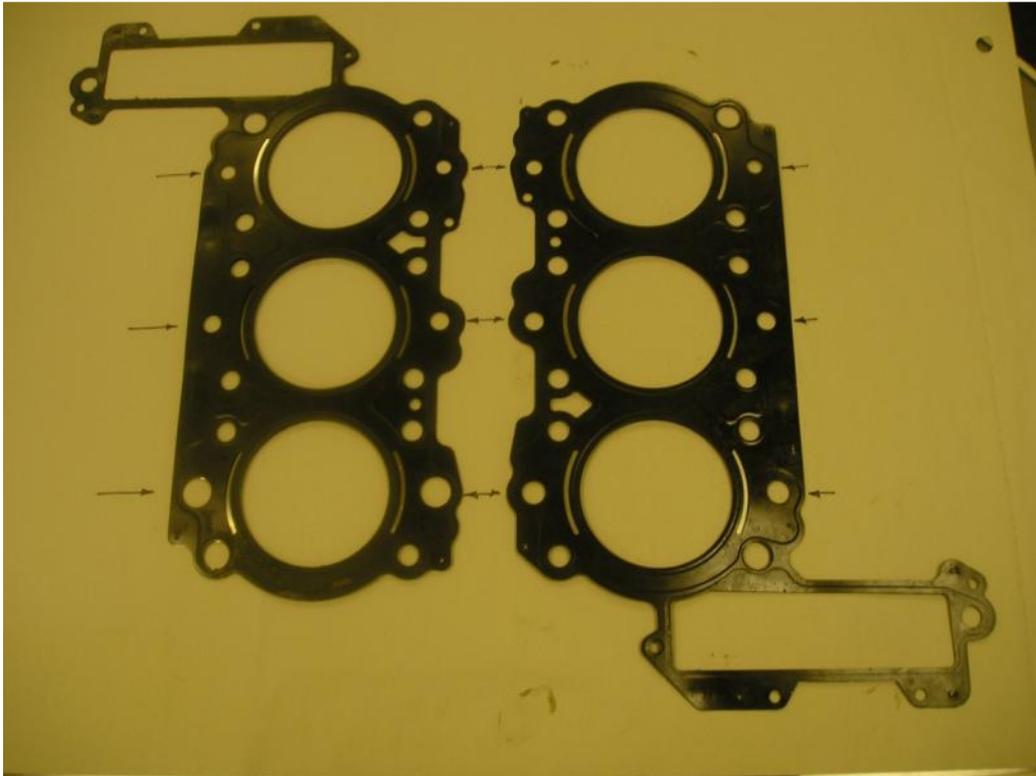
The opposite gasket is on the right hand side to that. If it was turned over so it mirrored the left hand side gasket you can see that the hole that is the biggest on the left hand side gasket would be adjacent to the smallest hole in the right hand gasket. So if the same head gasket was being used for both sides – it would reduce the coolant flow for the same cylinder by about 66%.

An independent specialist (that we repair engines for) actually had this experience when they mistakenly fitted the wrong gasket to the wrong side of an experimental supercharged engine (apparently the gasket had been supplied in the wrong package/part number) and by doing so innocently swapped the coolest feed (intended for the hottest cylinder) for the smallest feed and the result was a similar seizure and cylinder scoring – demonstrating the importance of this asymmetric arrangement.

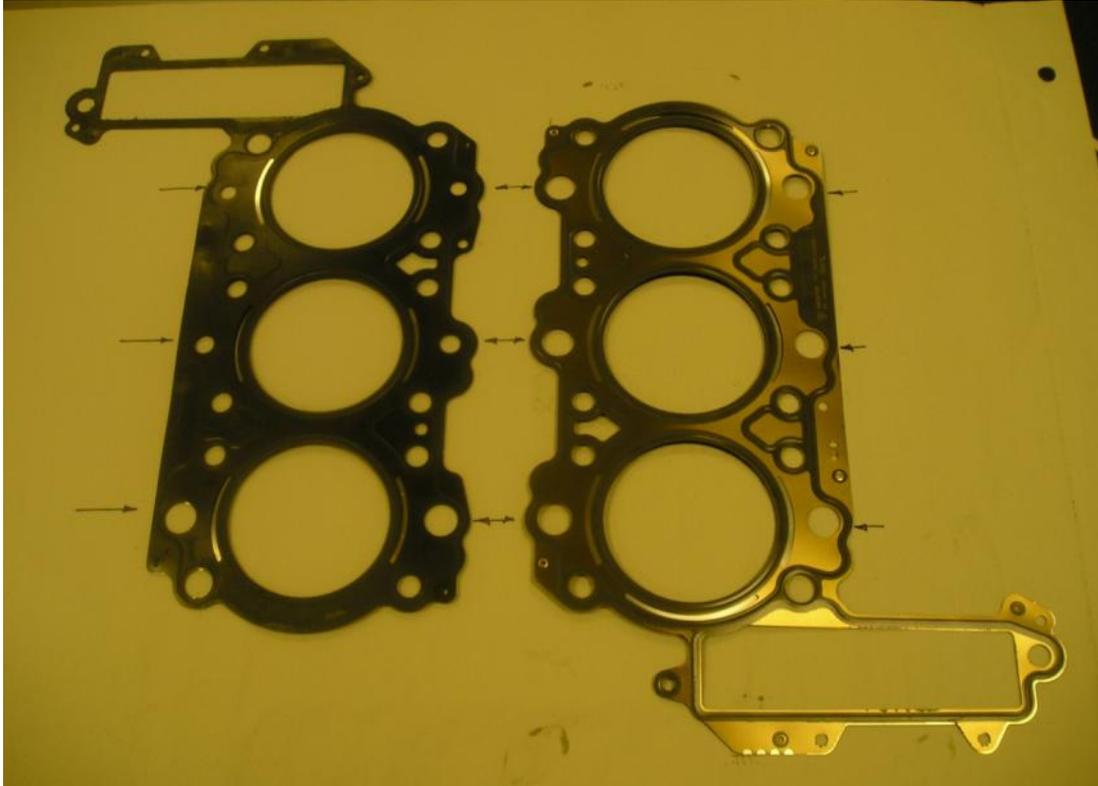
The next picture below shows the 3.4 gasket used above still on the left hand side set against a 3.8 gasket (the same as a 3.6 and 3.4 Cayman S gasket except for the bore diameter) on the right hand side that clearly has all the coolant feed holes the same size (so it can be fitted to either side of the engine). By this change only one type needs to be manufactured and stocked and production numbers double and unit costs drop – but in so doing the fine control to the coolant flow rate to each individual cylinder (that the original gaskets provided for in the older engine types) has been reduced resulting in a different temperature distribution that could result in some cylinders running hotter than others where they were previously better balanced.

These larger holes allow more coolant to pass into the heads (and therefore less into the cylinders which must then run hotter) so by standardising the feed hole sizes to save production costs the control of individual areas of some cylinders is not as good (and they will run hotter than the older versions), creating more hot spots promoting the idea of a cooler thermostat to compensate.

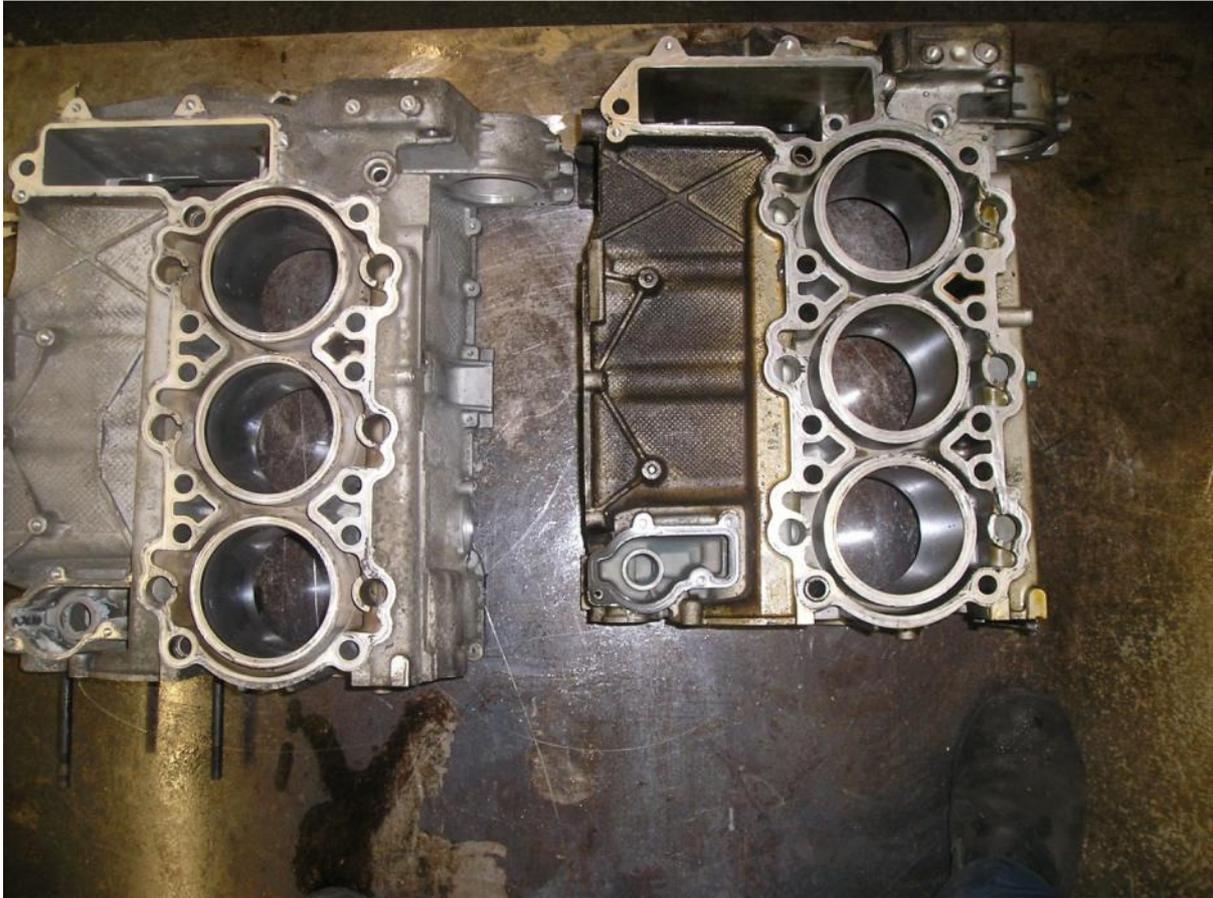
PICTURE TOP OF 3.2 Boxster S and 3.4 BLOCK

Section 4 of this buyers guide describes in detail how that results in gradual “creep” and the bores go oval in the thrust direction by up to or over 0.2mm (0.008”) and then can crack. This increase in ovality has four detrimental effects on piston temperature (1) Blow by of hot burning gasses past the piston increase and burn or overheat the oil film, (2) the contact area between the piston, the oil and the cylinder wall (through which the heat is dissipated) reduces as only one half is sufficiently in contact with the bore at any one time, (3) the piston rings are unable to bend into an oval shape (don’t wear either) so don’t do their job properly (4) when the engine has stopped the pistons sit on the bottom face of the bores (through gravity) and the oil tries to drop or flow down to the bottom of the bore. A tight clearance will keep some oil in the gap in between the piston and the bore (due to surface tension) but if the gap gets too big it will allow the oil to slide away leaving the top of the piston (the thrust face on bank 2) relatively dry for the next cold start-up. Some owners have a bad habit of starting a car with some throttle to let it rev to circulate splash oil quickly to all the internal parts (as most wear takes place on start up and older cars often had splash lubrication then). But in this engine layout there is very little splash oil anyway and big bore clearances leaves the top of the

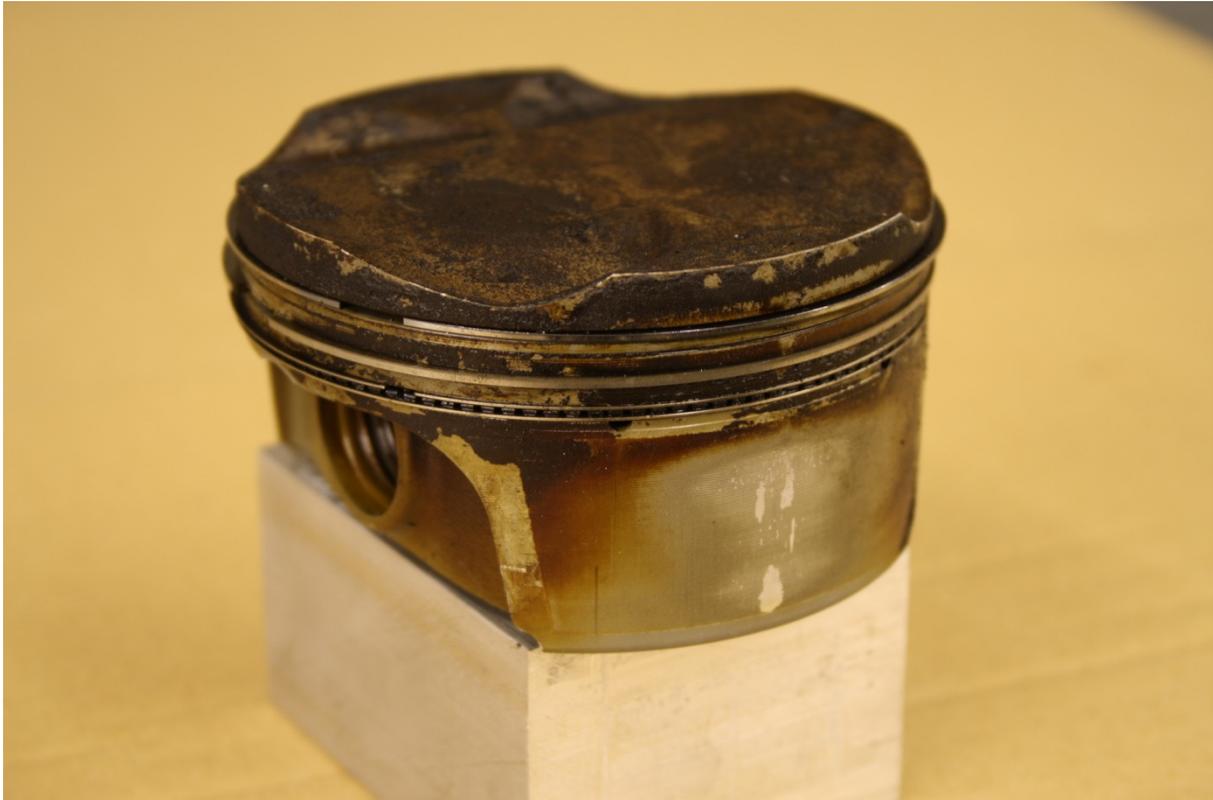
You can see from this typical picture above how the diameters near the rings (and the sides below it) are totally coated in carbon (because they are machined too small to reach the cylinder bore) and you can also see that the actual contact area where the piston is pushing hard on the cylinder wall is really quite small. Just like a stiletto heel making a depression in a floor because the load (or weight) is concentrated over a small area (compared to a shoe heel) rather than being spread over a wider area - this increases the force trying to squeeze out the oil film that is keeping the piston and the cylinder bore from rubbing against each other (causing scoring or a seizure).

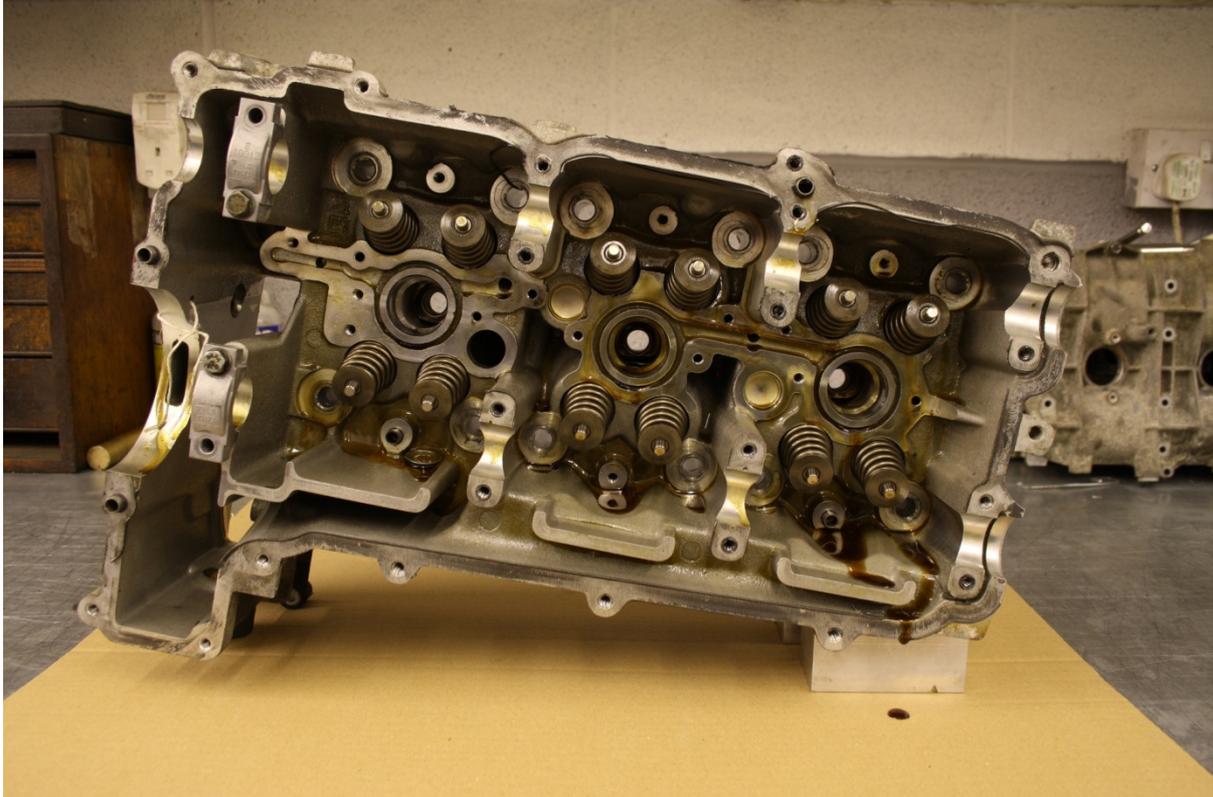
In this case the engine has been designed to allow the oil that is pumped into the cylinder head camshaft journals etc to flow back via the chain housing through a 5 degree slope in the casting (see photo below).

The drive at the home of one of our staff is steeper than this so if the car is parked at a similar angle to the photo – you can see that oil will become trapped in the right hand lower area of the 2 valves and springs. With each head being the opposite way around to the other – this cannot be avoided whichever way the car is parked (as there will always be one head this way around), nor is it different in a Boxster to a 996/7 even though the engine faces the other way around. It also seems to vary with the position the engine stops at – whether the exhaust valve happens to be open on the lower cylinders or not. If it is then there is less of it inside the guide and more overhang so it can tilt allowing oil to seep into a worn seal and down the valve shaft into the exhaust port where – on start up – fresh oil will quickly burn/smoke. We have tested this theory on the angled drive in numerous different cars - many of which we have later rebuilt and checked (together with the results) and it does seem to explain some of the start up smoking (which would obviously be worse on a worn out engine).

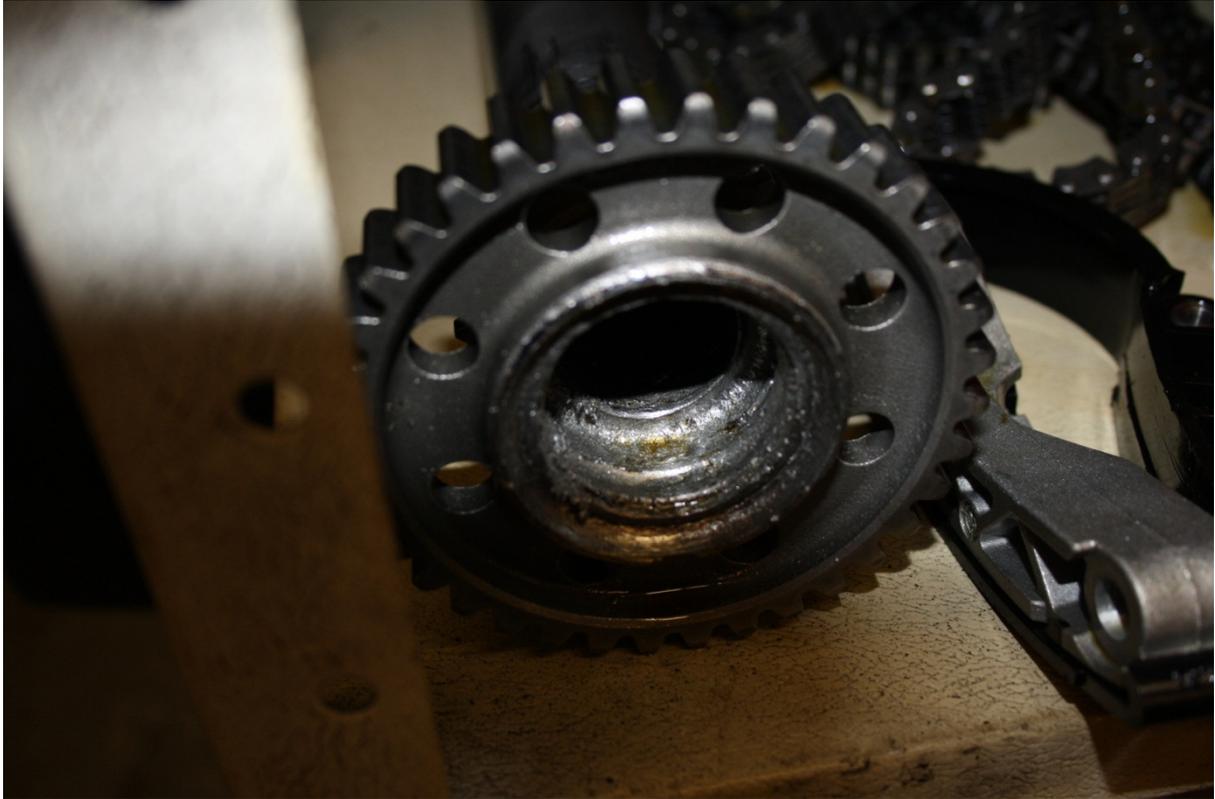
The majority of engines with IMS bearing failure have also damaged the end gear (that supports the bearing) beyond repair. Furthermore older engines with roller chain crankshaft/camshaft drives cannot be fitted with the later IMS shaft with the larger bearing because it would need a new crankshaft to mate with it – so replacing IMS failures is becoming more expensive.

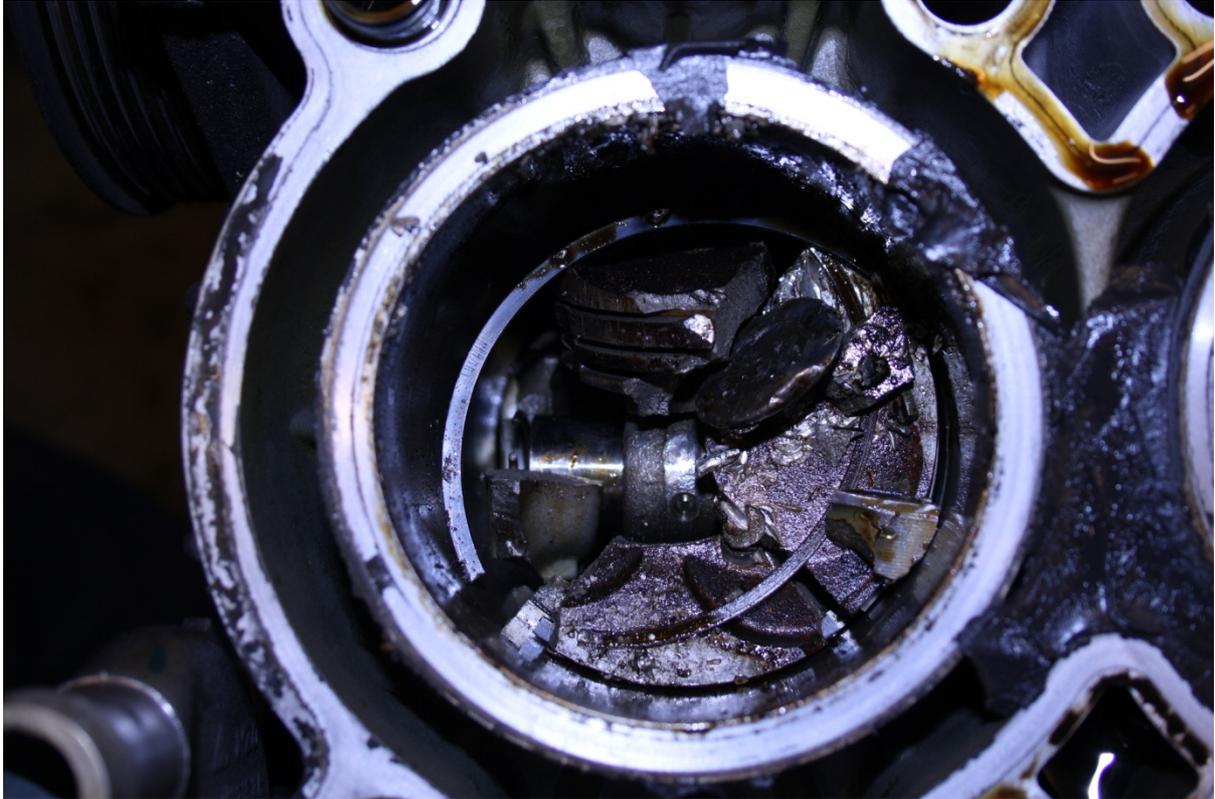
As a result - some specialists are trying replace damaged bearings in situ (to save costs) but the problem is knowing for sure if any damage has resulted elsewhere inside the engine that will come back and bite the owner and involve even more expense in the long run (as it did with the following photo of the end result of someone else's attempt to replace a damaged bearing) – wrecking the engine beyond economical repair..
