The main problems with Porsche engines

The 3 main failures of M96/7 engines

IMS bearing, Cylinder cracking and “D” chunking, Cylinder scoring.

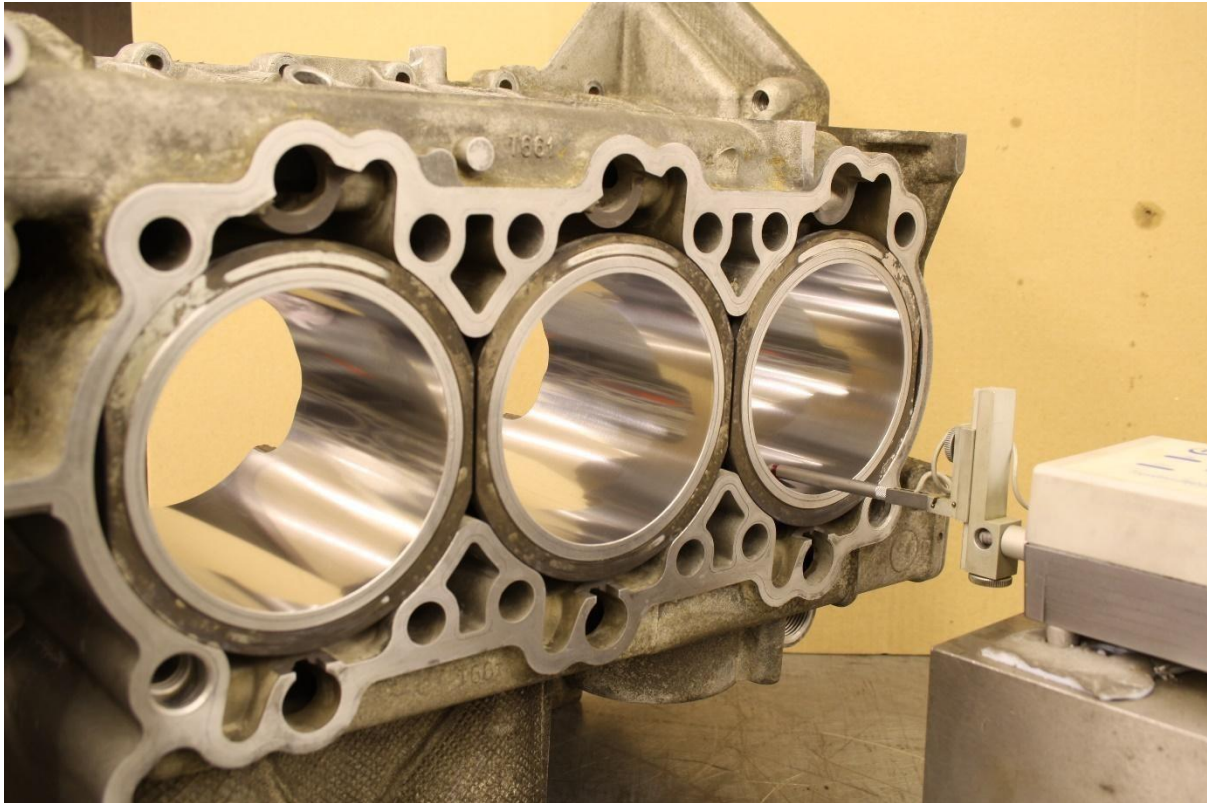
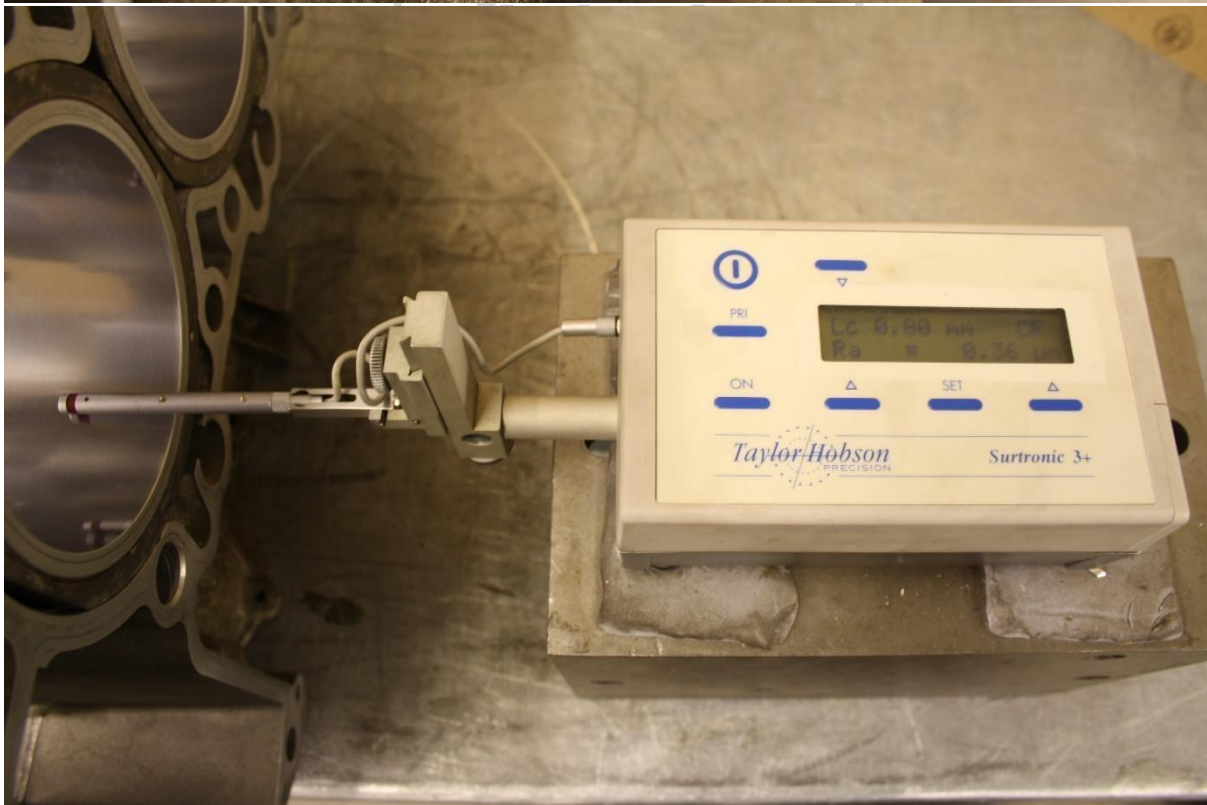
Pictures of one of our cylinders having the surface finish checked follow.

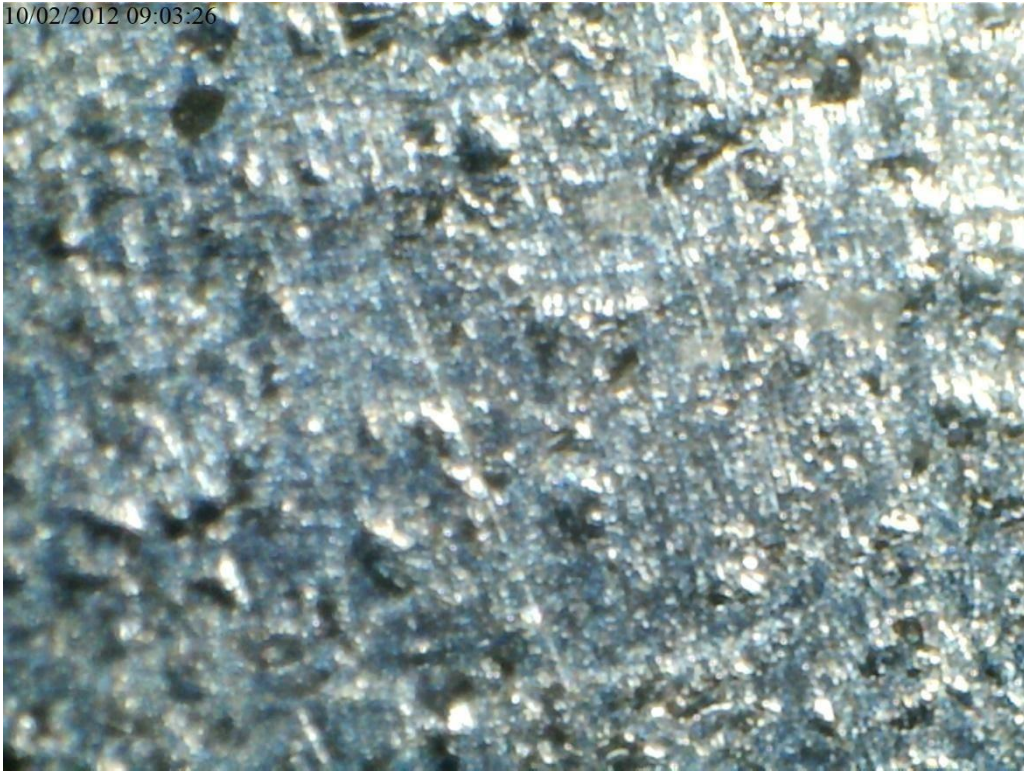
10/02/2012 09:03:26

This is a picture using a special microscope camera showing how the surface is composed, the aluminium and the small pieces of silicon.

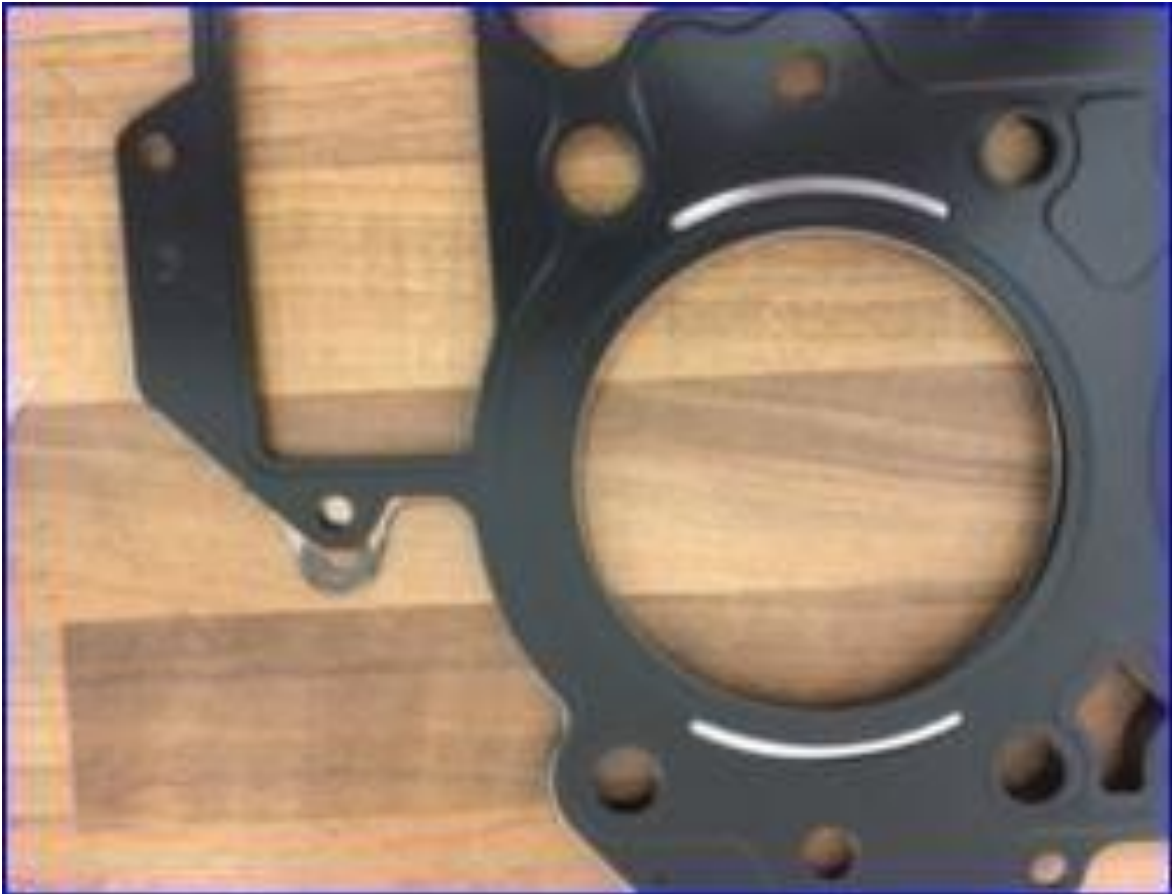
To maintain a good head gasket seal and prevent small flexing movements between the top of the cylinder face and the head gasket damaging the sealing face a thin plastic coating was bonded top and bottom – and that and the top and bottom layer of the gasket had a circular segment on the front and rear pressure face cut out – so the gasket face could move with the flexing cylinder and not damage the thin plastic seal. In this picture the centre of the 3 layer metal gasket is the light colour positioned in the thrust direction and reveals the area removed from the top and bottom layer to allow it to flex.

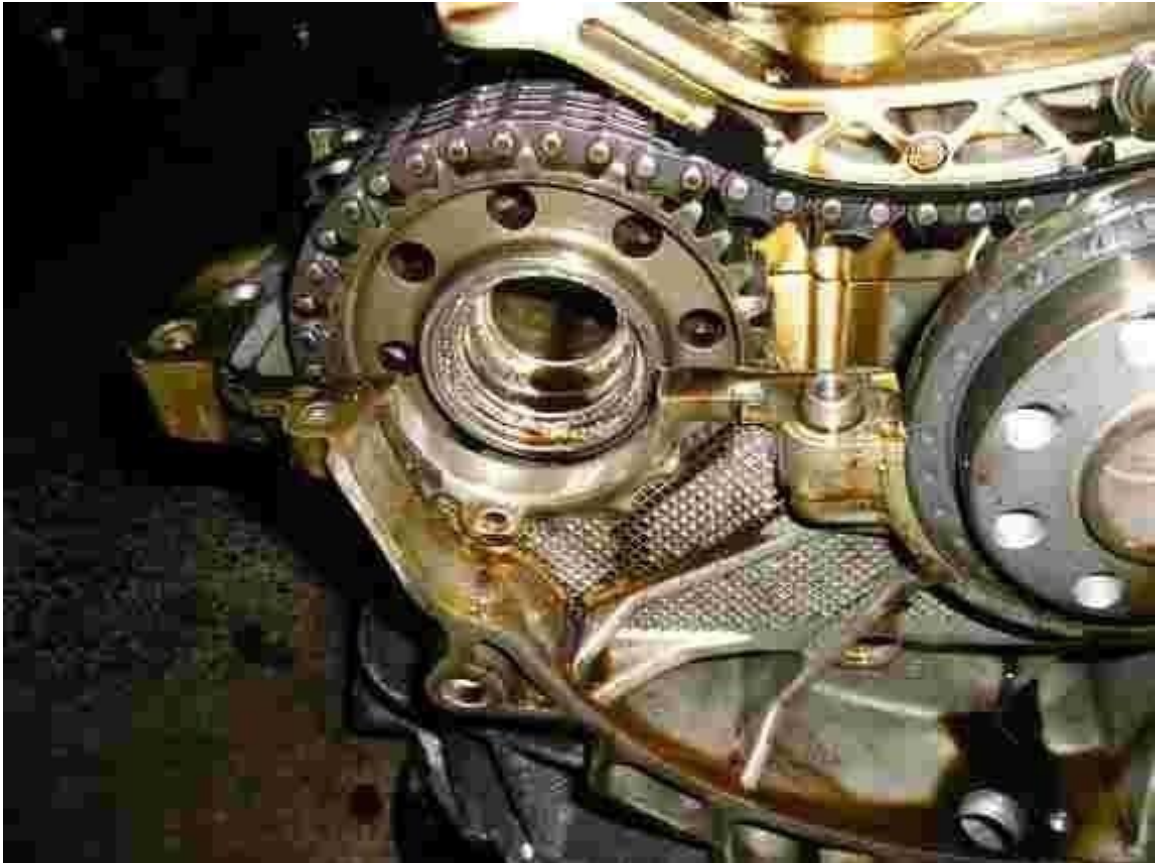
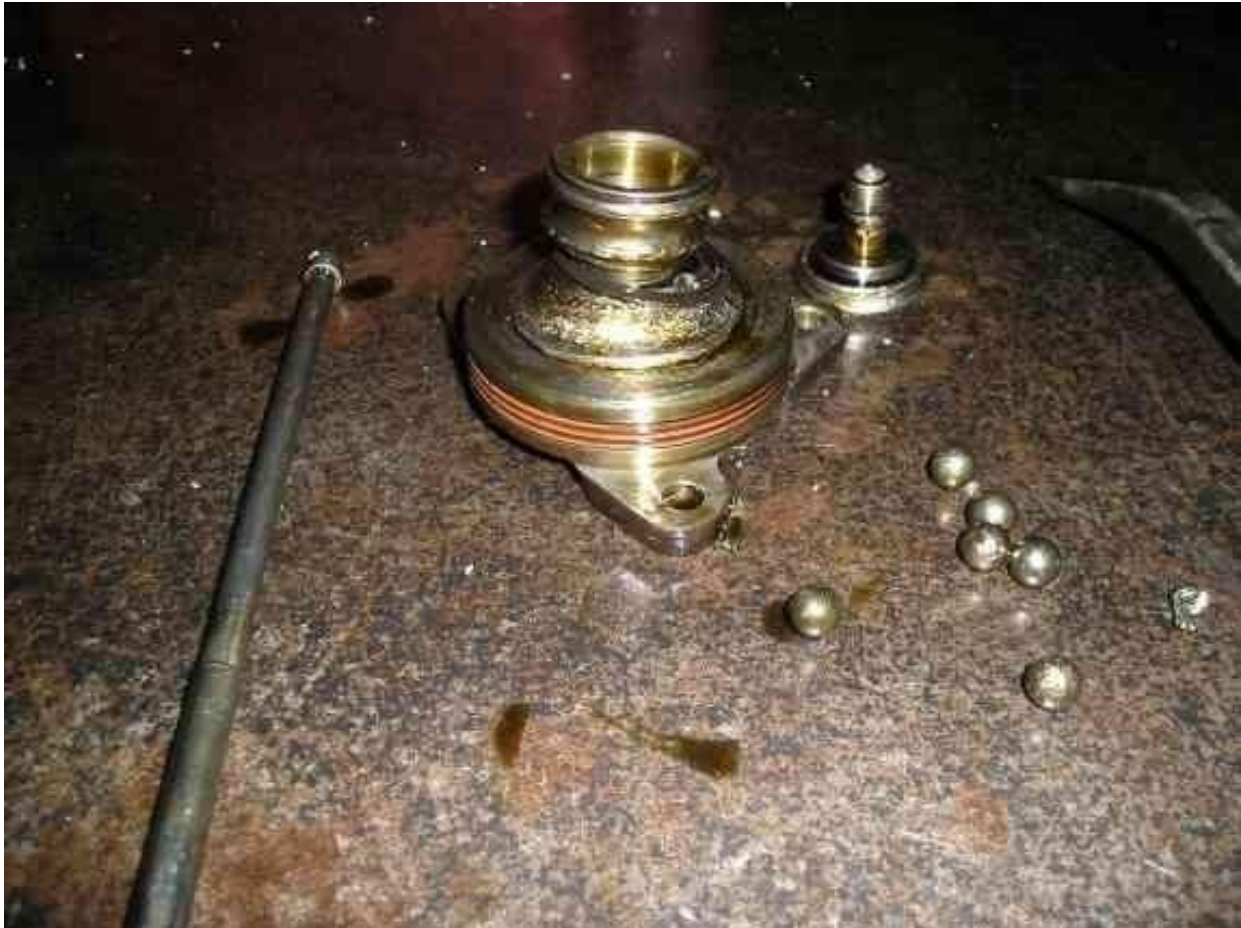
We think the original ball bearing was too small for the application. When fitted with an interference (i.e. tight) fit inside its housing the distortion to the thin outer bearing race made some run tighter than others wearing away more metal particles inside the bearing during “running in” than if it had been looser.

Pictures show the intermediate shaft bearing failure and the damaged internals.

The dynamic lateral loads from chain whip may have been higher than expected and the resulting metal contact inside the bearing housing led to premature wear rates and particle loss. Because it was fitted with a seal/cover with grease inside, instead of wear particles being flushed away to the oil filter (as in most oil lubrication systems) those that ran tighter entrapped those metal wear particles inside the bearing forming a grinding paste (that we have physically observed) that then speeded up the wear rates and damaged the balls and tracks.

But – even if the amount of metal wear particles was small - the grease became thin with heat and eventually leaked out of the shield (which is too thin and simple to act as a permanent seal) at which point the badly worn bearings could fail through lack of lubrication and the wear the balls and tracks had experienced. If however the interference fit was not too tight this allowed them to survive better and the wear rate of particles was reduced but they still wore the seal and gradually allowed enough debris to escape and engine oil to seep in and lubricate the bearing again sufficiently to last longer (ball bearings need very little oil to survive).

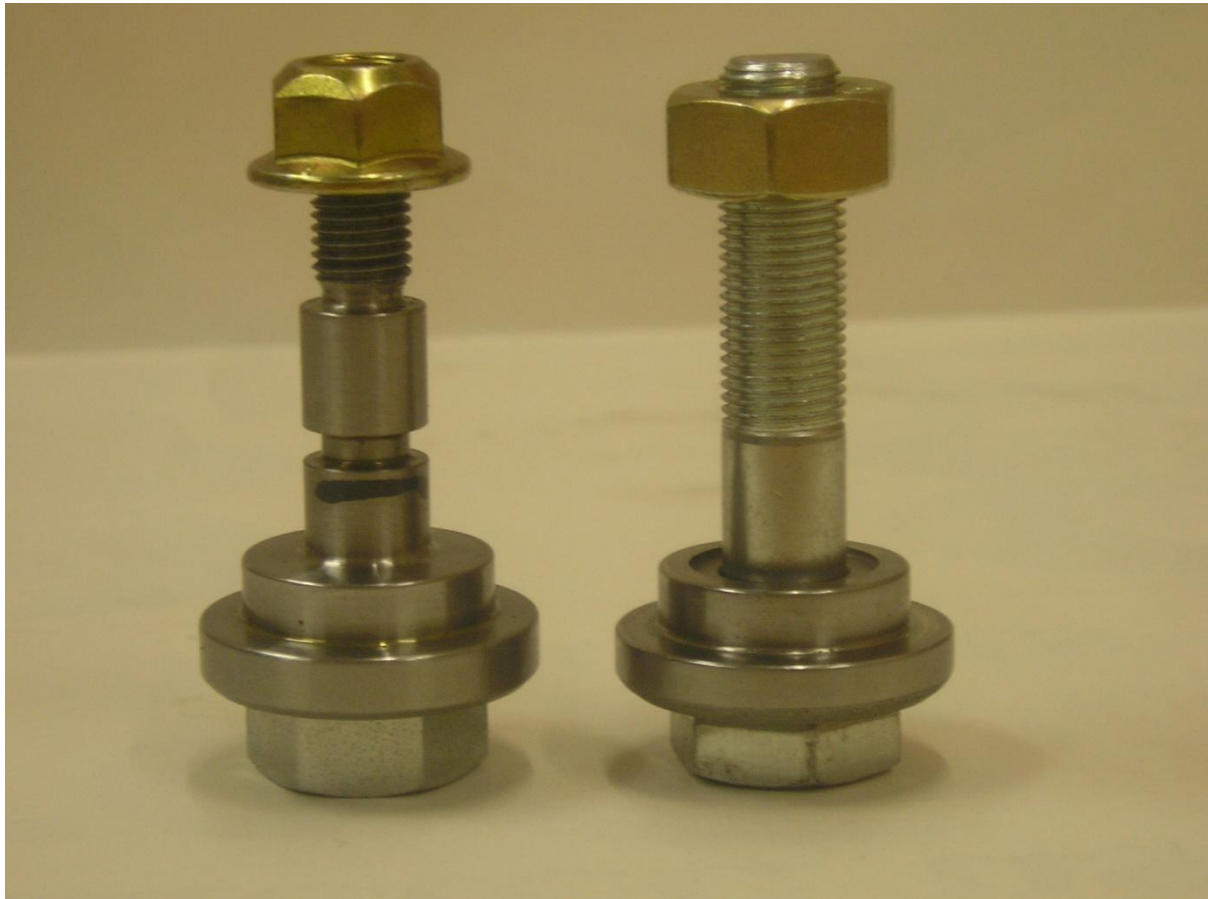
Also - the pinion shaft spigot (to tighten the bearing into the housing) had a sharp recess for an “O” ring seal resulting in a very small area to resist the loads and that created a stress raiser that could fatigue and break. When trying to fit a replacement bearing without stripping the engine - this small shaft had to be pulled against the chain tension to refit the spider into the housing which could initiate a crack leading to fatigue failure later.

The following picture shows the original shaft on the left and our original replacement shaft without the sharp groove for a smaller bearing replacement system.

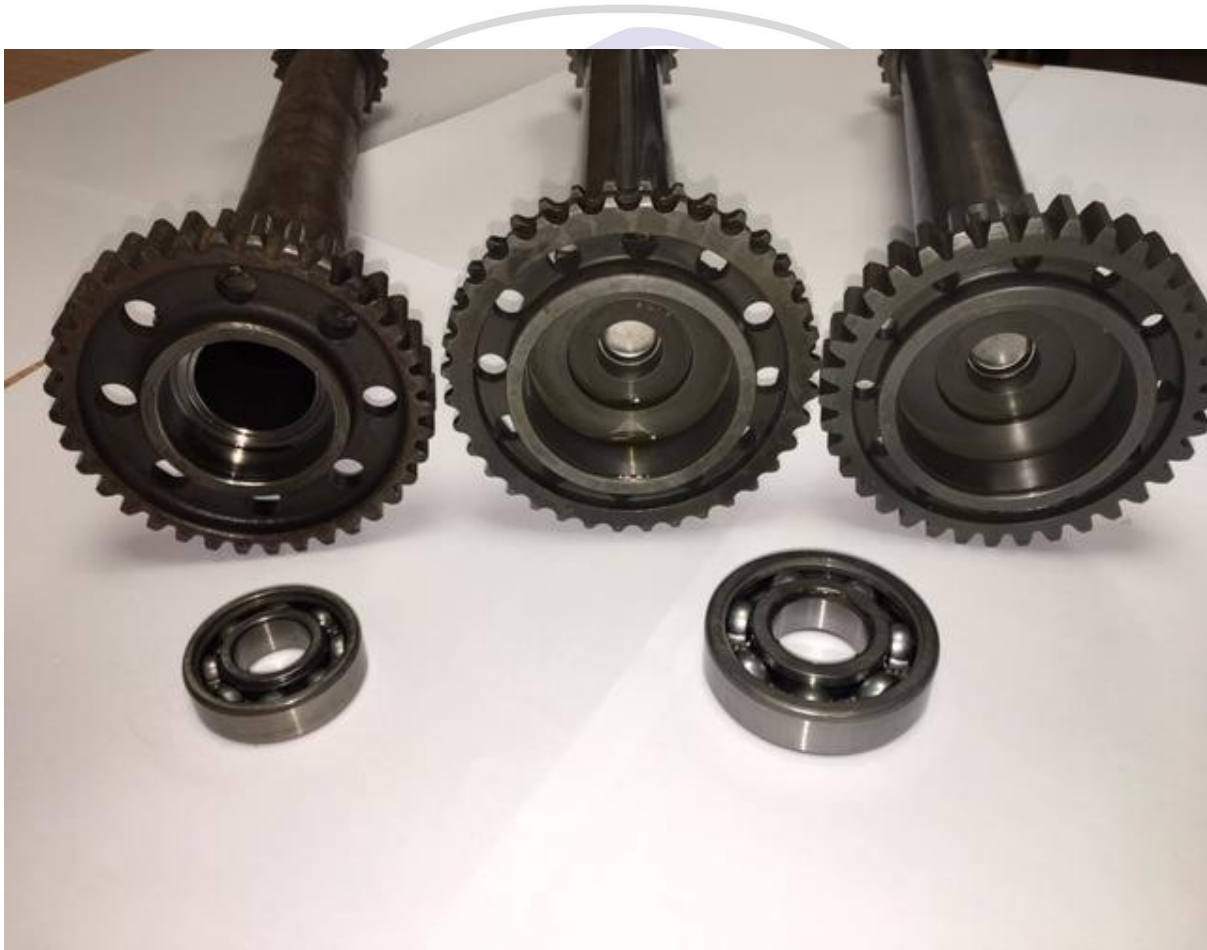
The following photo shows the original shaft and small bearing on the left (originally supplied in both roller chain and Hivo chain types), The centre and right hand side examples are our own Hartech re-manufactured shafts to suit the standard larger bearing fitted to both earlier roller chain shafts and later Hivo chain versions (the latter of which is the same as the more expensive Porsche supplied large bearing shaft only available for later engines). We also plugged the shaft to stop old oil collecting in it.

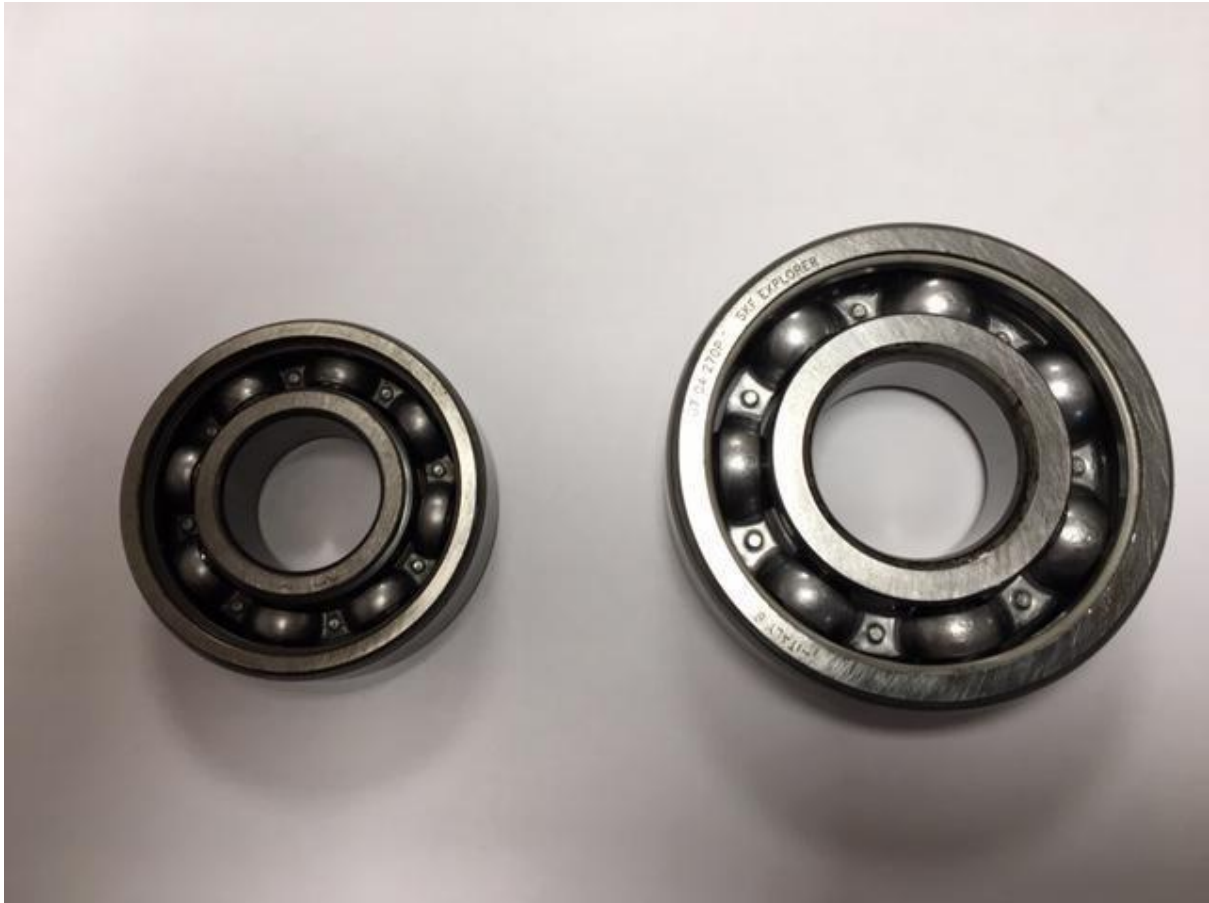
The two bearings shown reveal the difference in basic size and of particular interest should be the difference in the outside diameter thickness showing how much more able the larger bearing outer is to resist distortion on fitting with a tight interference fit into the outer housing.

We think our solution combines the best reliability against cost if the engine is apart and being rebuilt – but we are prepared to fit an LN plain bearing pressurised oil feed kit to an engine that is not due to be stripped and rebuilt - if preferred.

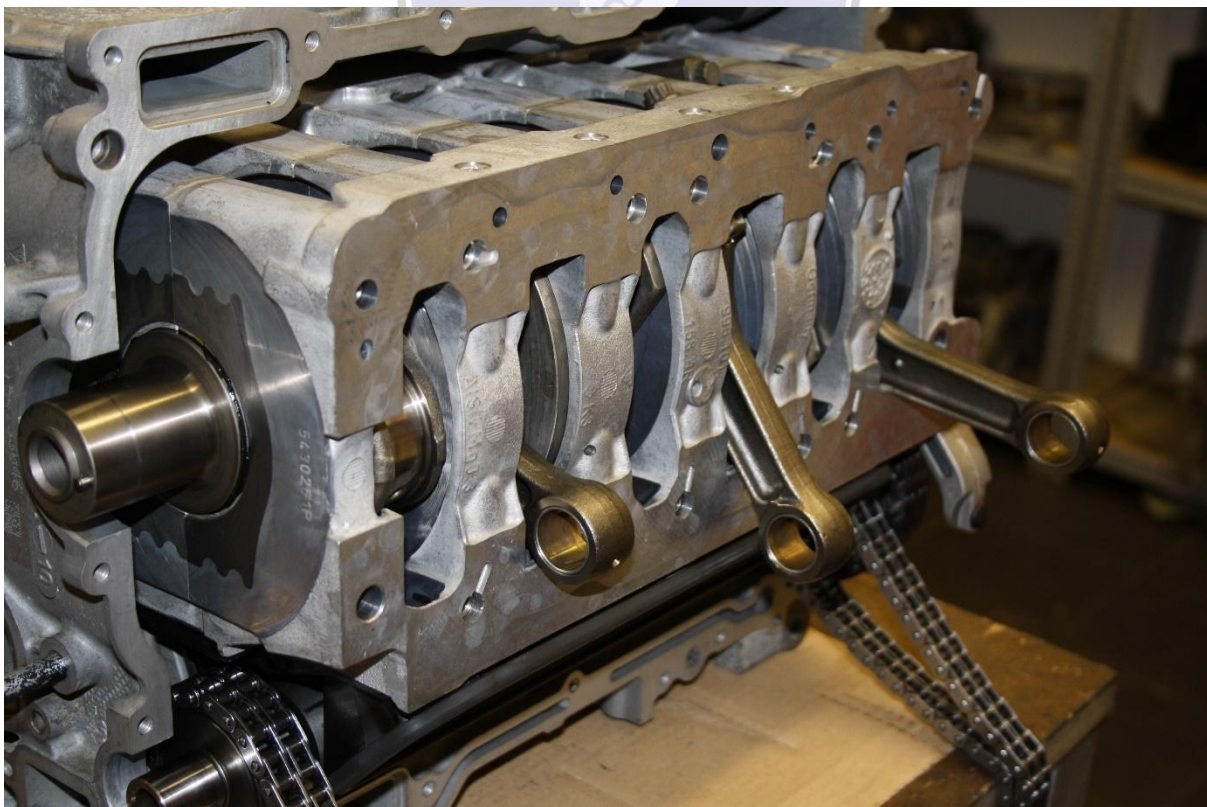
The following picture shows the 1 half of the crankcase and the crank carrying cassette around which the open bottom of the crankcase halves sit.

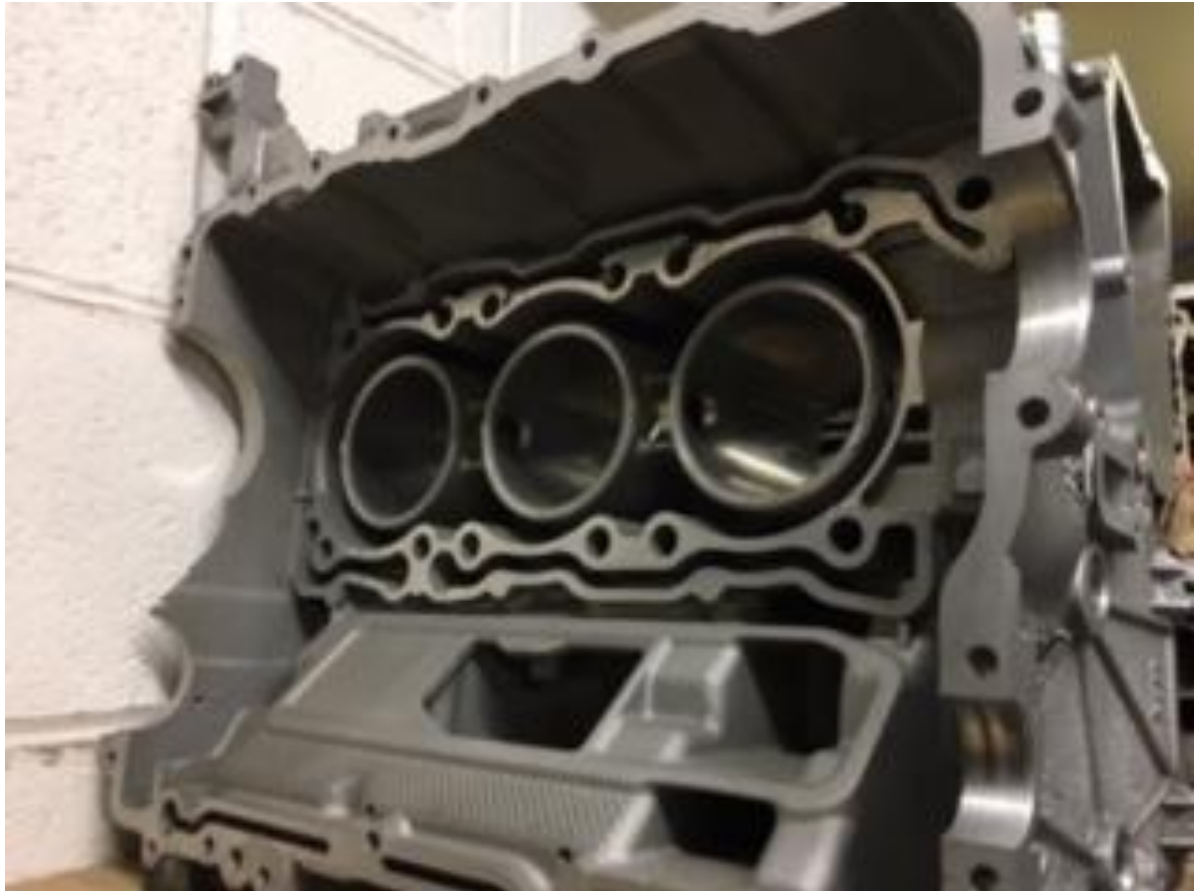
The picture below shows that the bottom of the std cylinders are a thin tube with no lower support (just like the standard top).

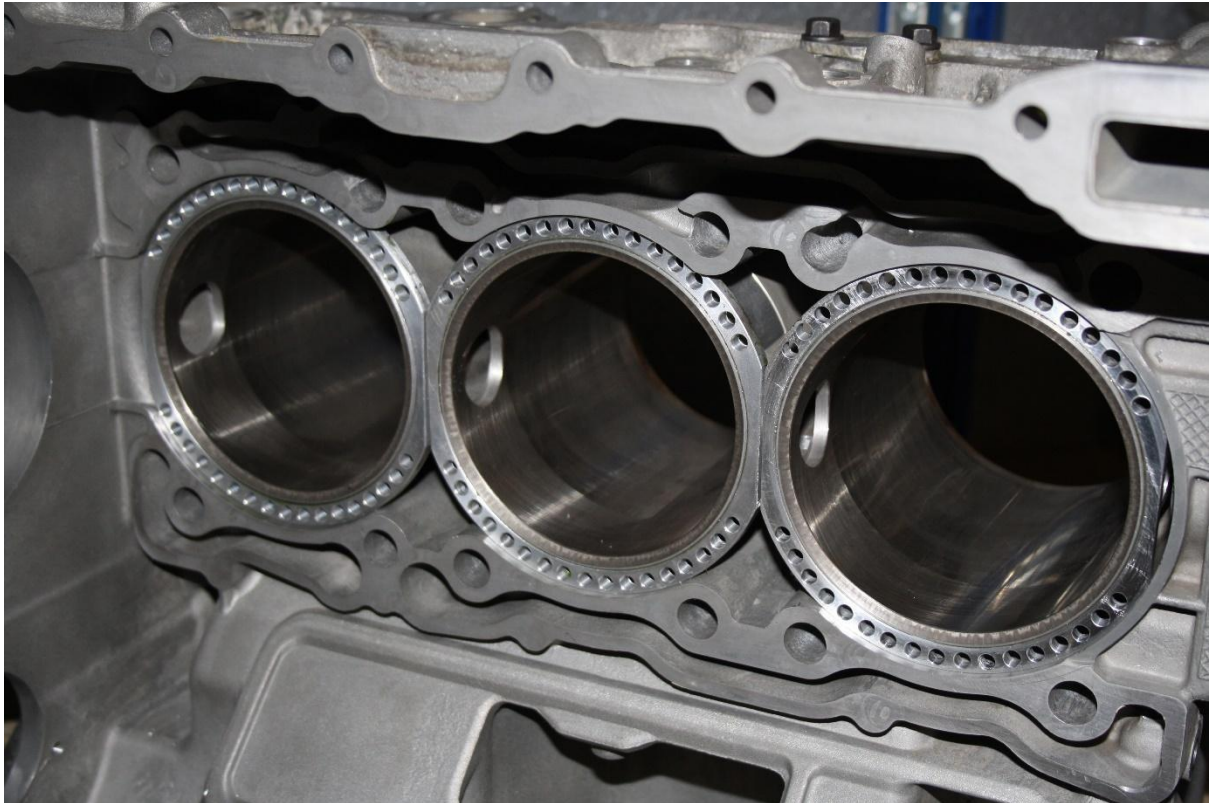
The cylinder tube is only connected to the rest of the block via a small section just above the middle leaving the top and bottom free to distort. The picture following shows how we fitted precision machined supports to the bottom of our oversized engines (as well as the machined location at the top pictured ahead) so our new cylinders are a true closed deck design, with support top, middle and bottom.

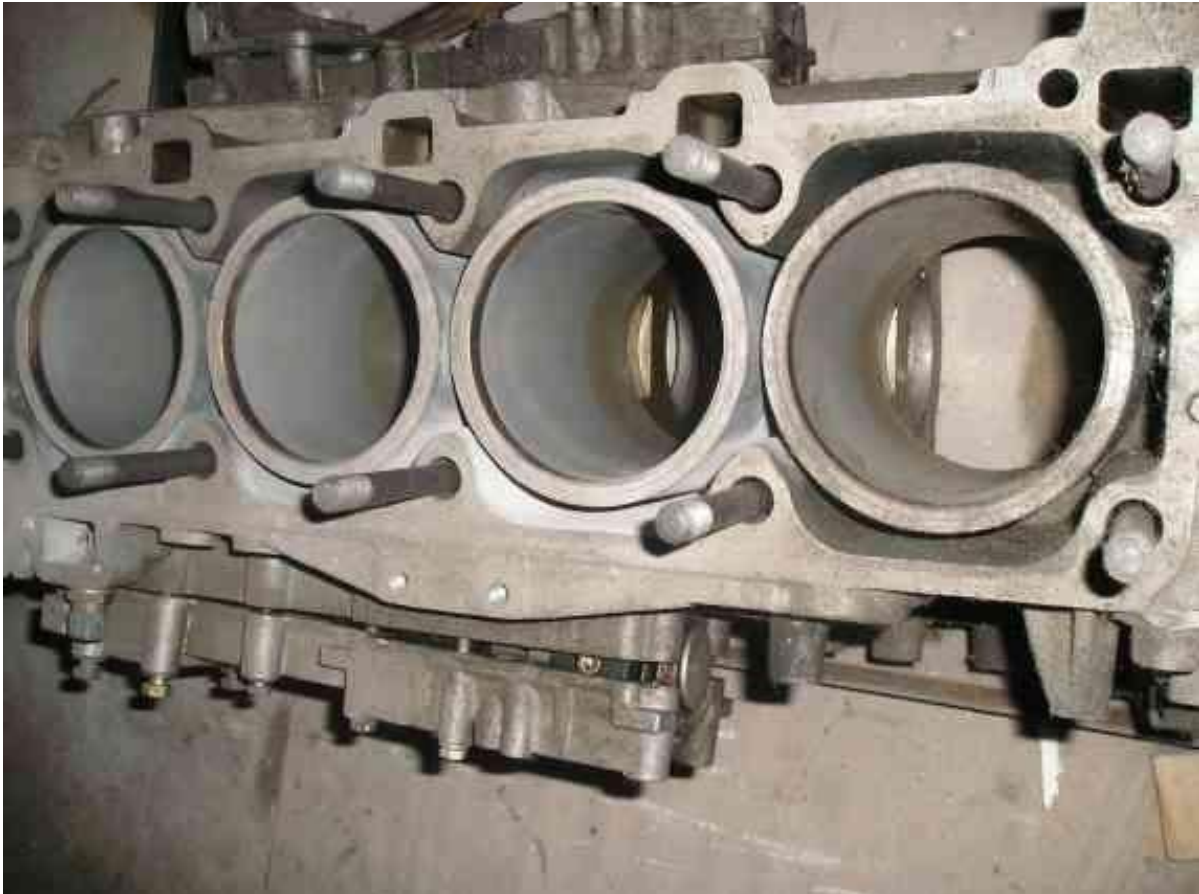
The following picture is the 944 Open deck casting in Alusil but the bottom of these cylinders was fully connected to the rest of the block leaving only the top free.

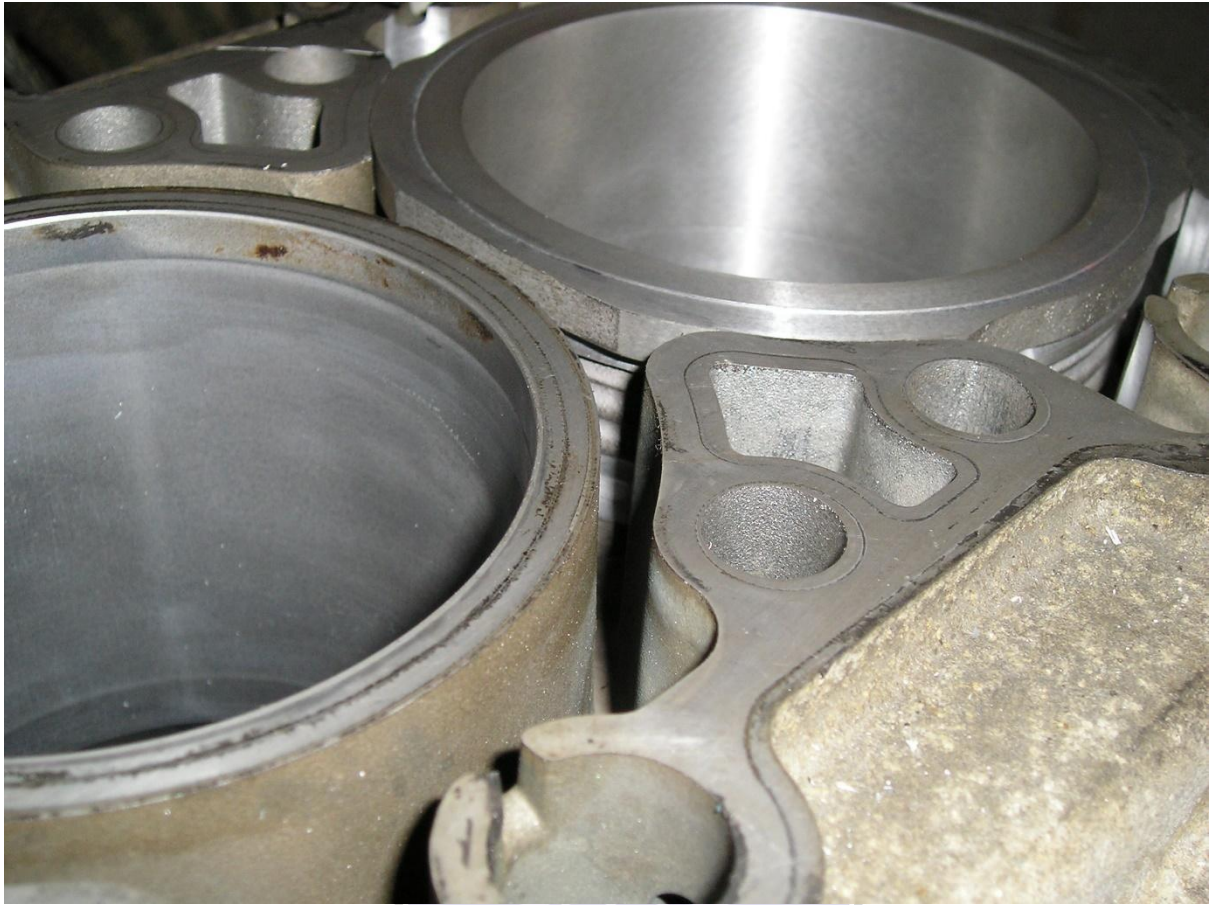
The cylinder of the LHS of the picture shows the 2 materials (the centre half darker and Lokasil) and next to it on the RHS a very early Hartech ribbed cylinder manufactured with a high strength alloy casting closing the deck.

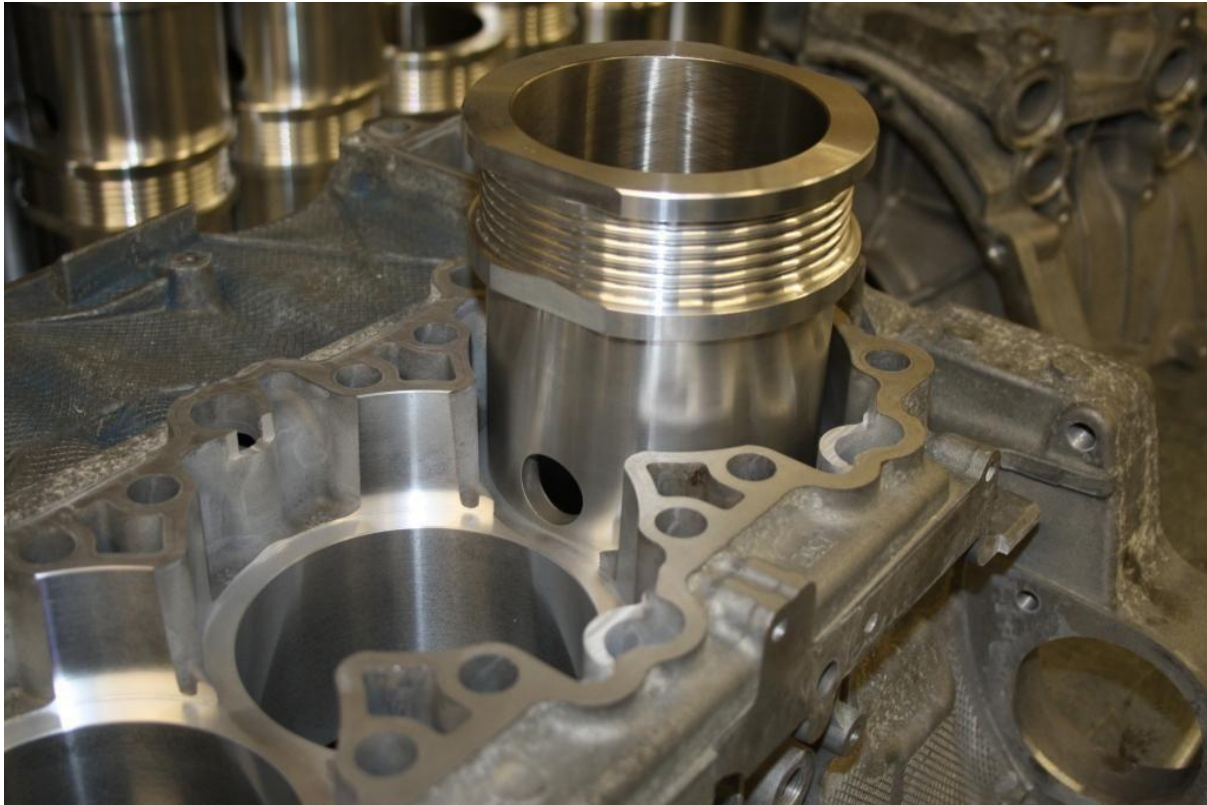
Later Hartech cylinders incorporated improved design features and liners manufactured from billet aerospace alloy - as shown in the following picture that demonstrate not only the increased strength and ribbed exterior but also how the top is bigger in diameter (to keep it round) and how it fits into a precision machined recess to stabilise it from moving under load.

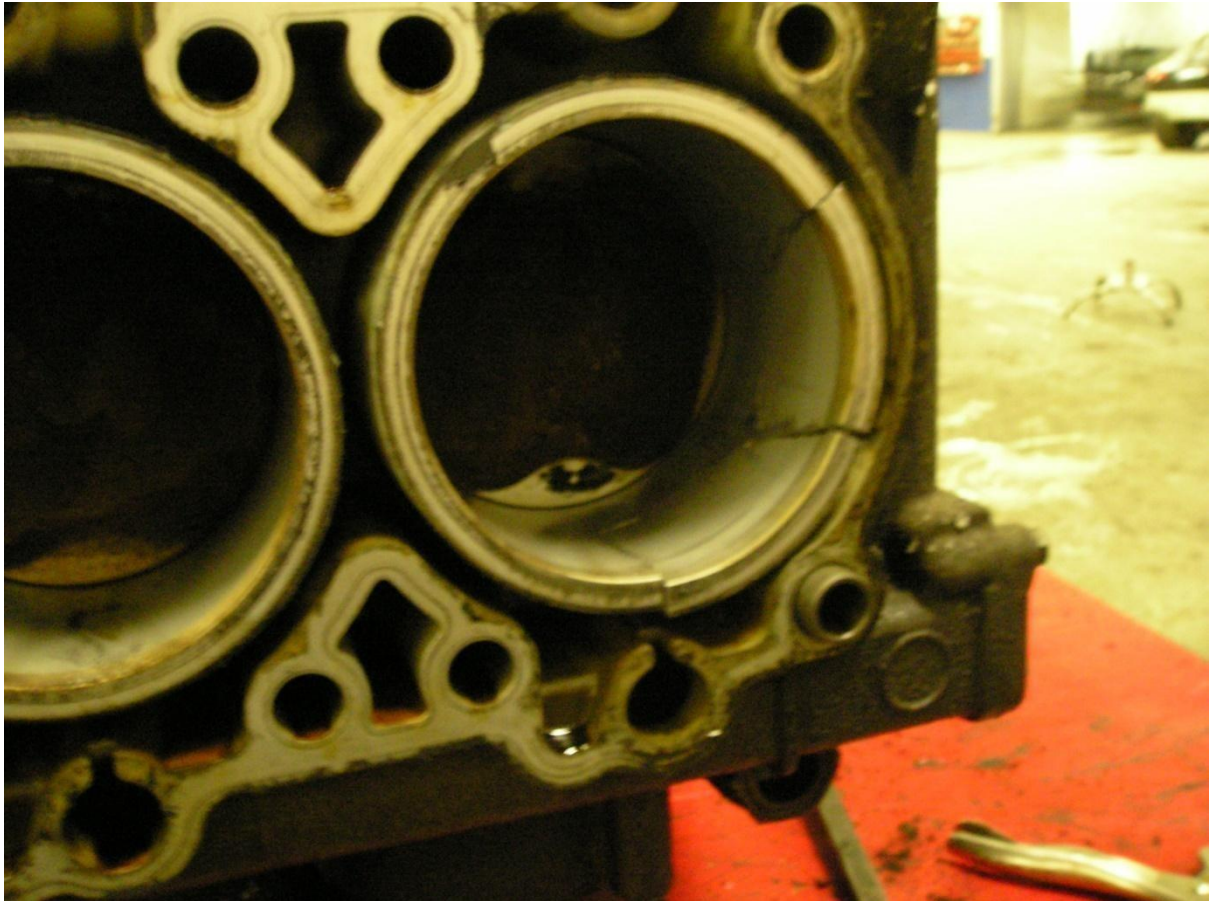
Picture following of a 3.4 996 bore well cracked (and off-centre revealing differences in the composition of different parts of the alloy casting strength).

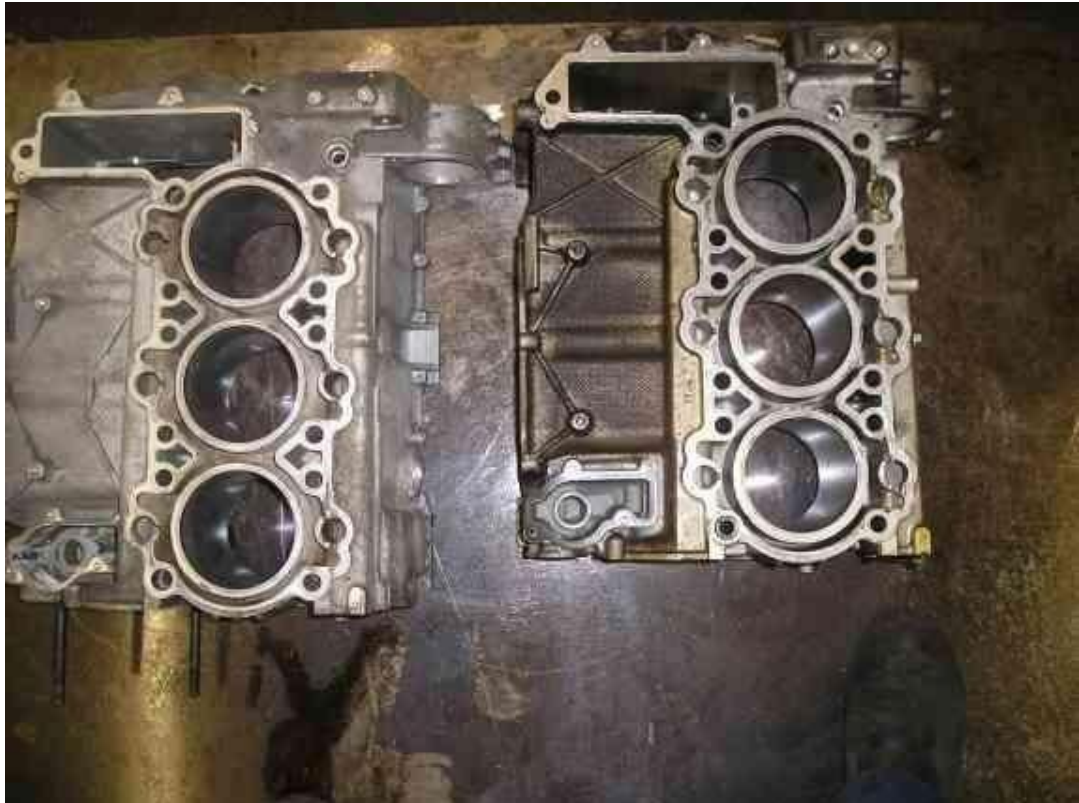
The 3.4 996 was the model that first displayed those weaknesses and we immediately noticed that the cylinder tube had a thinner wall thickness. Further investigation showed that it was basically the 3.2 Boxster S casting bored out 3 mm bigger in diameter to run with the larger 996 3.4 piston and the cylinder tube area was therefore obviously thinner and weaker but trying to resist even higher loads from the more powerful engine.

The following picture shows a Boxster S (on the RHS with the smaller bore and thicker cylinder wall) and 996 3.4 (on the LHS with the same outside cylinder diameter but a larger bore and thinner wall thickness and therefore weaker).

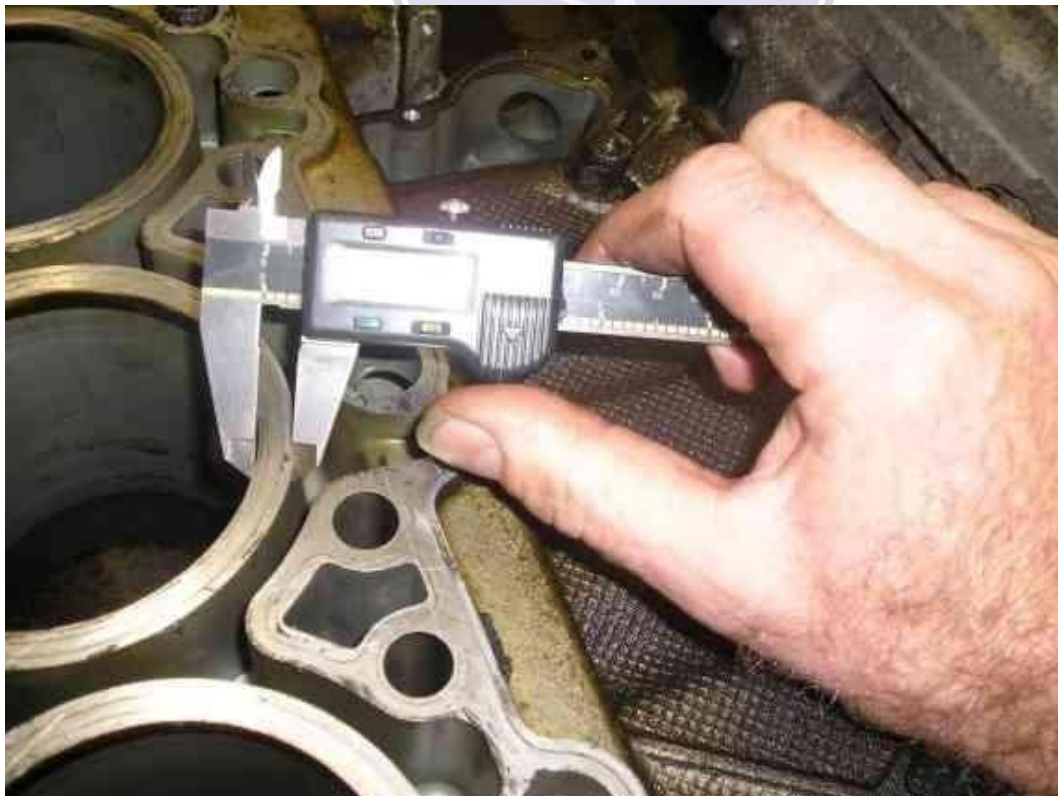
You can see how the 996 3.4 (LHS) is a bored out Boxster S (RHS) with the same external gap between the cylinder and the coolant channels - and following - how the difference could easily be measured.

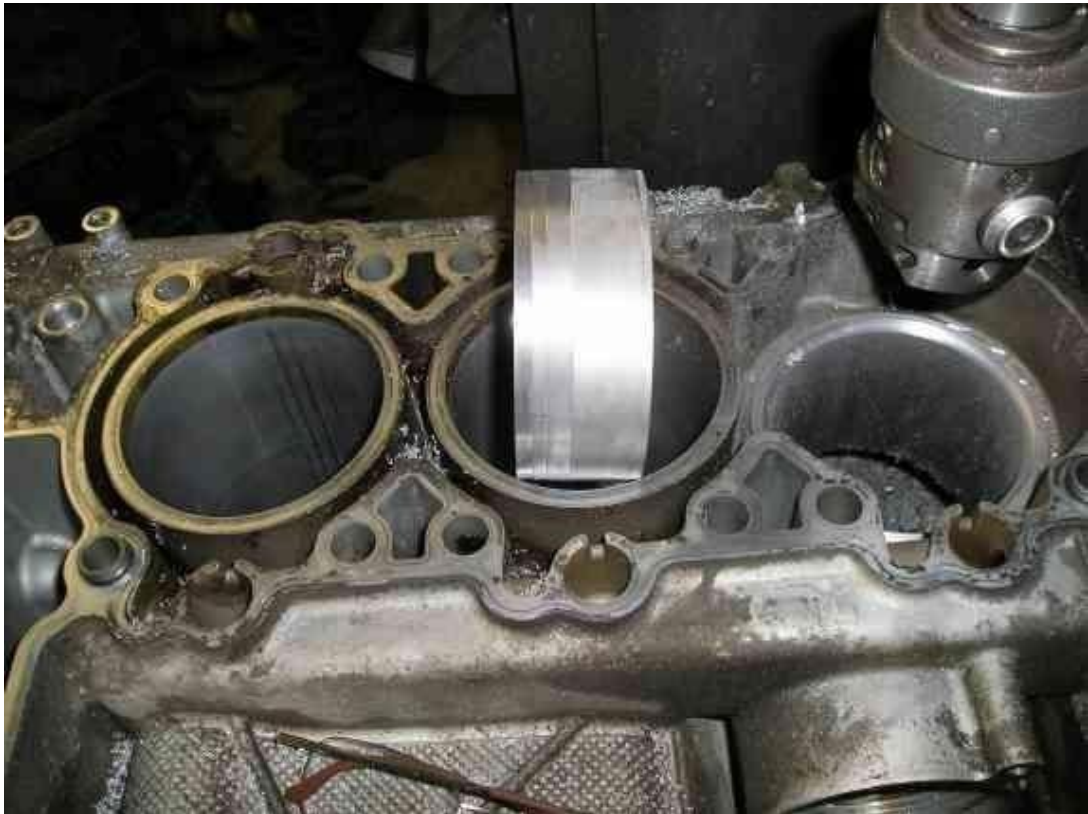
To establish the material strengths we cut out pieces of the base alloy and the Lokasil bore material to tensile test and found the alloy normal for aluminium crankcases but the Lokasil stiff and brittle – the combination of both and the thinner cross sectional thickness combined with the higher loads imparted from the more powerful engine (and heavier pistons) exceeded the yield point leading to ovality and eventual cracking.

Picture shows one of the sections we cut out.

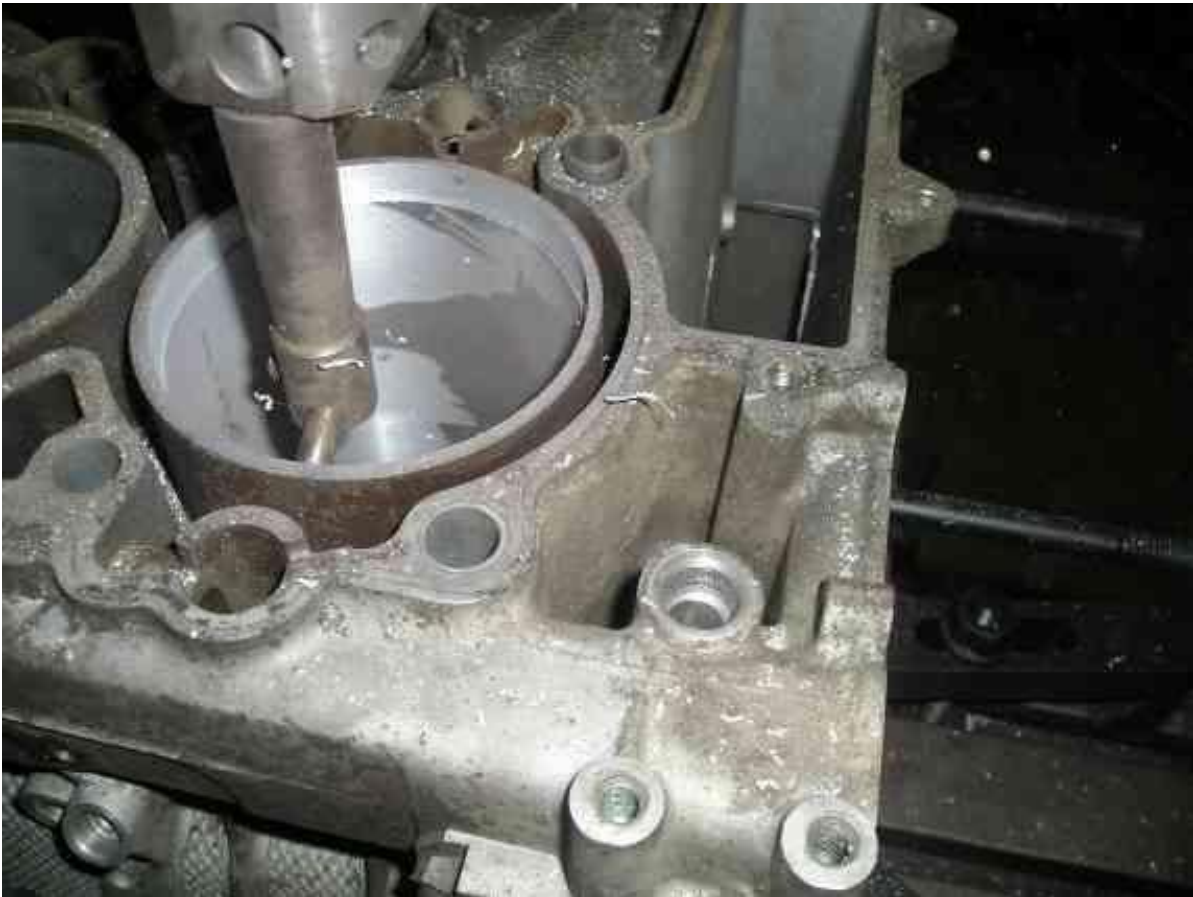
We found that once the bores had crept oval by 10 thou (0.25mm) they would soon predictably crack and in the same block some had crept by 4 or 5 thou while other cylinders by 8 or 10 thou confirming that there was a variation in the stiffness of some cylinders compared with others due we thought to different distributions of the silicon content internally varying the strength of the Lokasil half of the cylinder tube (because the aluminium would reasonably be expected to be the same).

Picture showing uneven Lokasil distribution in the cylinder.
