The main problems with Porsche engines

The 3 main failures of M96/7 engines

IMS bearing, Cylinder cracking and “D” chunking, Cylinder scoring.

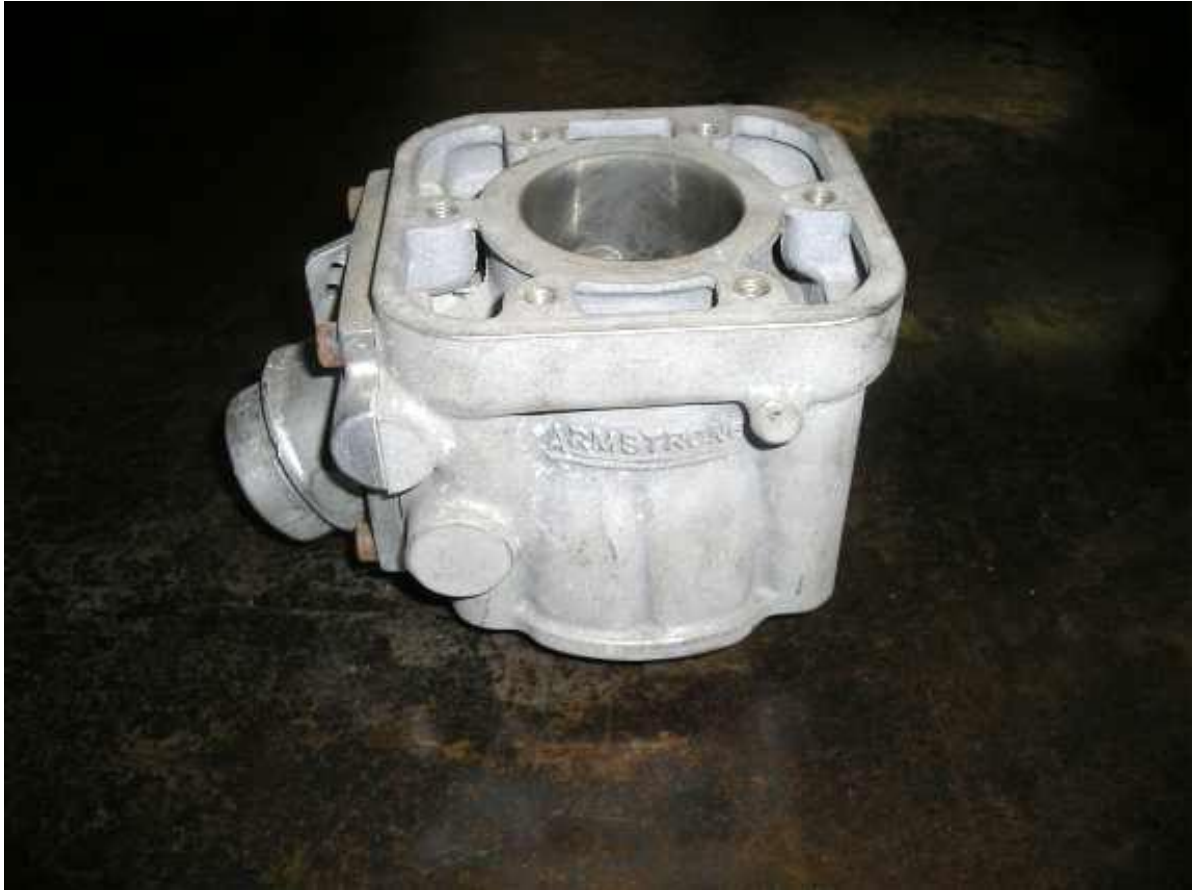
Picture of the Armstrong 250cc GP cylinder (with Nikasil bore) designed by me in the early 1980's demonstrating the bigger top hat section and connection to the outer cylinder (to close the deck) while creating space for coolant (very similar in concept to our present Hartech closed deck cylinders).

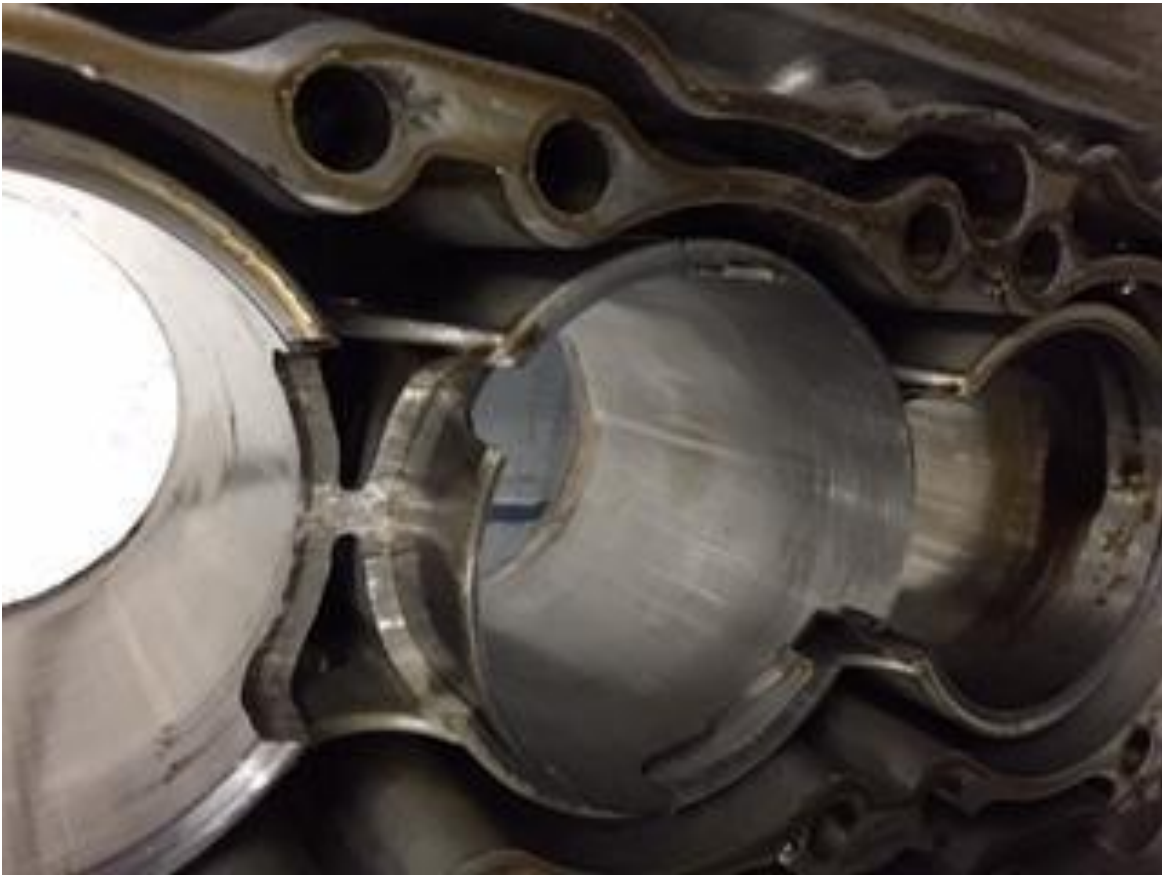
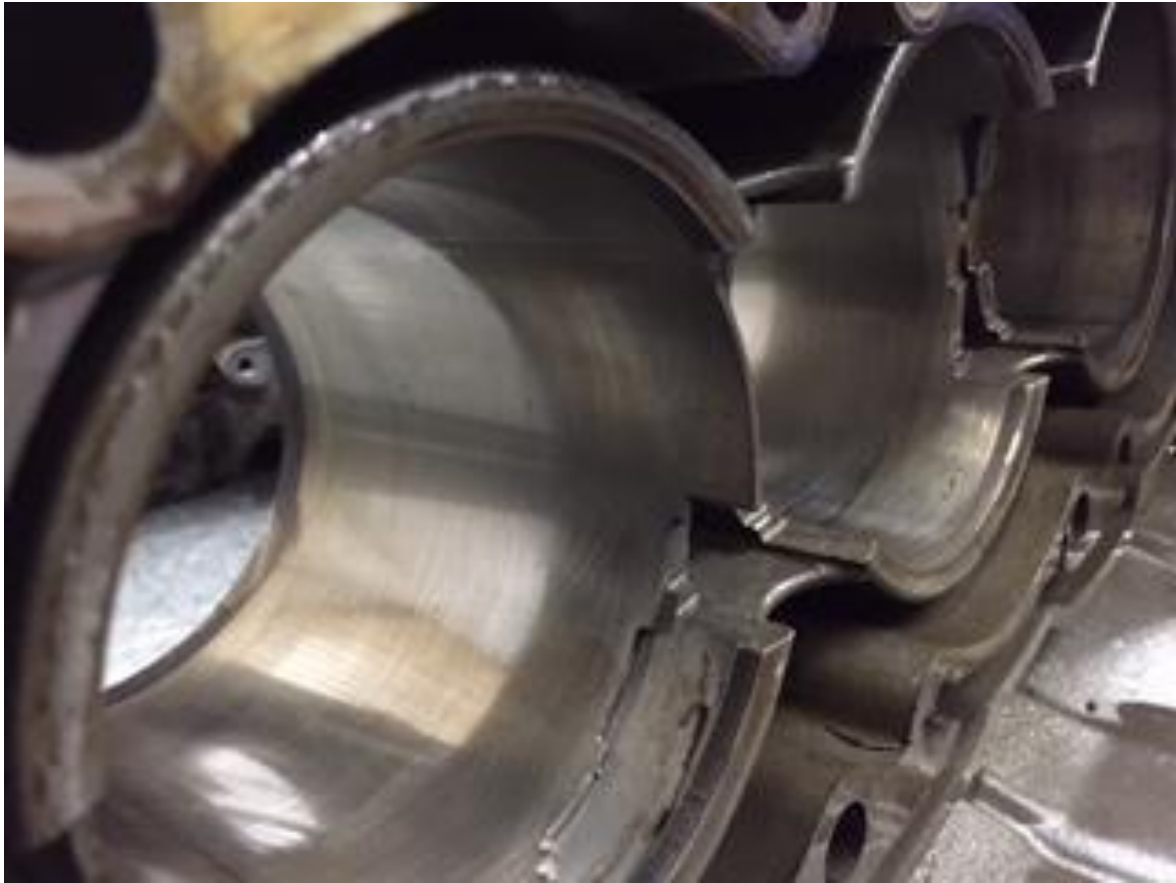
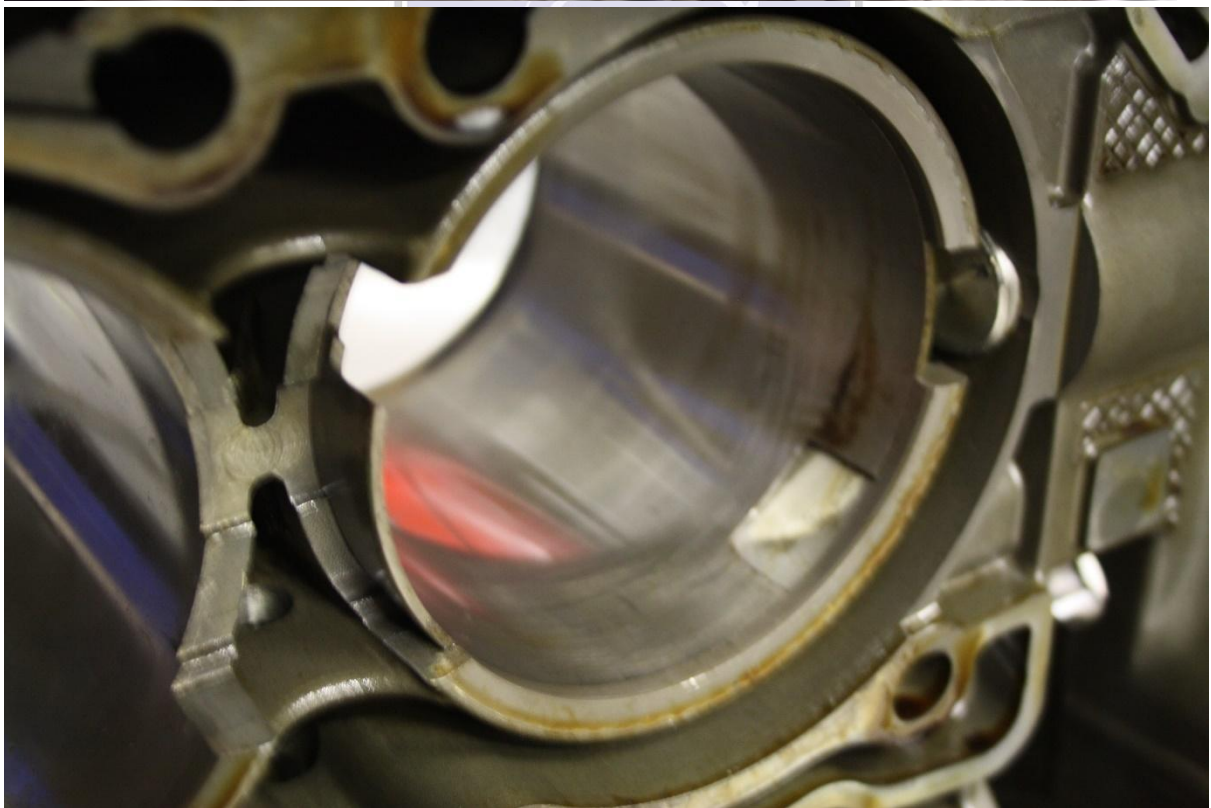
This first three show several issues – how thin both the liners and the original sleeves are once they have been machined out, and how the liner became loose when the cylinder expanded and twisted when the rings ran against the honing angles while it was loose.

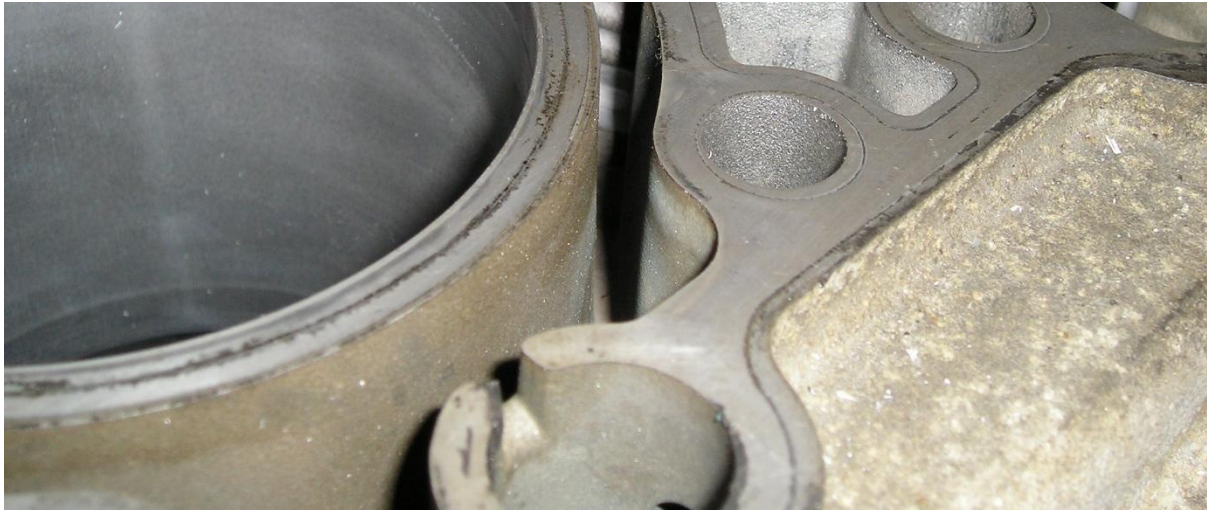
One of the other design issues we noticed was that the depth inside the cylinder was extremely shallow and that unlike the 944/968 design (where 100% of the coolant flowed first into the cylinder block) the amount of coolant directed into the cylinder block was only about 10% of the total (the rest directed into the cylinder heads) and that this inevitably would reduce cooling efficiency. We felt the coolant flow volume was too small so to improve this we designed our replacement cylinders to be wet cylinders (completely replacing the original duplex material cylinders) and with external ribs (to increase the cooling surface area).

The picture below shows at the bottom centre of the picture - the round channel for coolant to flow straight up into the cylinder head of each cylinder and the tiny rectangular slot allowing a very small proportion to flow at right angles into the cylinder block to cool the cylinders.

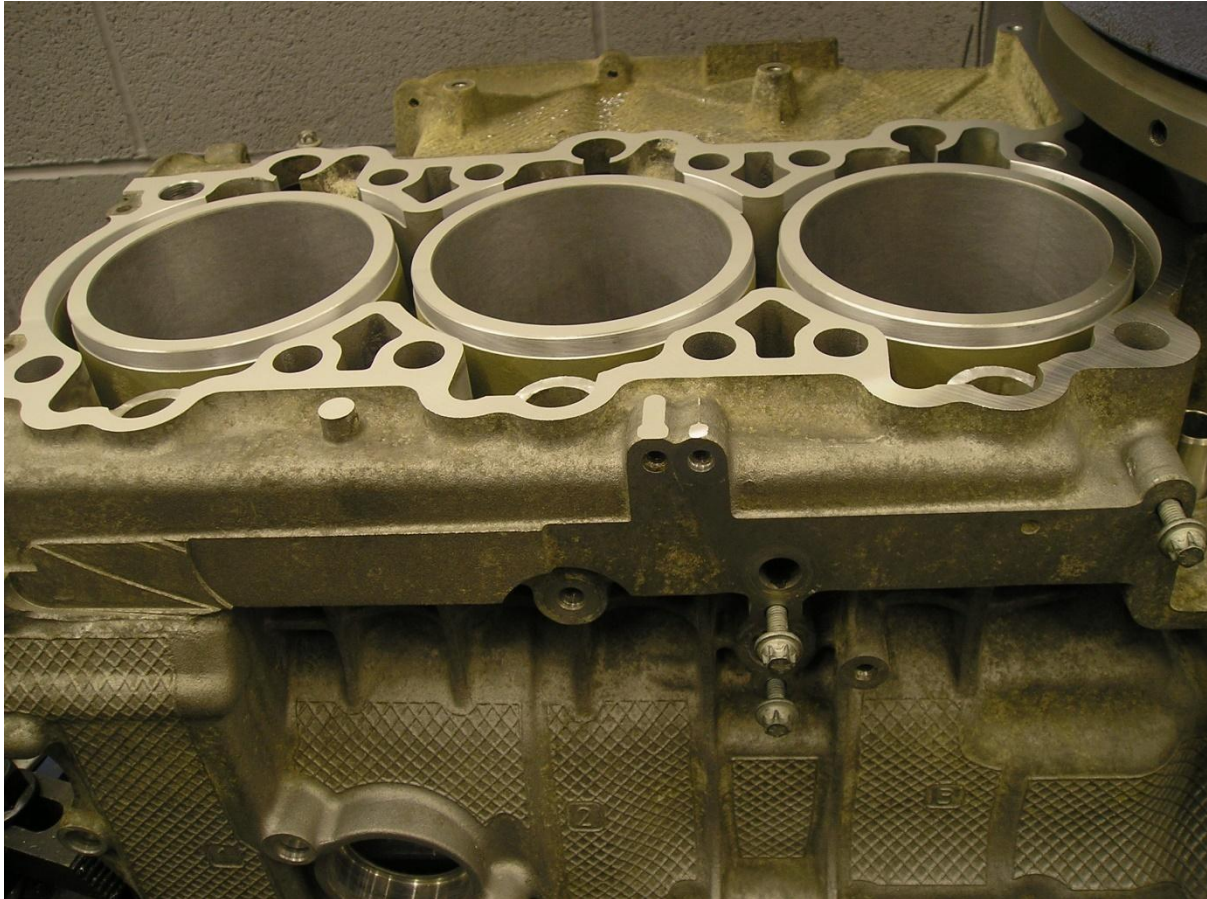
The following picture shows the machined diameters on the outside of the top of the cylinders and the inside of the top of the cylinder block - to fit support rings shown above the cylinders awaiting machining flats on and fitting.

Many however will be unaware that you cannot simply machine a full 360 degree round diameter into the top of the cylinder block (or you would machine away part of the adjacent cylinder) and this is why our rings and liner tops have flats machined on the sides where no load is imparted by the pistons). This practical problem prevents reconditioning shops with conventional boring machines from creating the circular curves necessary to convert the top of the block to a closed deck to support the top of the liners. This machining can only be carried out by a method using – for example – accurate computer numerical controlled (CNC) milling machines – which we have in our workshops (but most engine reconditioning workshops do not).

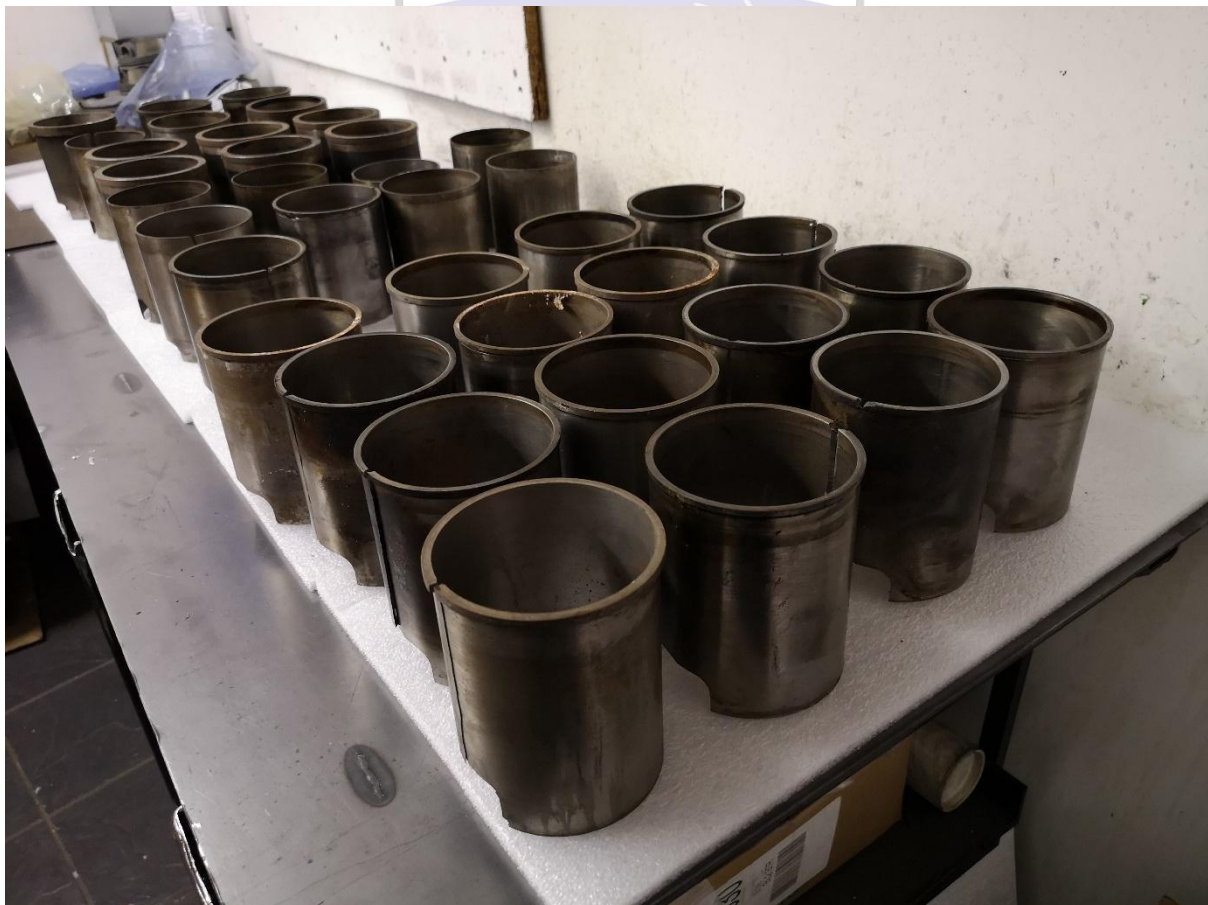
Despite warning about this potential problem we still receive a large number of engines to repair for the second time that were repaired with ferrous liners. Some had thin ferrous liners that were so thin the alloy crushed them after fitting (as the block cooled) such that the interference fit was reduced so much that when hot the alloy block expanded so much compared to the ferrous liner that the liner became loose and dropped or rotated. Others were thicker – but that meant that the remaining alloy tube holding them in place was even thinner and even weaker allowing the liner to eventually stretch the outer aluminium intended to hold it in place and become loose, especially at the top.

The following picture is a small selection of a 3 figure number of replaced ferrous liners that we retained showing 3 of 11 different versions all of which eventually failed and required replacement while several thousand of our alloy Nikasil liners have never suffered any retention problems.

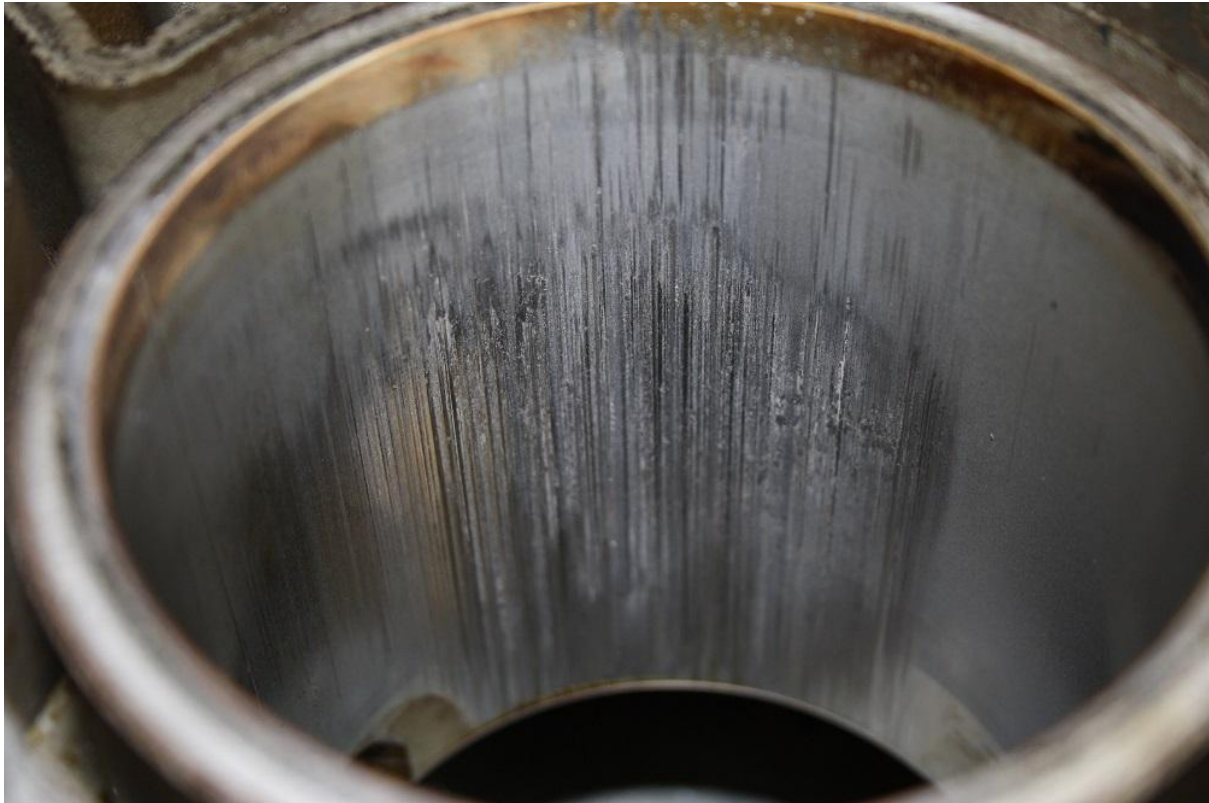
We did notice straight away that the scoring was unlike a seizure (where the piston expands more than the cylinder bore and therefore seizes the piston and bore surface on both sides as a result of metal to metal contact) but the scores were only on the side of the piston that pushed the crankshaft round (via the con-rod) under load – which we had not seen before (and had only heard about afflicting larger diesel engines) with only a couple of exceptions when older 944 S2 high mileage engines occasionally scored (usually more on the thrust side than the opposite side – sometimes only on one side) even more rarely afflicting high mileage 968's. This is very unusual because while it is possible to imagine why a piston that has for some reason expanded bigger than the cylinder bore would have no clearance for an oil film and rub 2 dissimilar metals together hard, overheating the surfaces and leading to micro welding and seizures – it was difficult to understand how one side of the piston can be rubbing hard enough to cause scoring while the other side is unaffected and running perfectly.

Typical bore scoring picture showing how the top (where the piston is machined very much smaller) was hardly scored but the rings still carried debris to the top. This scoring is only on the thrust side of the cylinder bore.

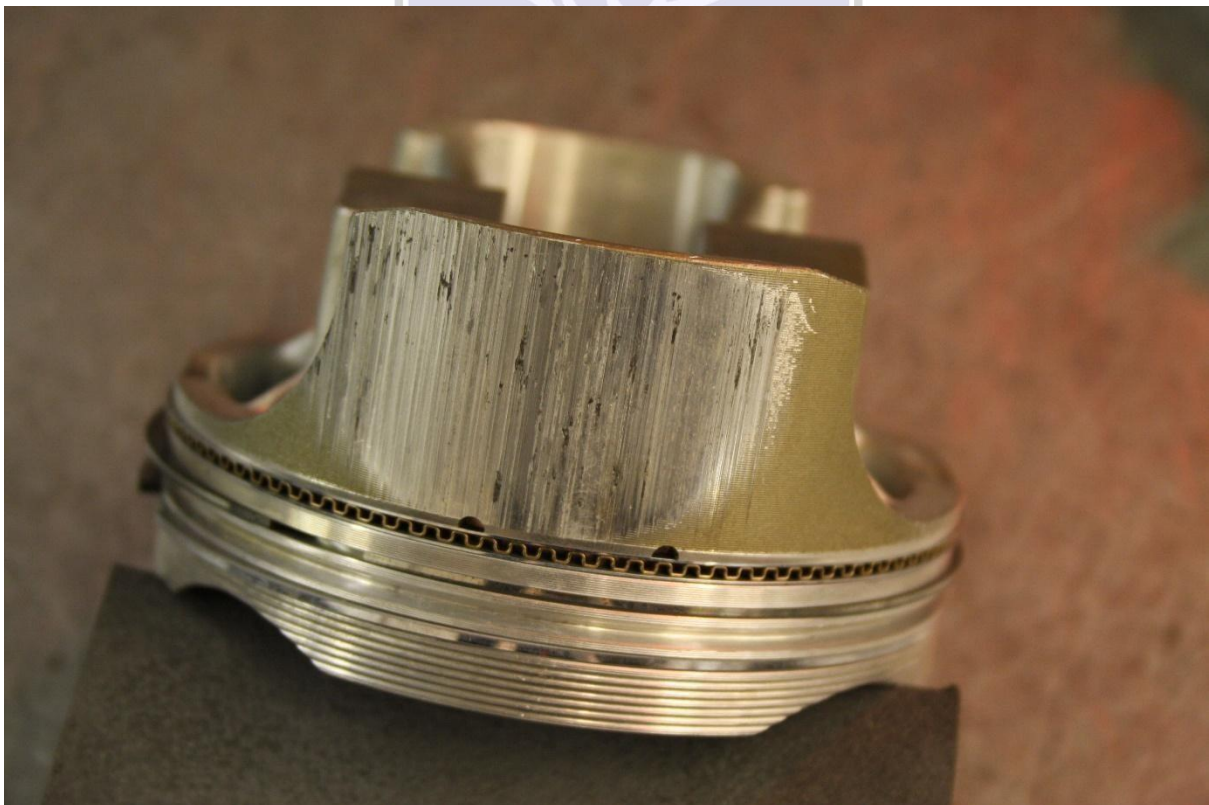
A typical scored piston (notice the black flecks in the surface).

The top of a piston (where the rings fit) is machined much smaller than the body under the rings so rarely touches the cylinder and this can be seen in the above photos.

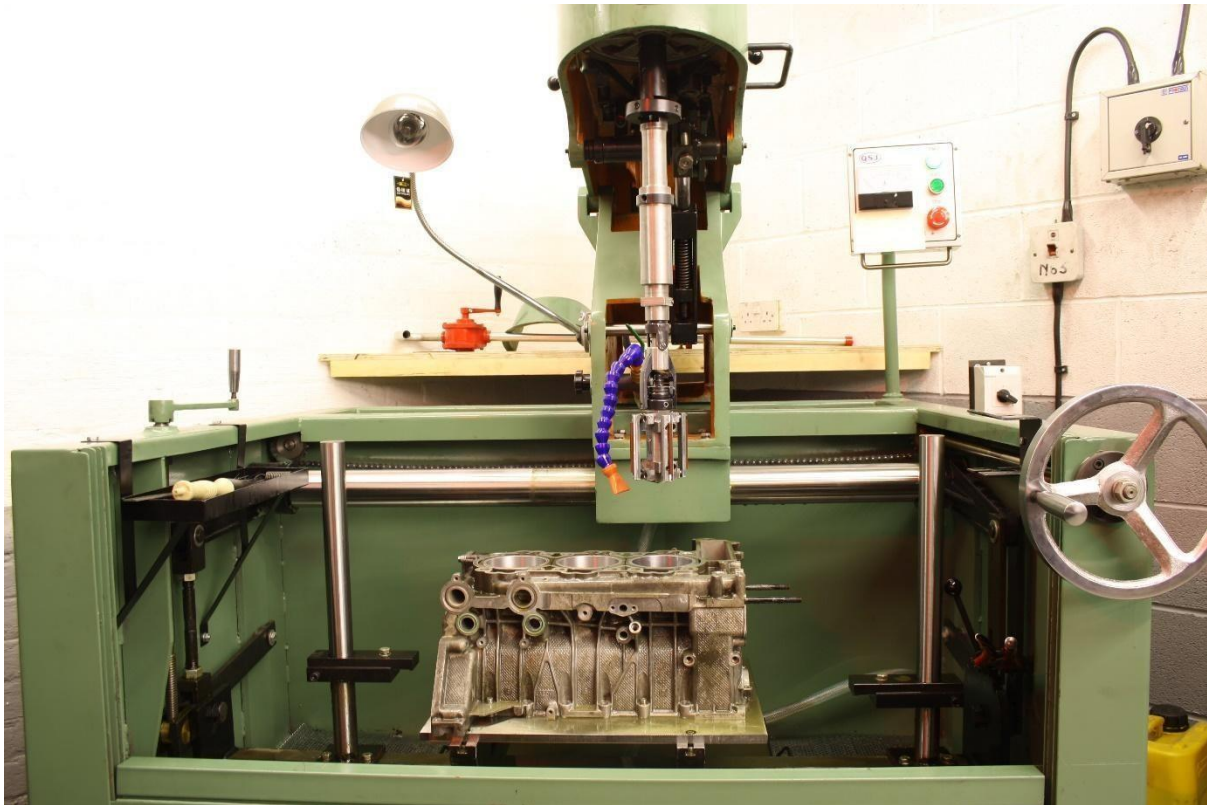
However trying to reproduce faults that only reveal themselves after many years, miles and heat/cool cycles is not easy in a short period (especially for small businesses) and after many more thousands of reliable miles - the test engine started smoking and upon stripping we found a piston and bore had scored again (and at much too low a mileage to provide a reliable repair solution).

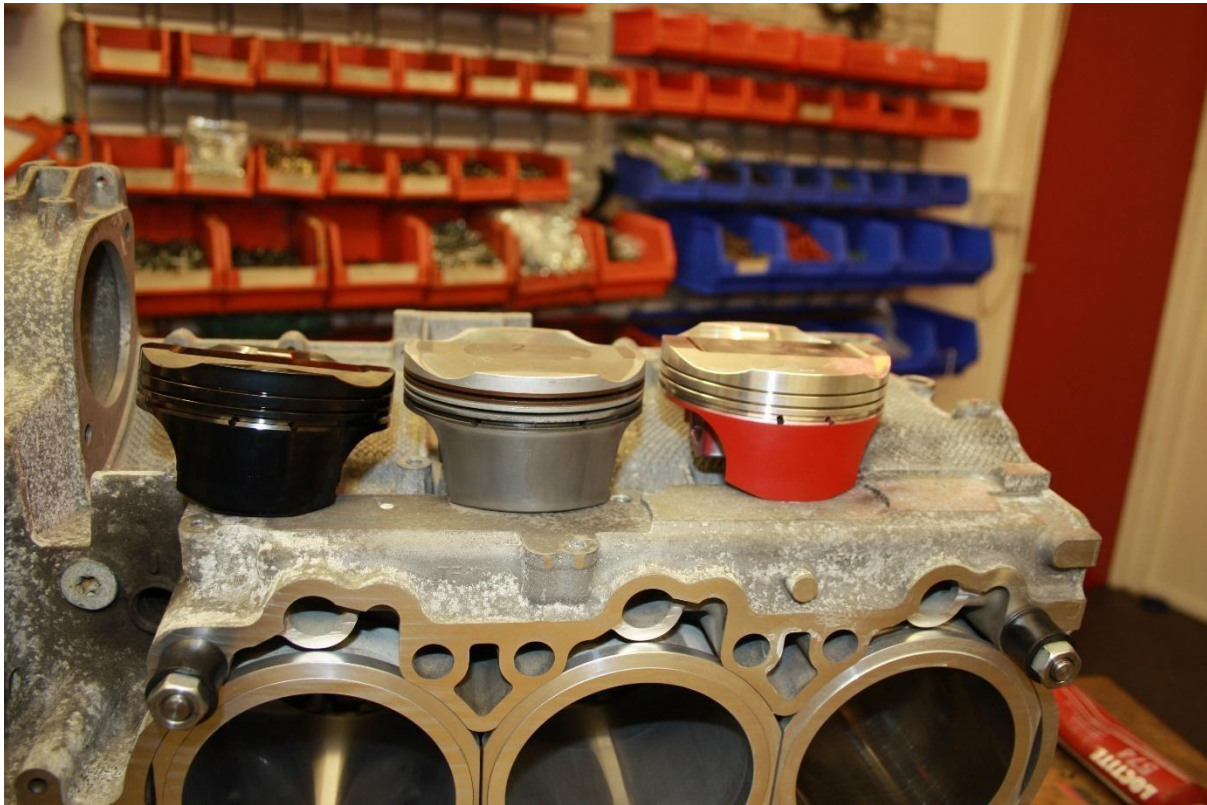
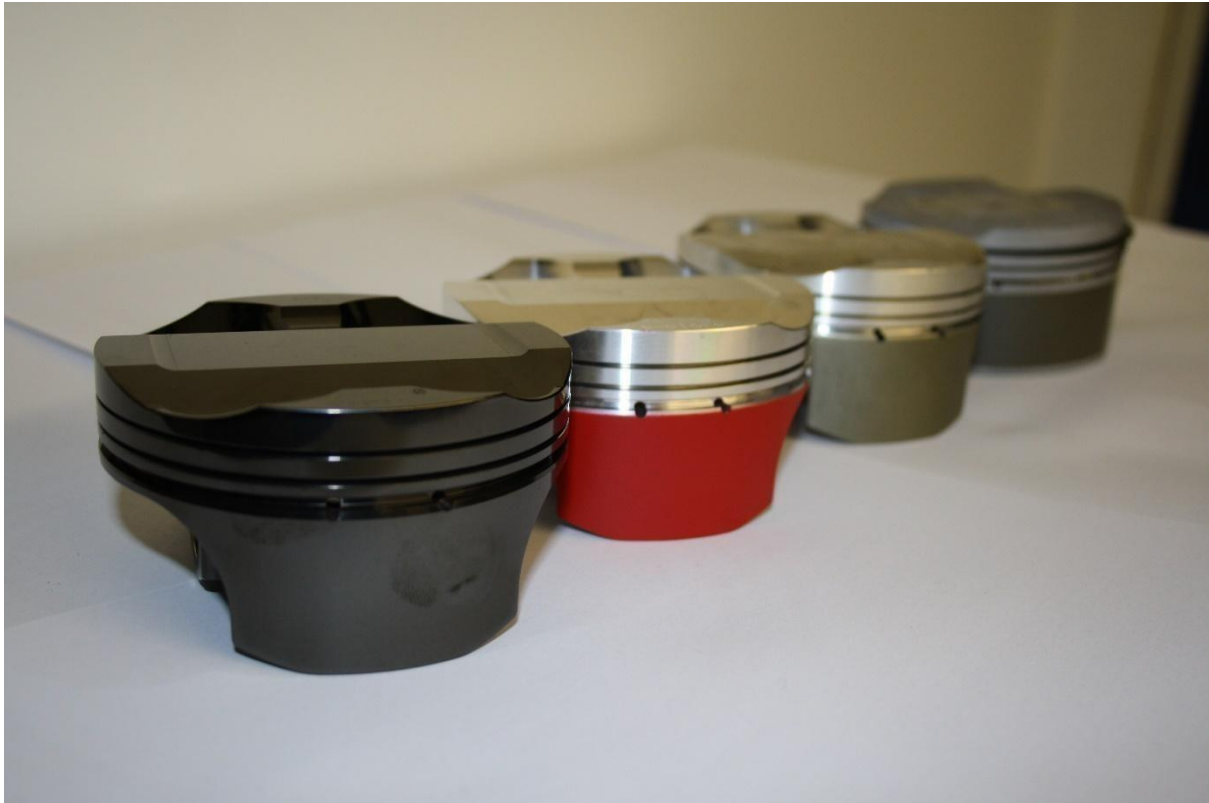
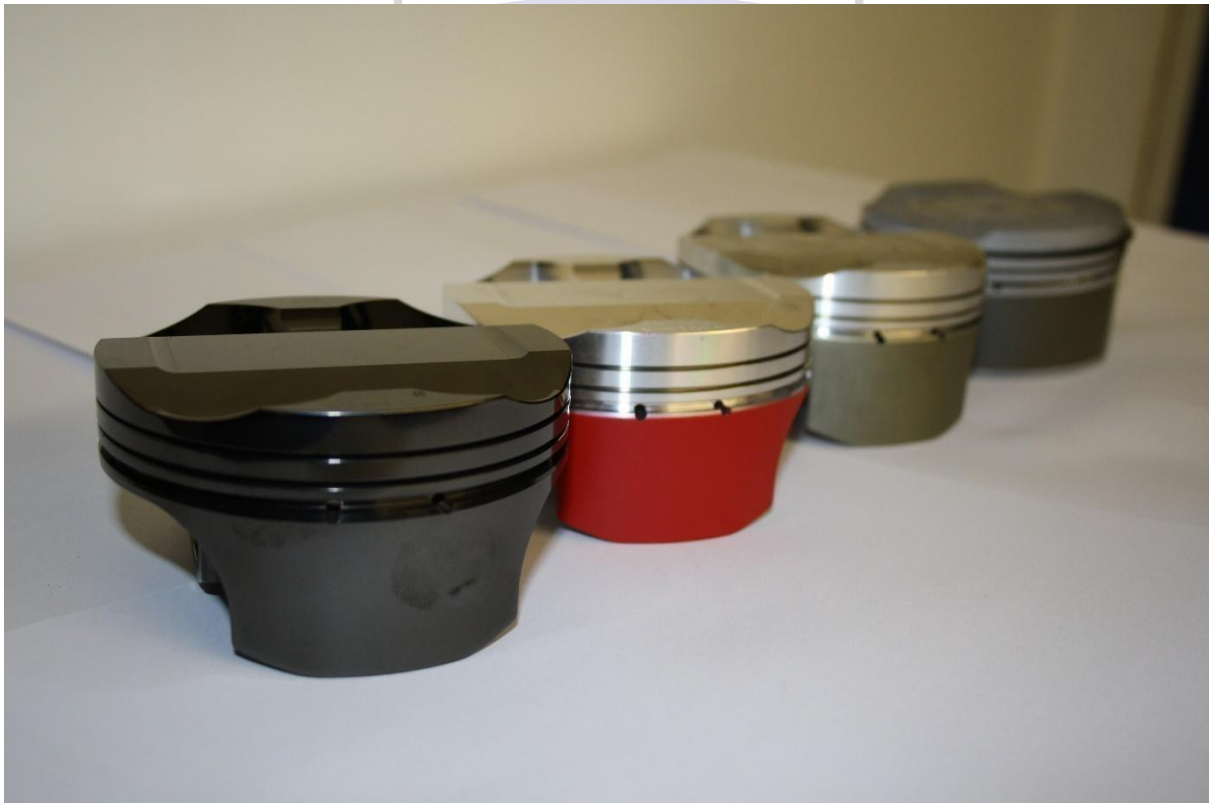
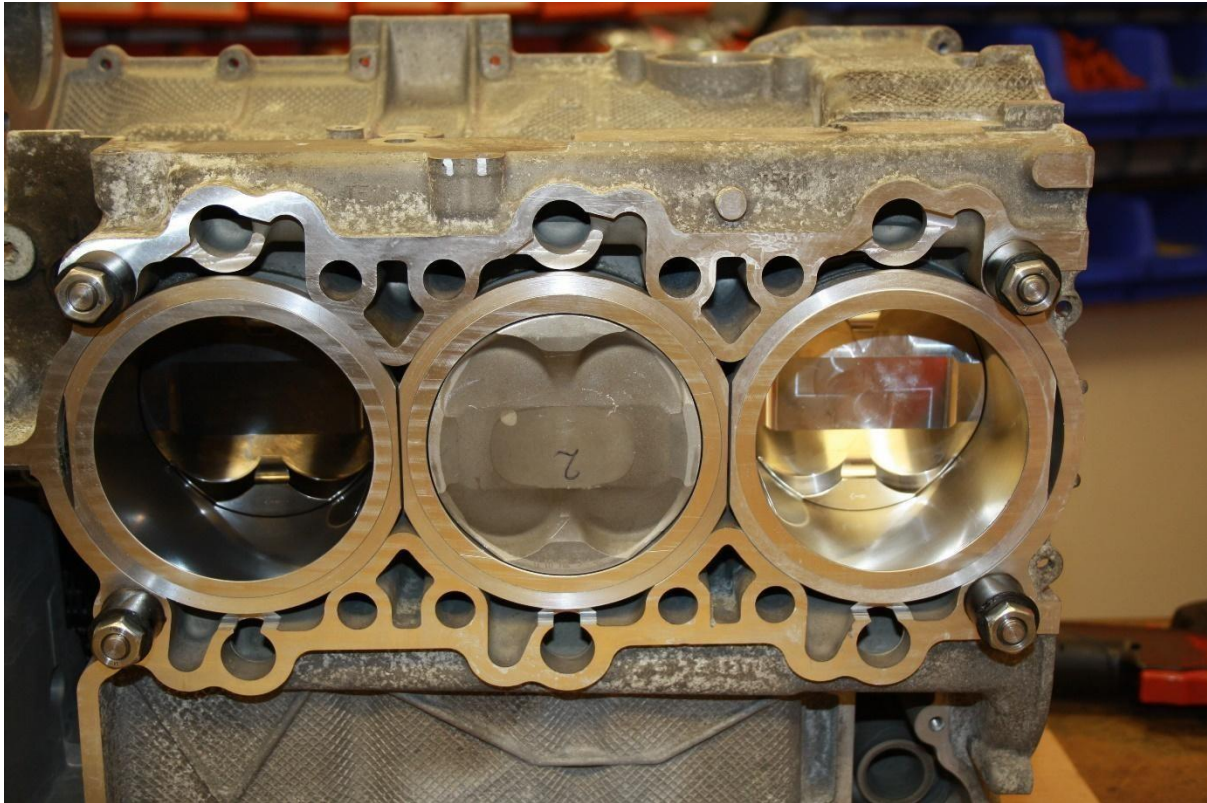
to have samples coated by reputable alternative suppliers we could find Worldwide (including different materials both plastic and an alternative type of metallic coating) and to save testing costs fitted 2 of each in each of our test cars (one in each bank) to test 3 variants/test engine runs and 6 different coatings overall in 2 engines, as shown below.

Upon stripping and inspecting we found none were hard enough to last for an acceptable mileage. The best was a new metallic plated coating (ferrotec) from a major piston supplier but that didn't seem to be magnetic (which we think is probably the same coating used in the later 9A1 Gen 2 Alusil engines – but more about that later on).

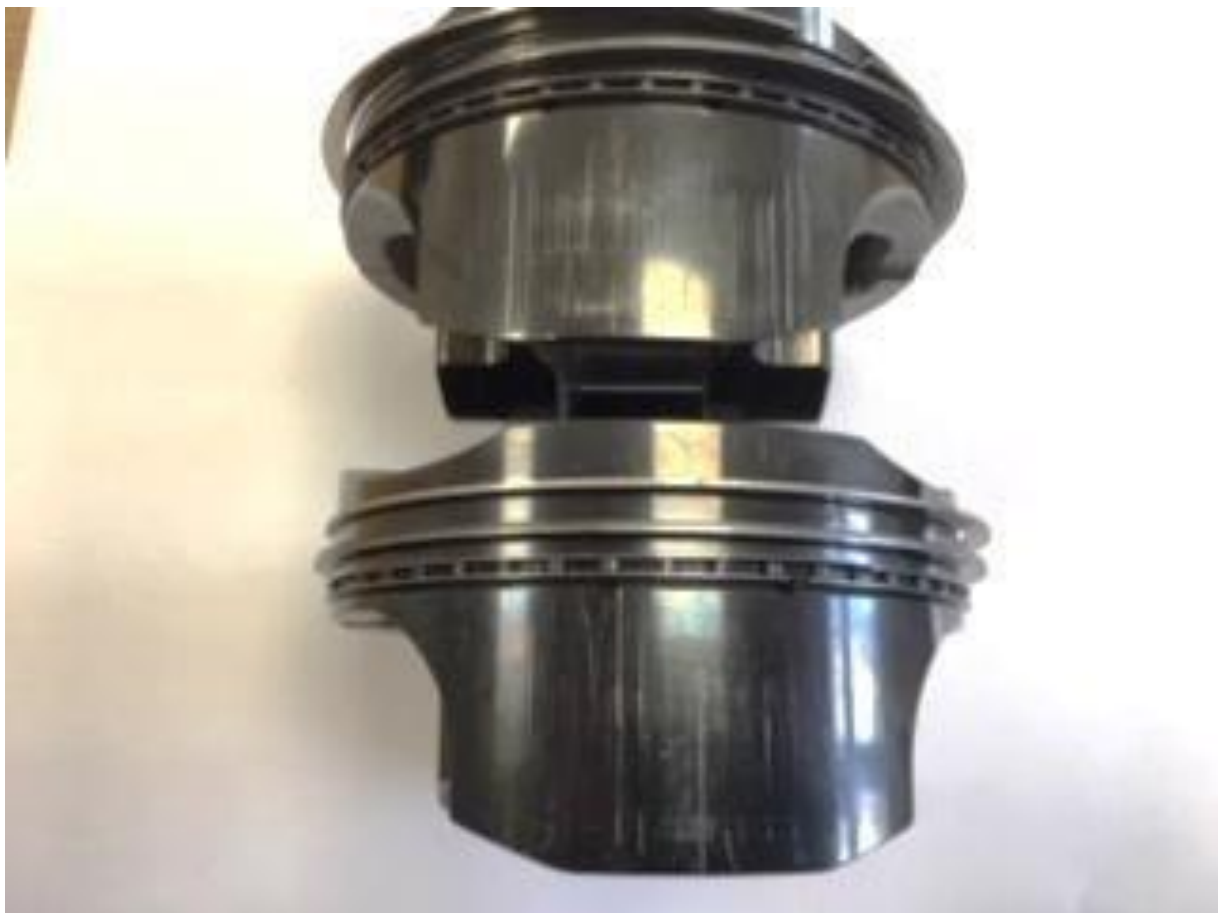
To be fair to others that have reached different conclusions - we are not so sure **we** would have understood this as quickly if we had not been able to see the evidence for ourselves through simply trying a DLC coated piston – but once we had, the evidence was clear and convincing. You can even see in the following photo - places where the score was initially quite deep and then probably because the particle changed in position to a smaller section – the scores reduced in depth.

believe that the hard silicon particles in the Lokasil must have become free from their matrix and floated free between the piston and the cylinder bore until the oil eventually washed them away or they stuck to the softer plastic coating in most of the pistons we tested and upon rubbing up and down the cylinder bore – created bore scoring. We were also surprised at the width of the scratches (that we were clearly seeing for the first time).

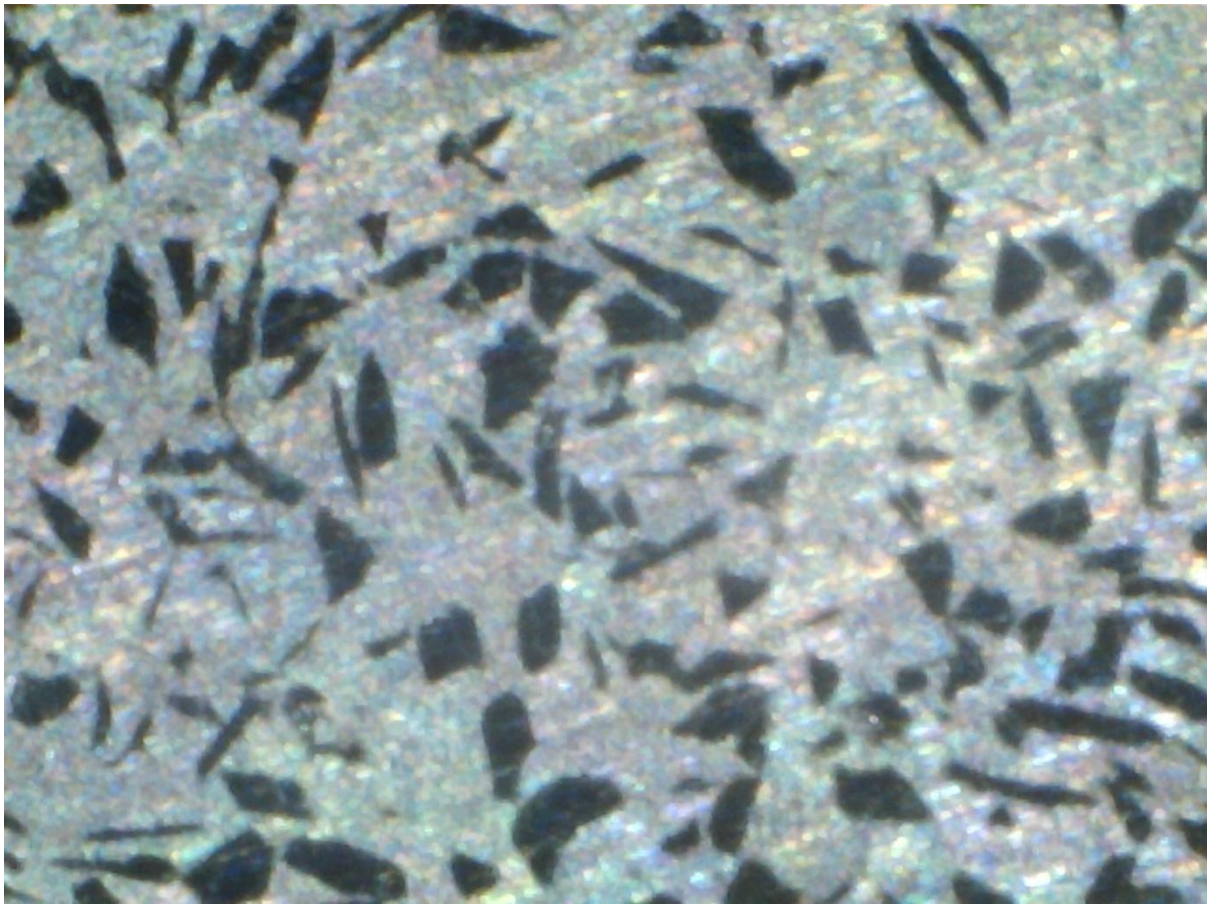
The picture following shows the shapes of the silicon particles in Lokasil. It is not difficult to imagine that if these sharp edges (that might be as big or bigger than the bore clearance in their longest direction) came into contact with a relatively soft plastic coating – that it could damage it or wear it out.

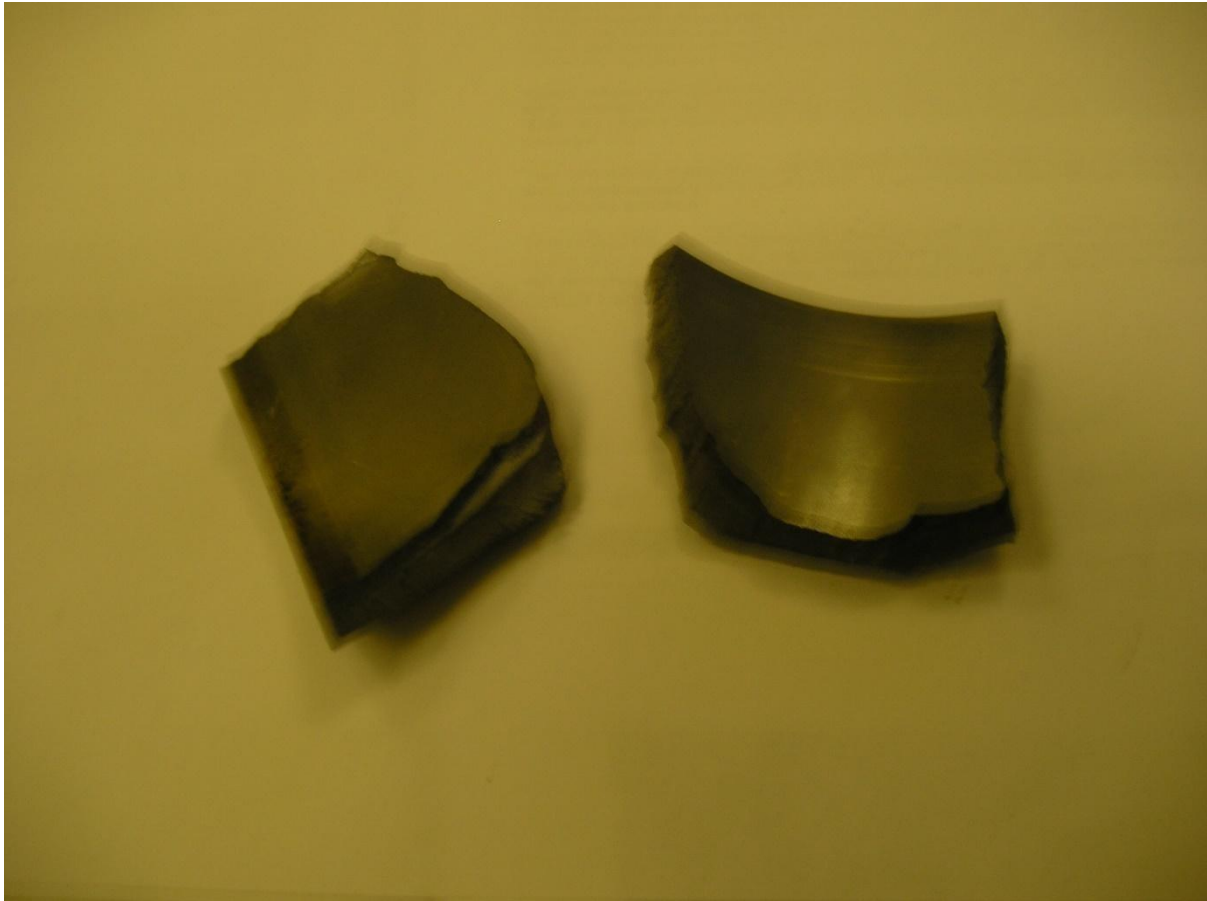
Despite the manufacturers description it is clear from the result of looking at broken "D" chunk sections that the Lokasil portion is not as homogeneously cast in as you might expect and breaks showing a clear division between the two matrix's.

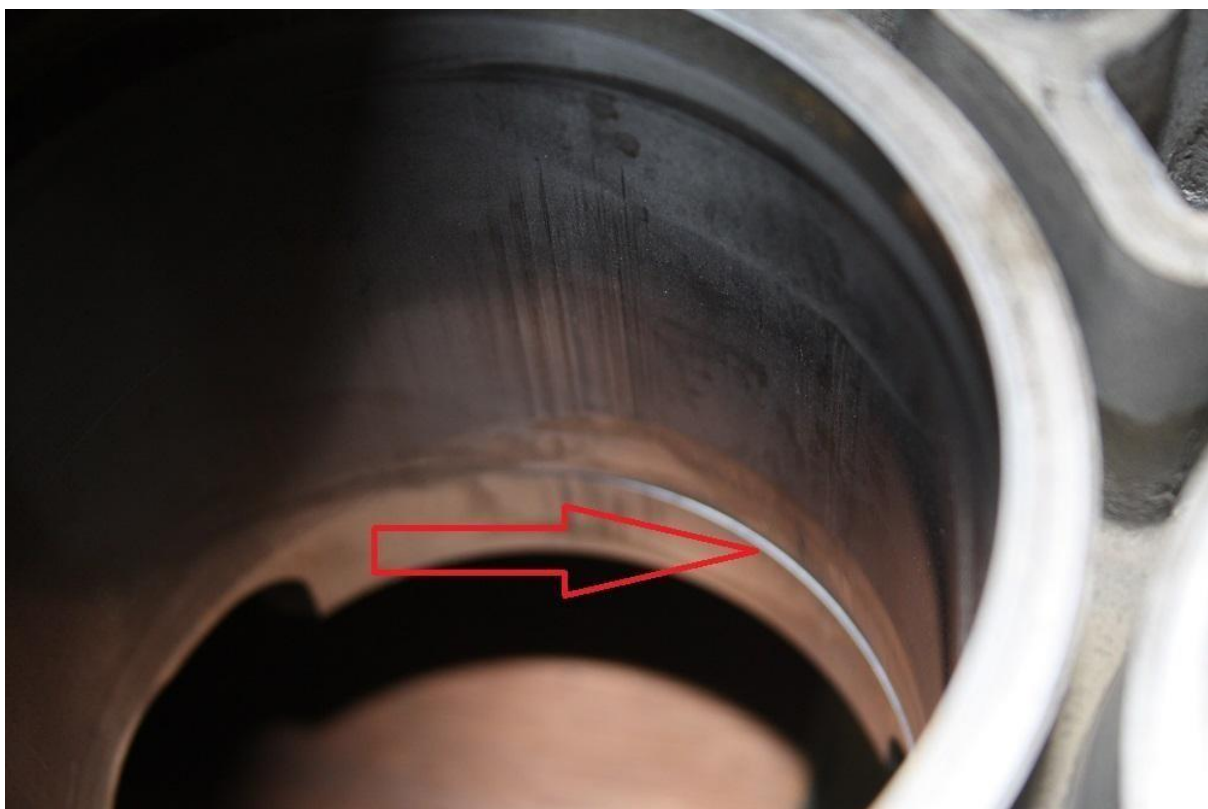
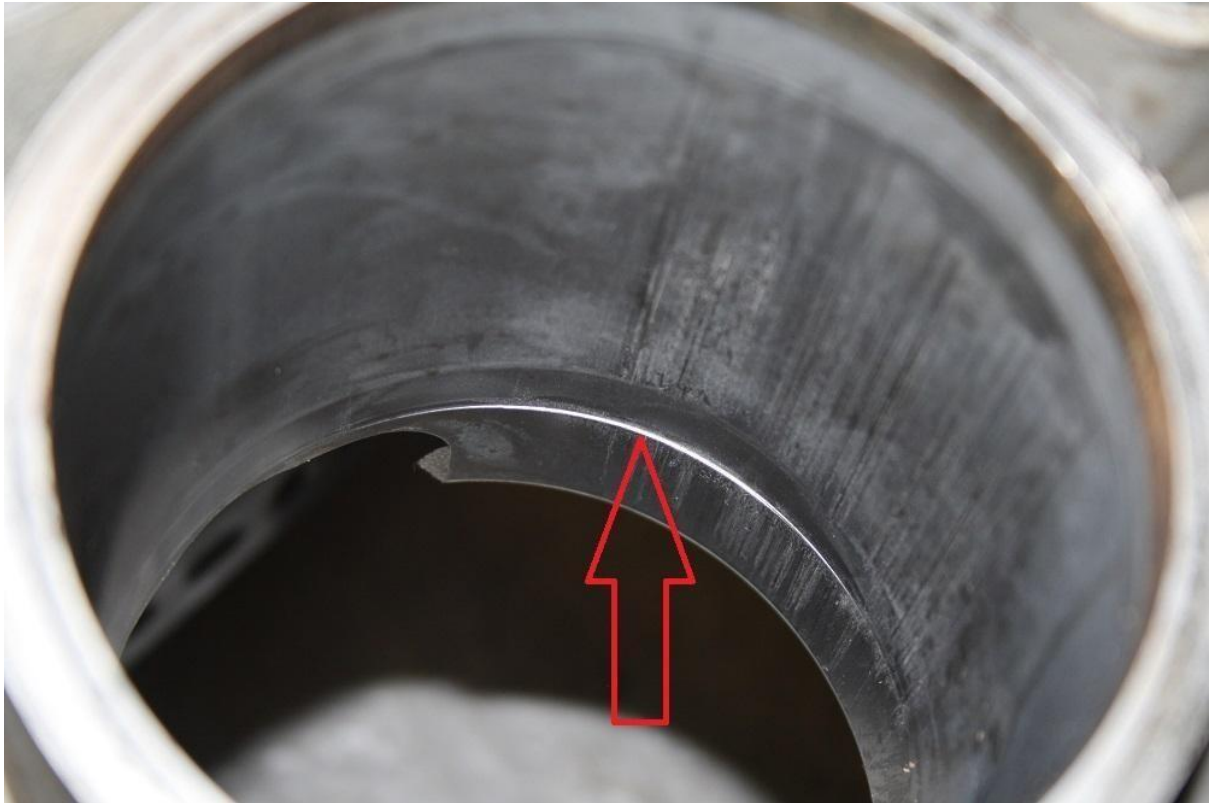
bore material had completely been washed away by oil or eroded to an unacceptable depth by the rings in some areas and many others where the distribution of silicon was not even and we thought this was similar to our analogy of a road surface that areas where too many stones were more densely distributed (and therefore with less tar between them) always seem to be the first to create pot holes.

The following pictures show loss of silicon and alloy washed or scraped away by the rings and demonstrating the variation in the make up of the original preform before it was cast

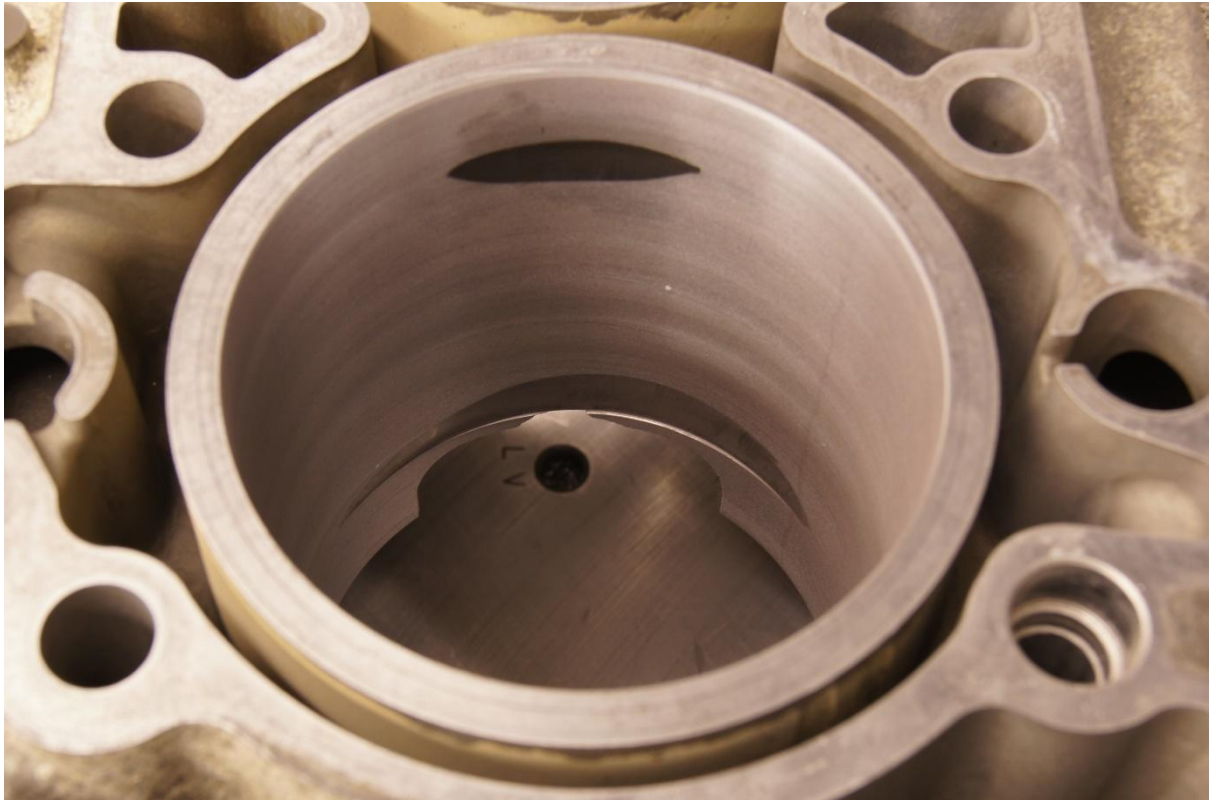
Despite already having machined away some of the original bore - this next picture shows areas not touched by the rings and clearly washed away.

It also shows again the small standard slot that passes coolant into the cylinder block (on the RHS) and the main hole that delivers the majority of it directly into the cylinder head.
