The main problems with Porsche engines

The 3 main failures of M96/7 engines

IMS bearing, Cylinder cracking and “D” chunking, Cylinder scoring.

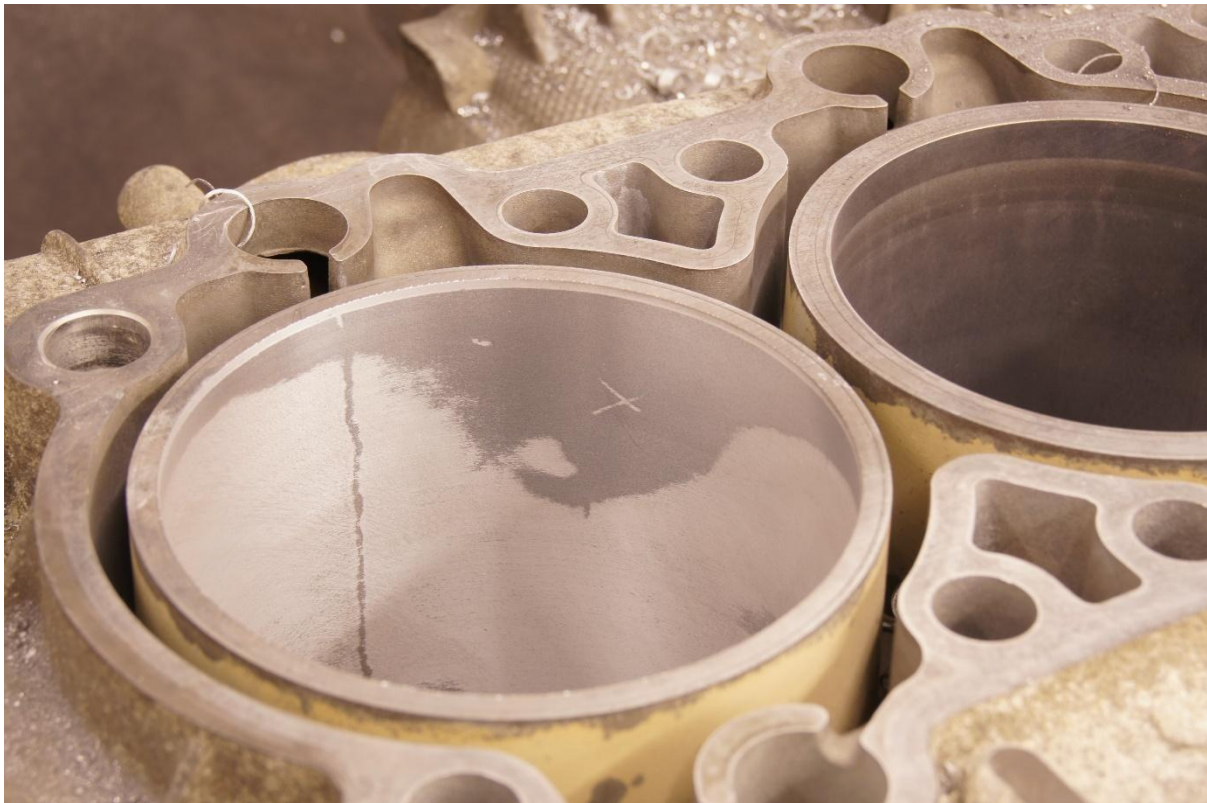
Another interesting observation was that as we machined away the Lokasil (to a point where it was microscopically thin) we saw a cross drawn on many of the preforms which were usually set away from the main thrust face and towards the sides (where there is no thrust load) and concluded that there may have been a selection process to place the observed best area of the preform (with the most suitable silicon distribution) to the thrust face (and therefore that the distribution of the silicon particles did indeed vary) and the rotational position of the preform was assembled in the casting moulds accordingly.

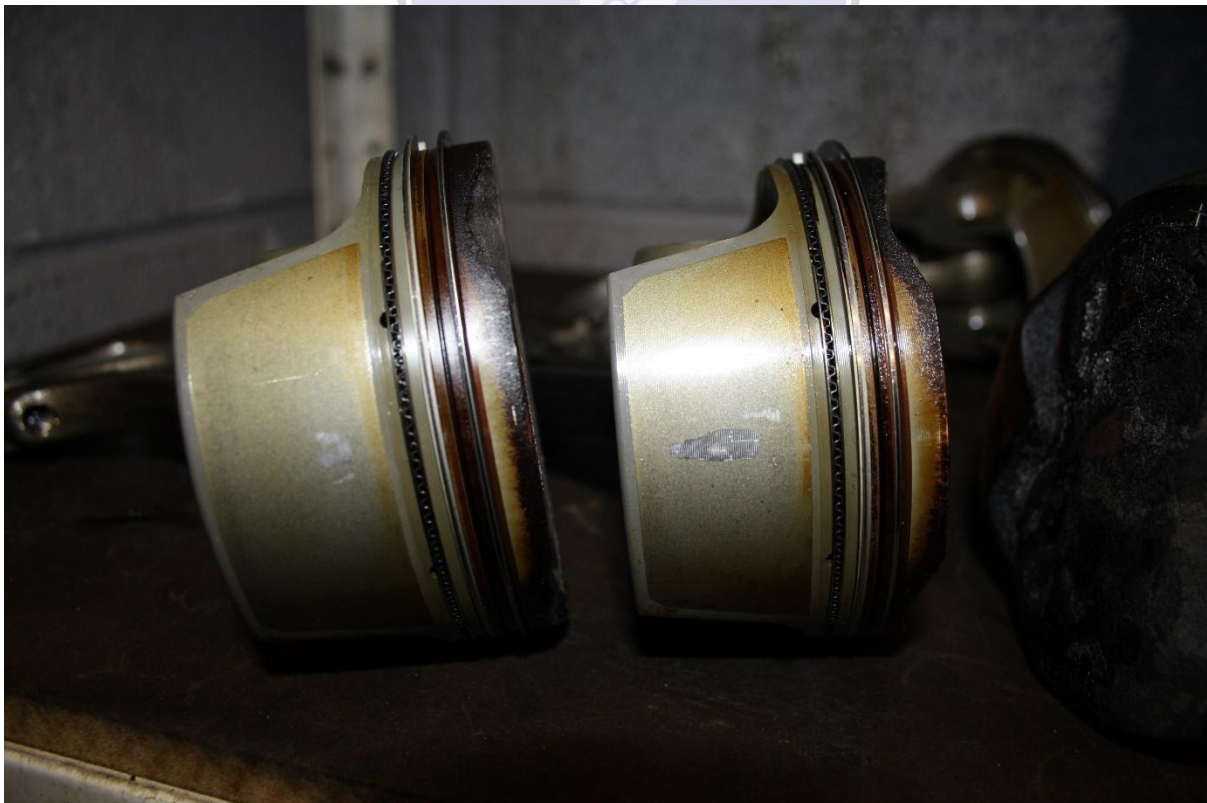
You can see from the following pictures of early marked pistons that the damage is indeed right in the centre where the clearance is smallest and visual inspection shows that it would take a particle to do this damage and not a smooth bore suffering from inadequate hydrodynamic oil film.

Once the centre coating has been picked off or worn down – the ovality reduces and the contact patch spreads further round the circumference so the positions each side of the centre would then be the next to be closest to the cylinder wall and so the wear would gradually spread around the thrust face of the piston until there was little or no coating left to try and resist the impact of a large piece of released silicon (and this was evident on stripping and inspecting hundreds of pistons).

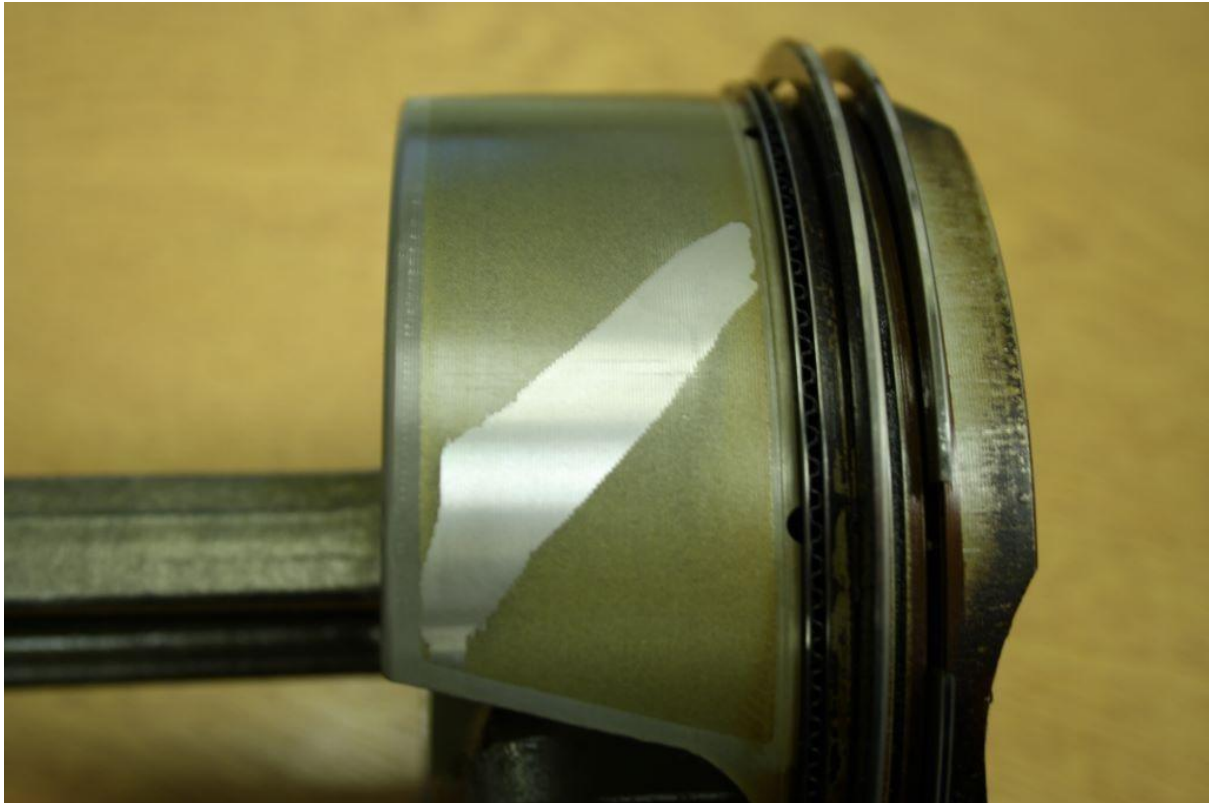
And this photo shows that bonding strength of the plastic coating to the piston face must also be an issue to enable a diagonal strip that will have been plucked in the centre first - to come off diagonally when all the motion is only vertical.

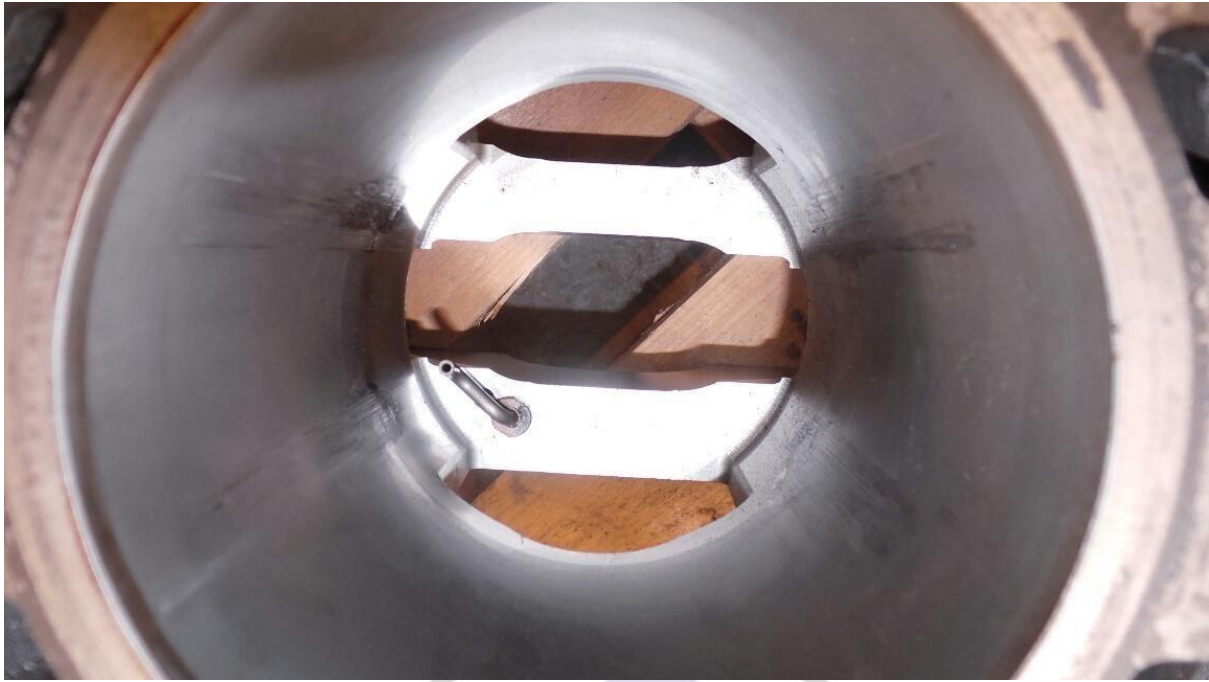
Seizing occurs when the piston has expanded more than the cylinder it is fitted into so that the forces pushing the piston faces against the cylinder wall exceed the ability of the oil to keep them apart and the heat generated from the increased friction loads results in micro- melting and welding of aluminium particles on the piston face that then rub deep grooves in the cylinder wall. This then causes more cylinder wall material to be scratched out creating a rapidly failing sequence sometimes resulting in the piston being jammed in the bore and at other times still free but with the piston badly damaged – often crushing the piston faces inwards which increases the original clearances and sometimes leaves the engine running but badly damaged.

The following picture is looking down a Gen 2 bore and shows the seizure marks on both sides of the bore (and coincidentally very much nearer the bottom where there is a pair of casting portions connecting and restraining both sides of the bore).

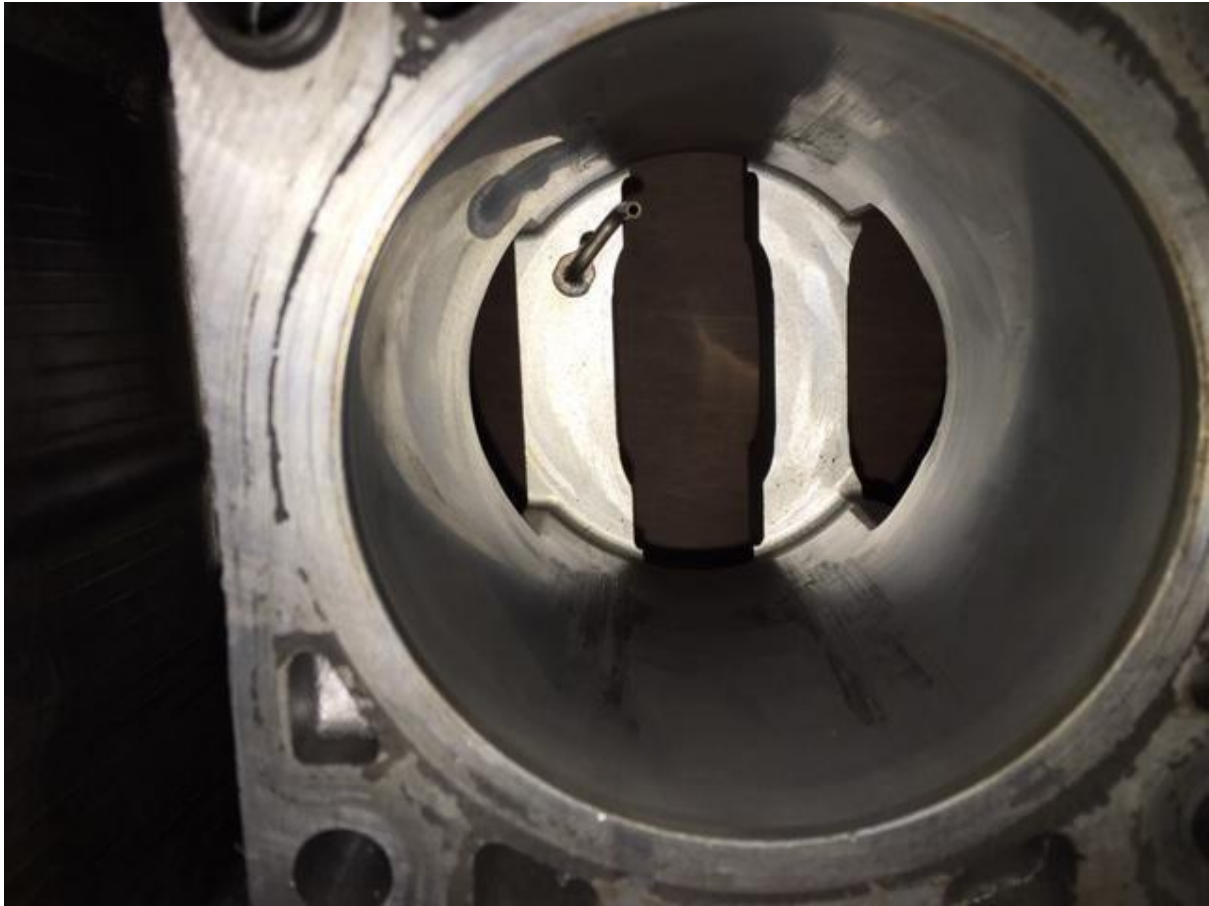
But we cannot be sure if this gradual shrinkage is because of released cast-in stresses or the result of the difference in expansion and contraction rates during heat cool running cycles (or both) as described above. So we are not sure if the contraction was due to this uneven expansion rate between the different areas of the cylinder block over many heat/cool cycles - OR because of entrapped stresses during the casting cooling process – if this area gradually shrunk so that

the bore went slightly oval and smaller in the thrust direction (where the piston is at its biggest), then it is even more likely that during fast warm up the clearances would be too small and the piston could seize.

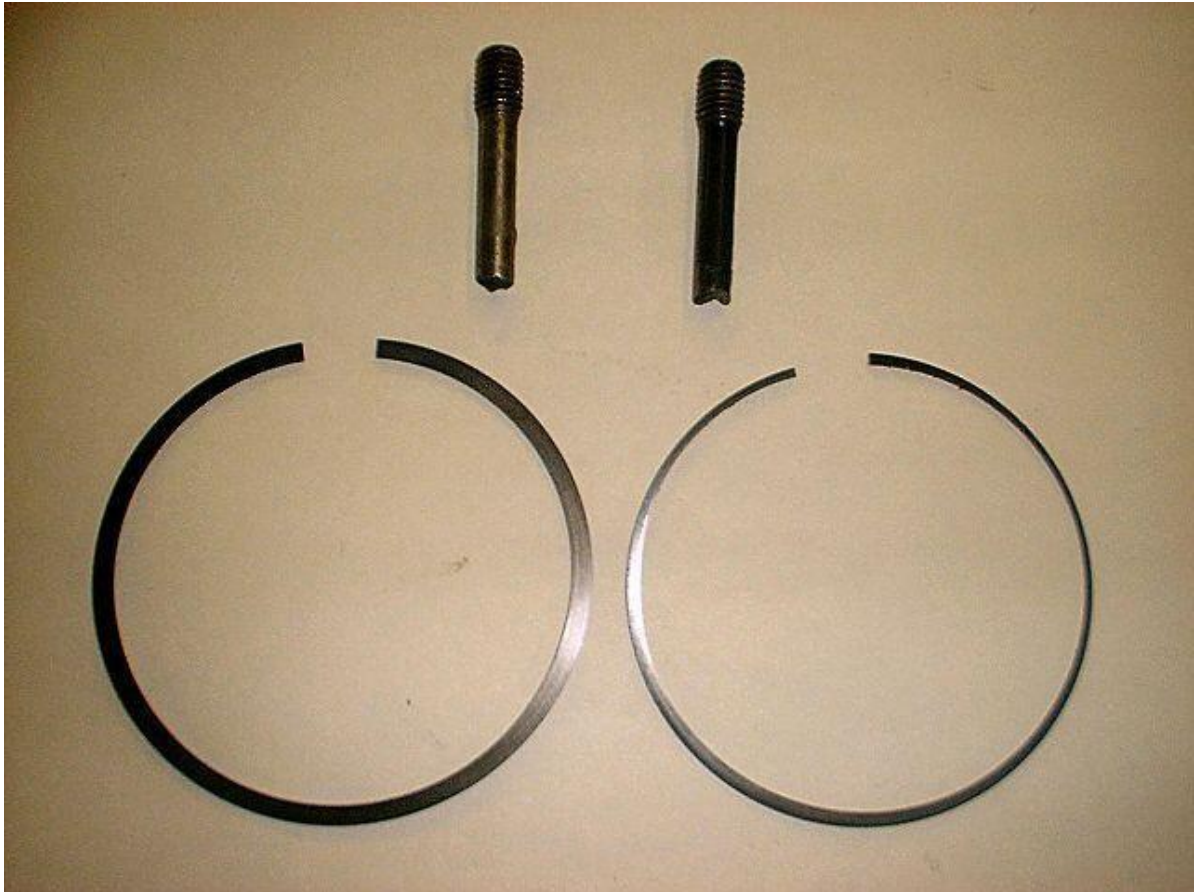
The following picture shows broken cylinder studs and the difference between a new and worn Carrera piston ring after 70K.

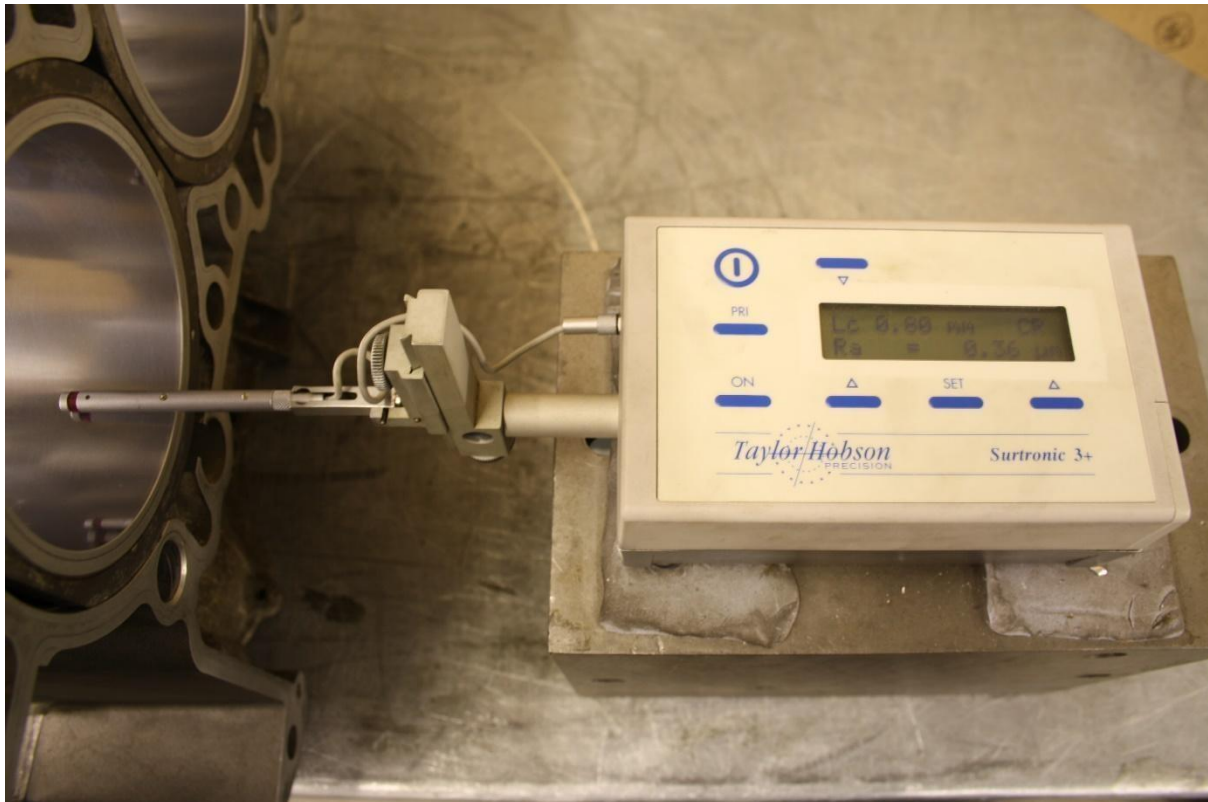
Typical shiny bores being measured by us for surface finish.

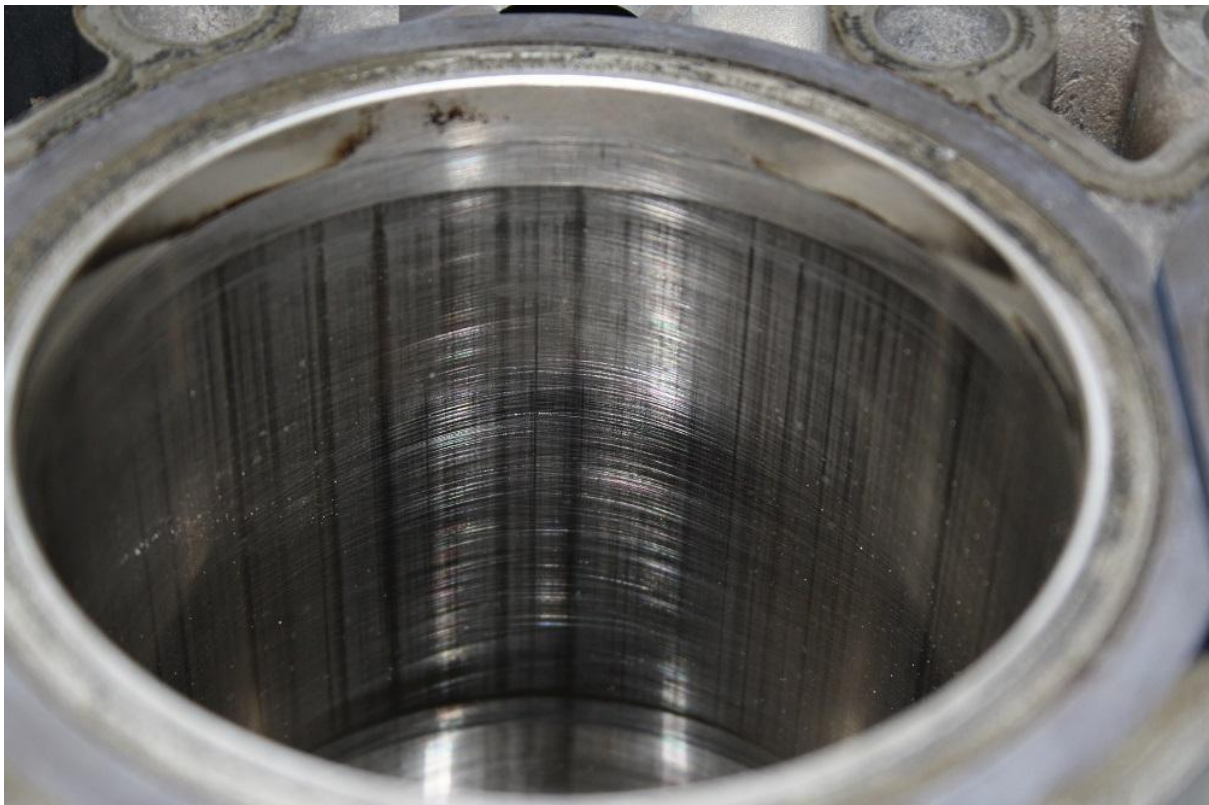
The following picture shows typical polishing marks of a high mileage Hartech cylinder that might appear but have no depth and cannot be measured by normal bore measuring equipment.
