Hartech Engine Rebuilds (interim)

Index of the content with explanations and descriptions.

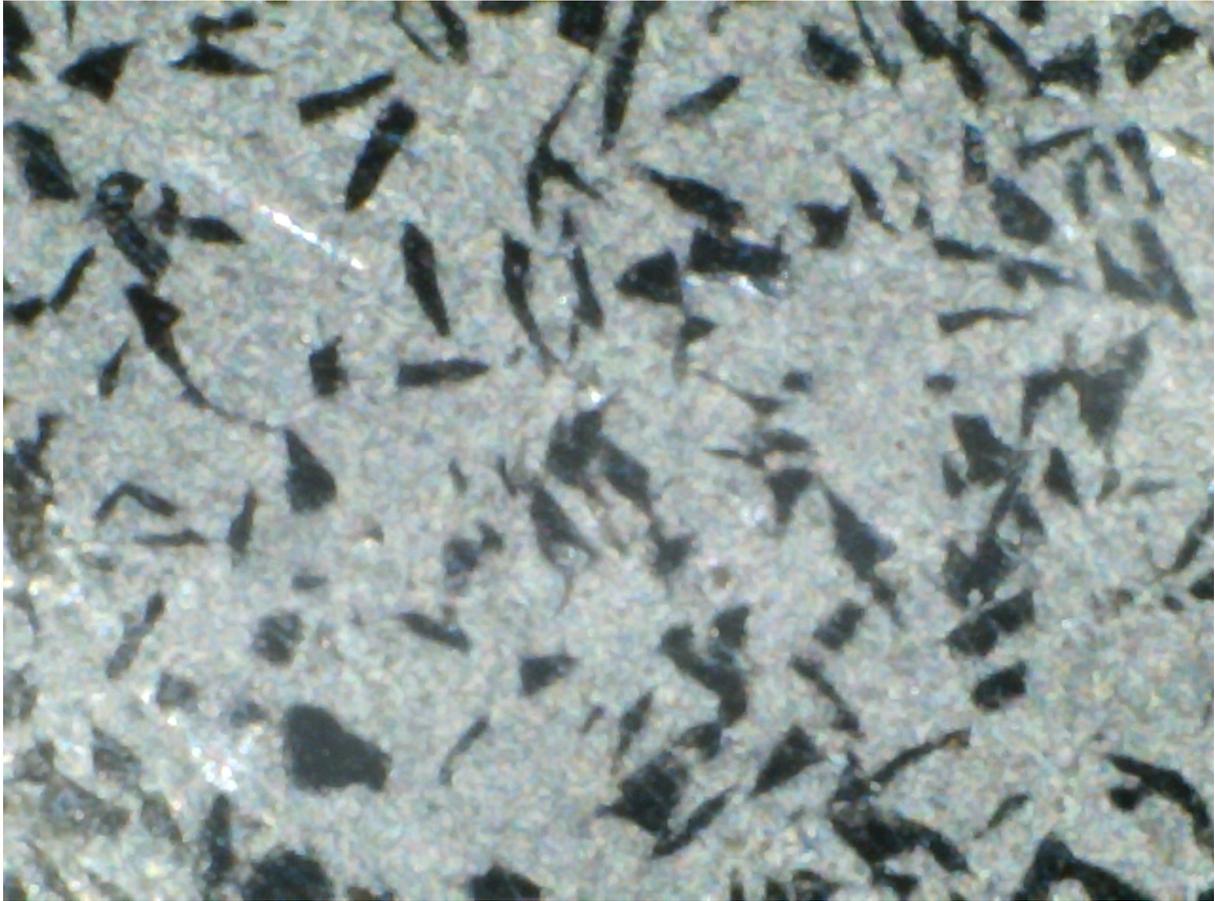
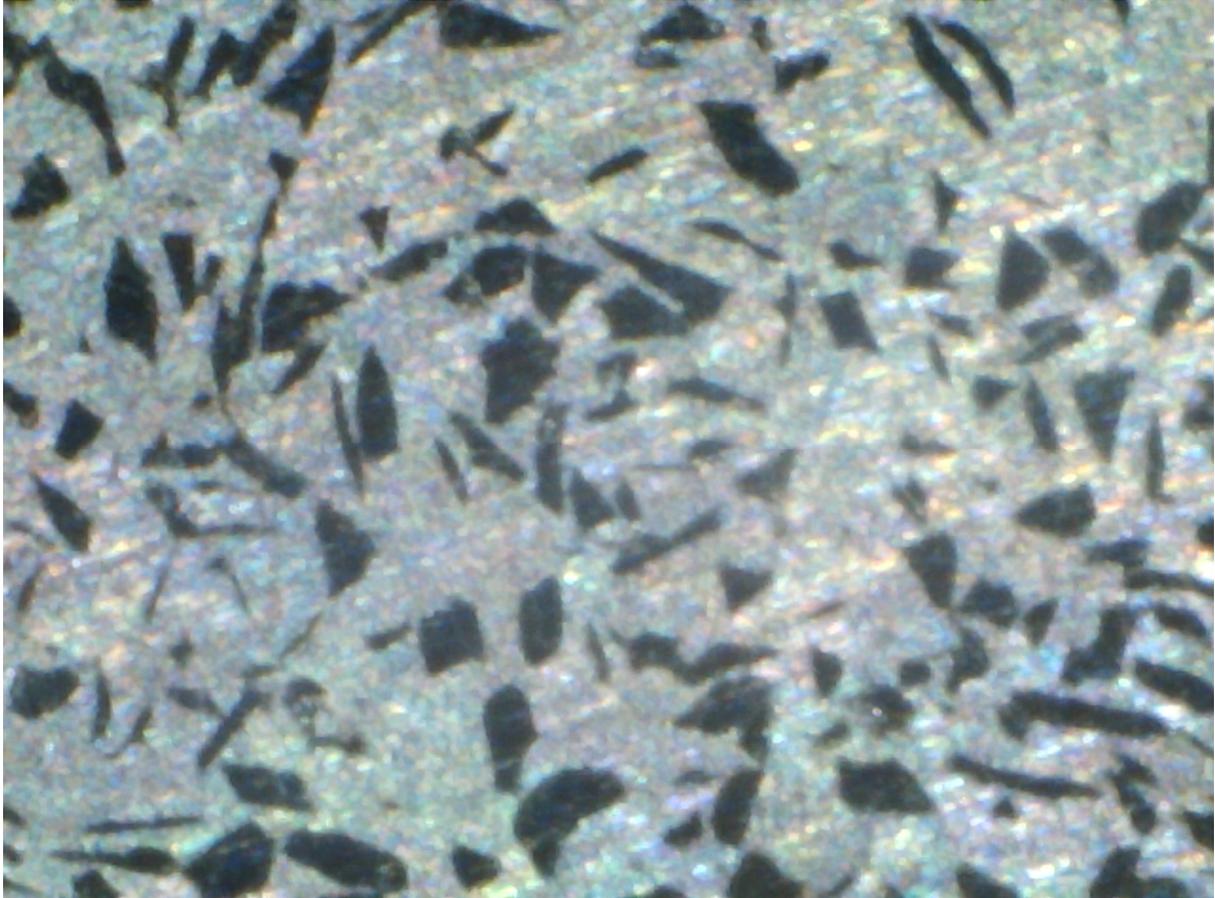
The following pictures are taken with our own microscope used to compare the surface finish of our own re-bored cylinders (the first picture) and an original brand new Porsche supplied cylinder block (the second picture) . It shows the flakes of silicon embedded in the matrix and the degree of exposure of that matrix needed to create the right surface finish. This whole process is extremely challenging and demands a great deal of experimentation and testing – which involves driving cars and then re-stripping down the engines to inspect and measure the results – that we have been through and are reaping the benefits from.

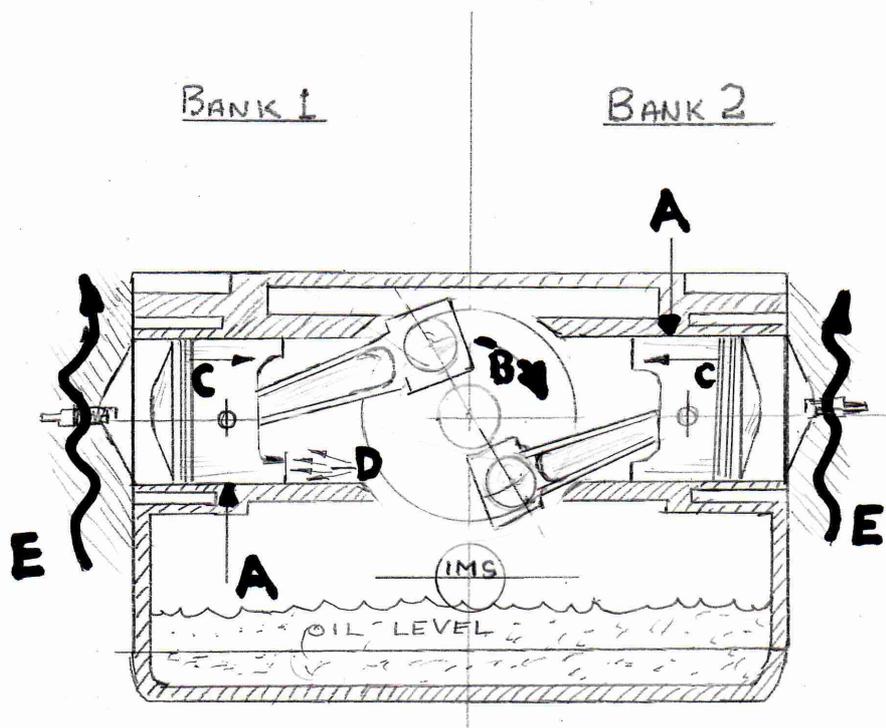
The wiggly line "E" shows that the coolant enters both banks at the bottom – so bank 2 coolant is hotter on the thrust side than bank 1 – hence the oil viscosity will be lower. You can also work out approximately where that maximum thrust will occur because the maximum cylinder pressure occurs after top dead centre and as the fuel burns it continues to increase while the piston is moving down the bore. The greatest mechanical advantage is when the angle between the rod centre line and the tangent at the crank pin is the same (90 degrees to the radius - approximately as drawn) – but by this point – although the pressure has been increasing the volume it occupies has been reducing (as the piston moves down the bore) so there is reasonably constant force on the piston at and around the 90 degree angle point – where the highest cylinder and piston face loads then occur. This is also where the evidence of the worst amount of scoring occurs in all the cylinders we see.

The sketch also shows the oil level being lower than the crankshaft and how spray jets lubricate the little end and bore "D". Bank 2 also has the spray jets in the same place at the bottom (not shown on the sketch as the rod is in the way). Because gravity will naturally pull oil spray downwards and because both spray jets are located at the lower end of the cylinder – the bottom will naturally get better lubrication – once again favouring bank 1.

All this is why BANK “2” IS USUALLY THE SIDE TO FAIL (by some 97%).

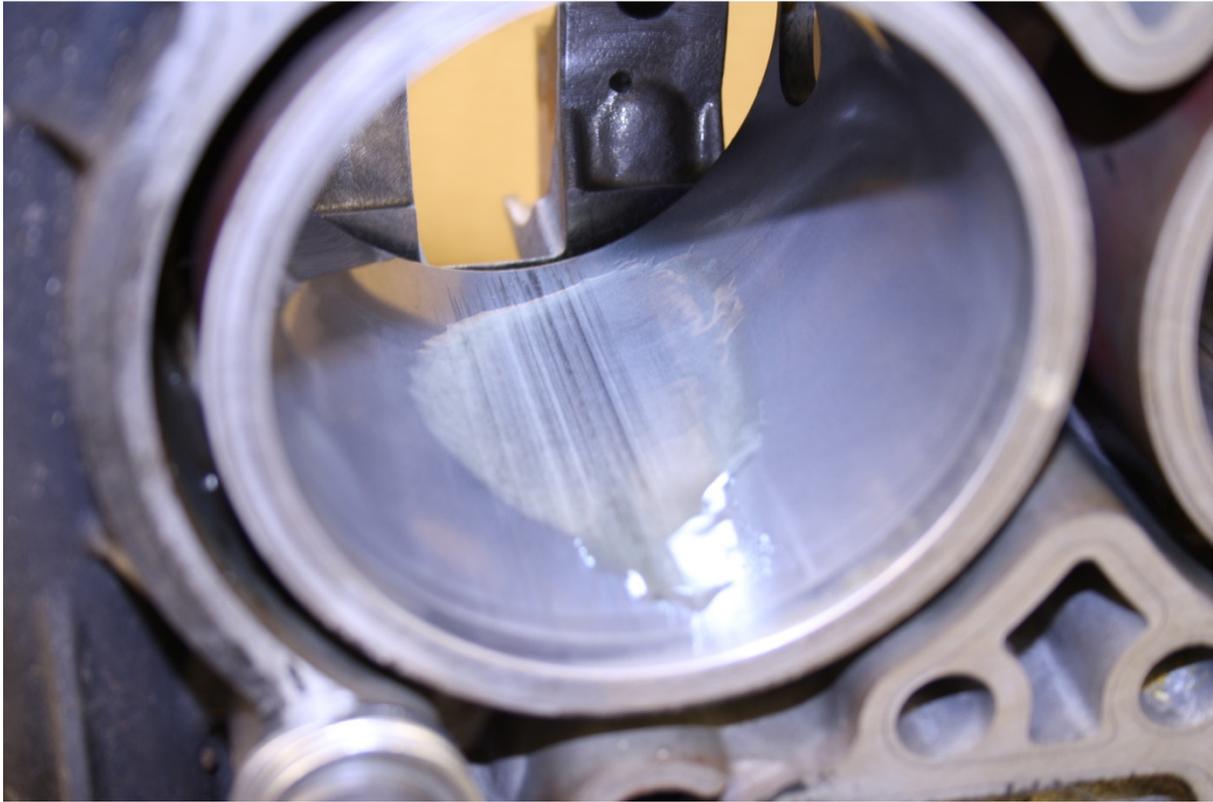
The following photo shows oil after spraying through the new spray jets into the area it had previously been scored. If there was a piston there it would spread that oil film across the whole area of the scoring on its way down – thus ensuring there is sufficient to cope with the loads and at lower

oil temperatures and therefore greater viscosity. You can see how the oil spray jet distributes oil across the surface – but the photo is from simply squeezing oil through the jet and allowing it to run down – when we do it under pressure the view is much more conclusive that it does spread the oil all across the surface – but we cannot manage to take a photo that shows this perfectly under pressure as the mist blocks the view and spreads oil everywhere including the camera lens.

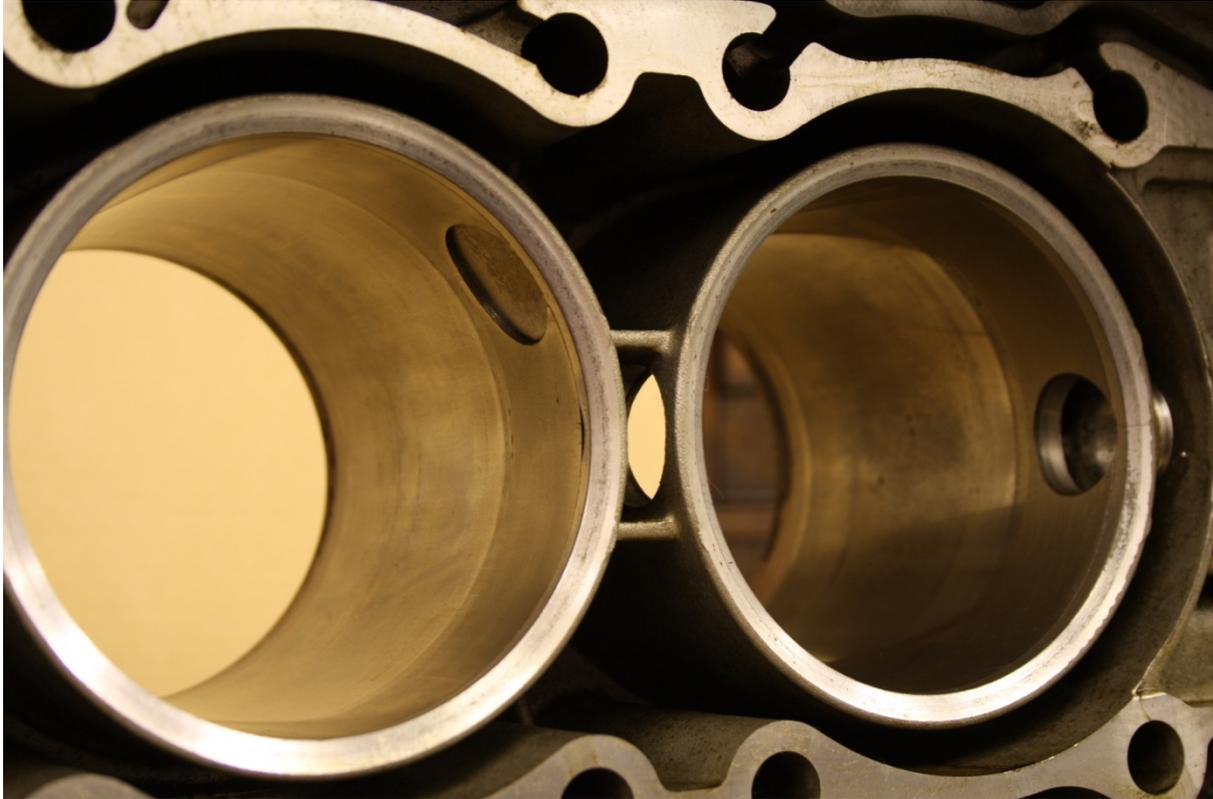
Already evidence of this poor solution has come to our attention in rebuilding failed engines fitted with iron liners (as the iron liner in the following photo clearly demonstrates – having turned after assembly from the position to fit the gudgeon pin shown on the RHS) potentially allowing the piston skirt to catch the edge of the assembly hole. Similarly another engine with a thicker liner had problems.

However – although fitting an iron liner (which we could easily do well) is cheaper than fitting a Nikasil alloy liner (as we do for cracked and scored pistons) – the new solution we are currently testing in several engines (of simply re-boring the existing Lokasil bore) is even less expensive as the additional cost on top of the new piston is simply that of a rebore. As previously reported though – that re-boring has taken a lot of expensive equipment and machinery and a lot of learning and not getting it right initially – costing several builds and rebuilds for inspections and adjustments.

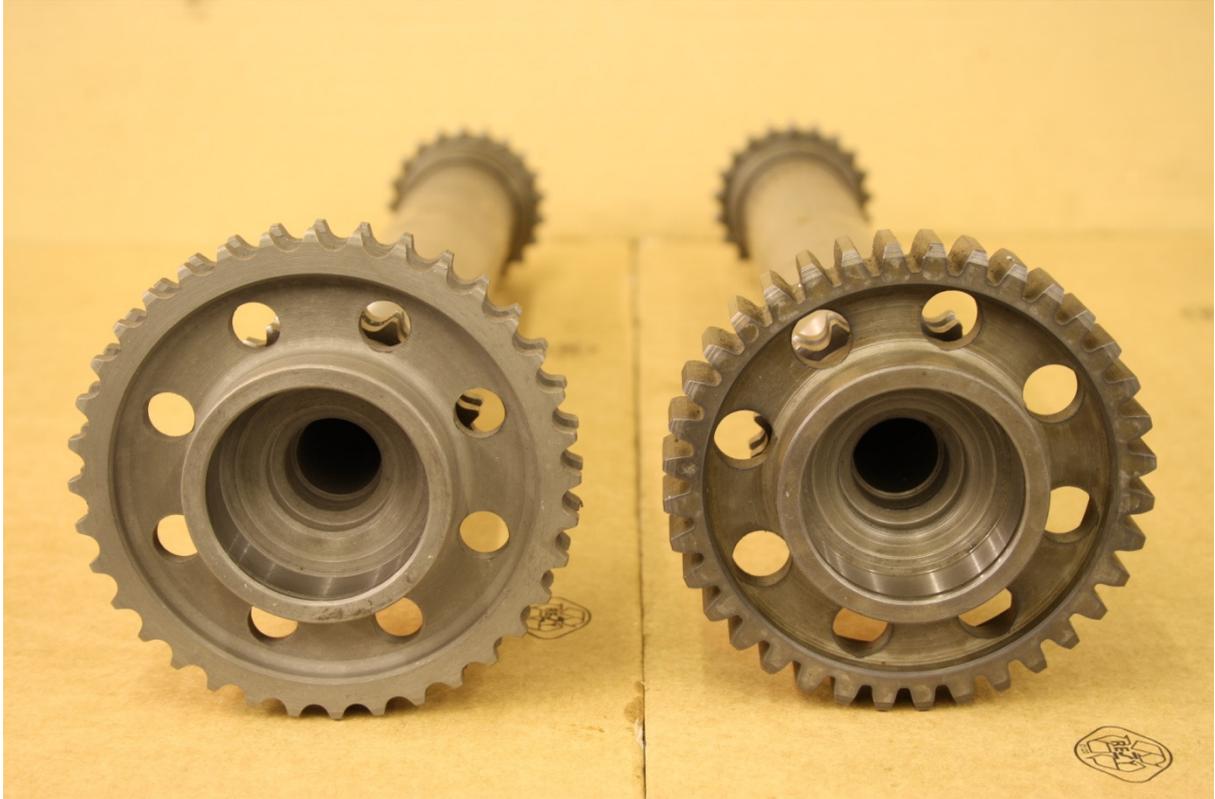
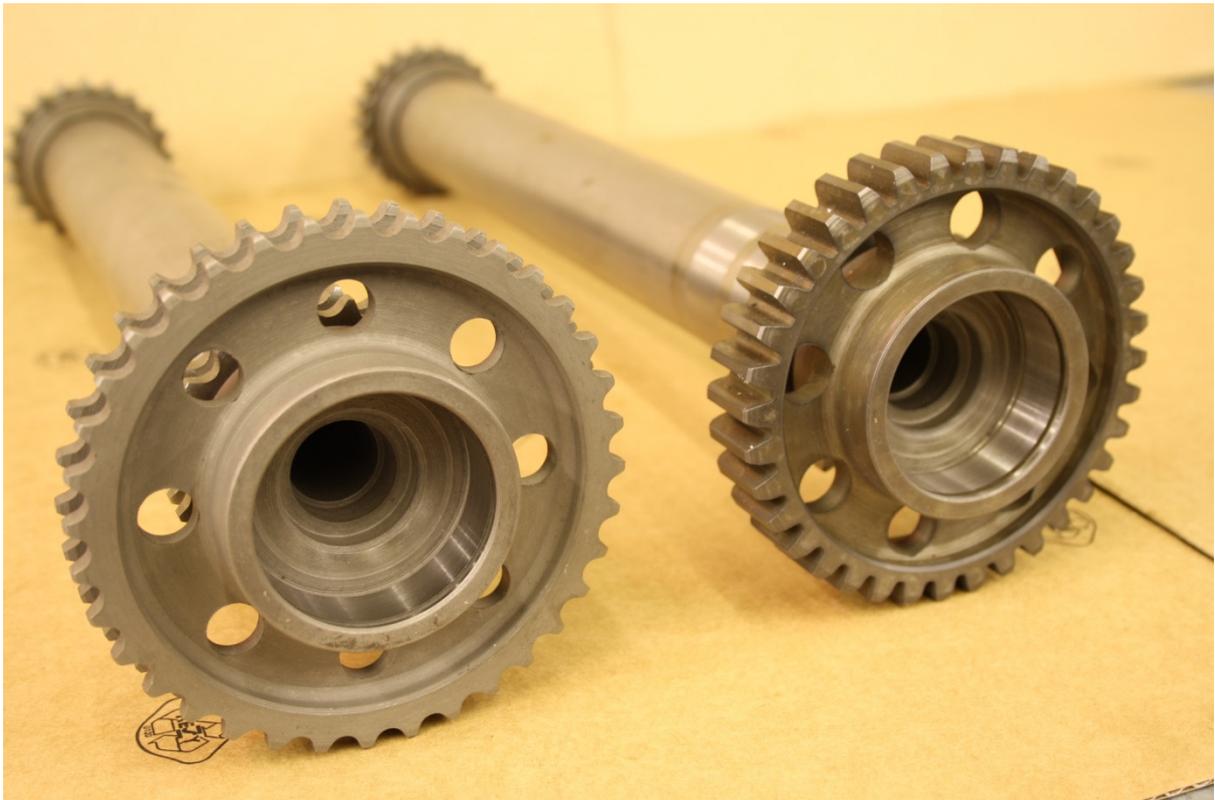
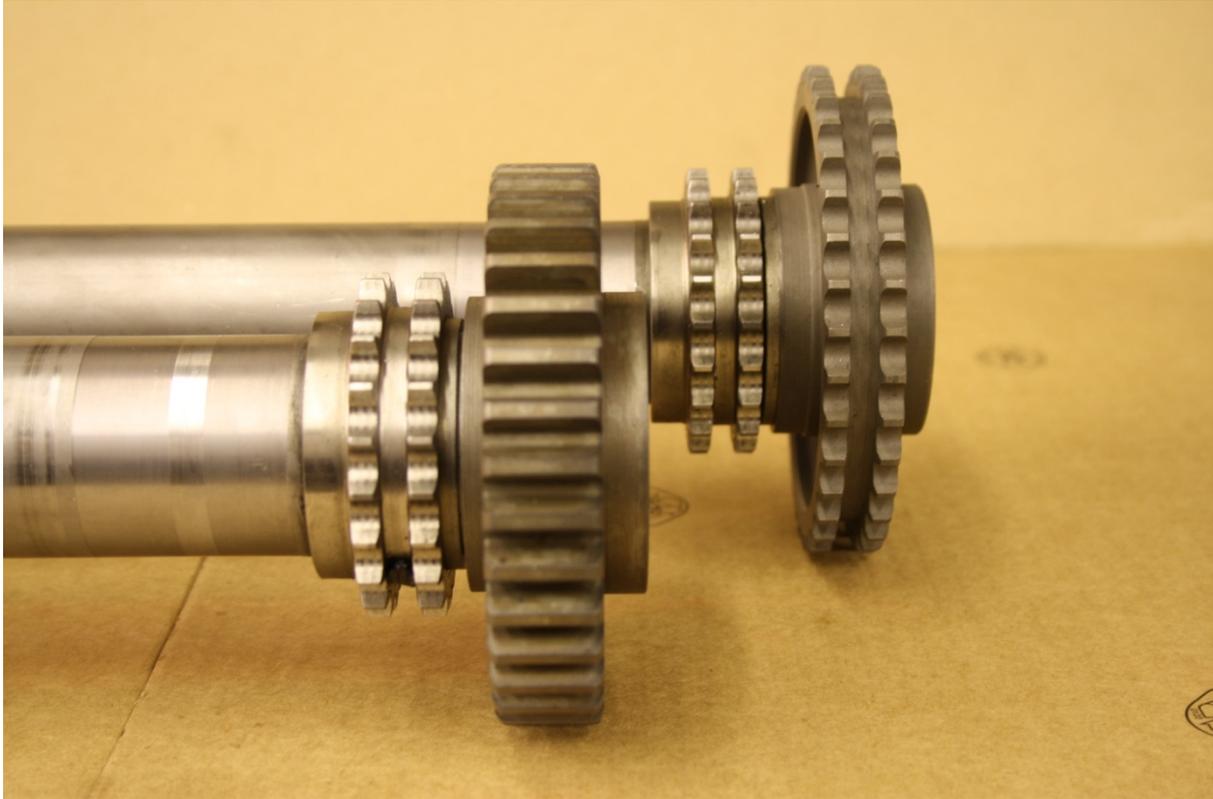
The majority of engines with IMS bearing failure have also damaged the end gear (that supports the bearing) beyond repair. Furthermore older engines with roller chain crankshaft/camshaft drives cannot be fitted with the later IMS shaft with the larger bearing because it would need a new crankshaft to mate with it – so replacing IMS failures is becoming more expensive.

A long time ago we designed, manufactured and tested both roller chain and the later Hivo chain new Hartech end gears (designed and manufactured "IN HOUSE") with satisfaction – in readiness to replace the damaged ends (in preference to buying a new shaft) but at the time new IMS shafts were reasonably priced and we had quite a good stock of good used ones to work through so we didn't go into volume manufacture or make them generally available. See following photos.

However the price of a new IMS shaft has more than doubled to almost £1000 (including Vat) and meanwhile the larger IMS bearing fitted to the newest cars has proven more reliable. So we have now re-designed these same replacement end gears to accept the later and larger bearing and these will be available later this year to enable any IMS shaft of any year to be fitted with a new replacement end gear of either roller or Hivo chain design and fitted with the larger and later IMS bearing throughout.
